Profile/Photo Observation Report

Street:	FOXCROFT STREET	Flow Control:	Not Controlled
City:	Hobart, IN	Year Renewed:	
Location:	Yard	Tape/Media #:	
Purpose:	Routine Assessment	Dia/Height:	10"
Use:	Sanitary	Material:	VCP
Drain Area:	NA	Lining:	
Category:	NA		
Comment:	Flow direction is wrong.		
Location Details:		Direction of Survey:	Upstream
US MH:	M-507-015	DS MH:	M-507-016
		Total Length Surveyed (ft):	215.7

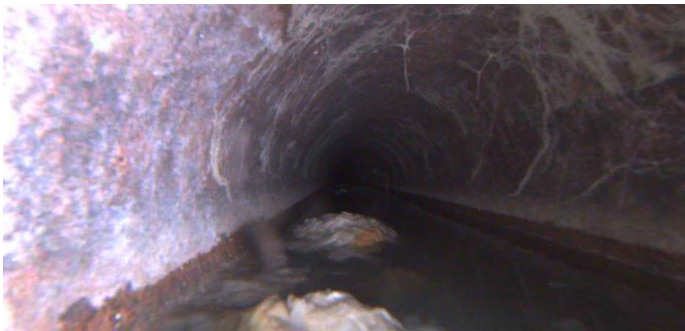
Code: **AMH**
Description: **Manhole**

Distance (ft): **.0**
Structural Grade: **0**
O&M Grade: **0**
Clock Start/From:
Clock To:
1st Value:
2nd Value:
Value Percent:
Continuous Index:
Within 8" of Joint: **NO**
Remarks: **M-507-016**

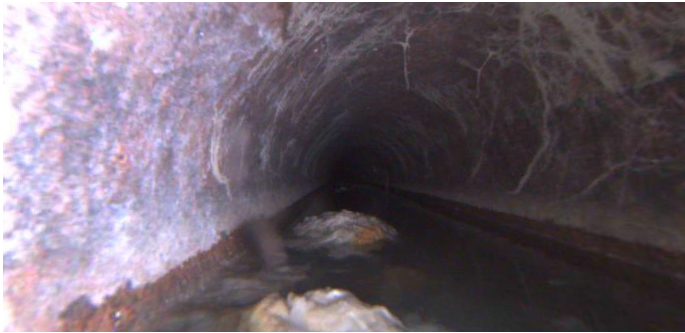
Code: **MWL**
Description: **Water Level**

Distance (ft): **.0**
Structural Grade: **0**
O&M Grade: **0**
Clock Start/From:
Clock To:
1st Value:
2nd Value:
Value Percent: **30.000**
Continuous Index:
Within 8" of Joint: **NO**
Remarks:

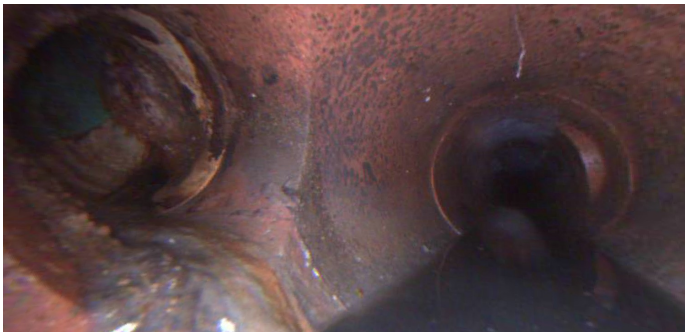
Code: **TFA**
Description: **Tap Factory Active**

Distance (ft): **39.7**
Structural Grade: **0**
O&M Grade: **0**
Clock Start/From: **9**
Clock To:
1st Value: **4.000**
2nd Value:
Value Percent:
Continuous Index:
Within 8" of Joint:
Remarks:

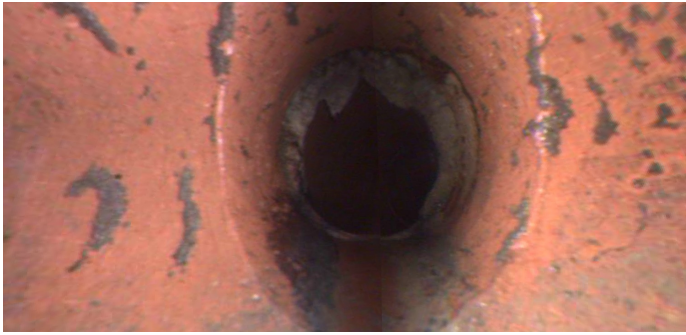
Code: **TFA**
Description: **Tap Factory Active**

Distance (ft): **41.9**
Structural Grade: **0**
O&M Grade: **0**
Clock Start/From: **3**
Clock To:
1st Value: **4.000**
2nd Value:
Value Percent:
Continuous Index:
Within 8" of Joint:
Remarks:

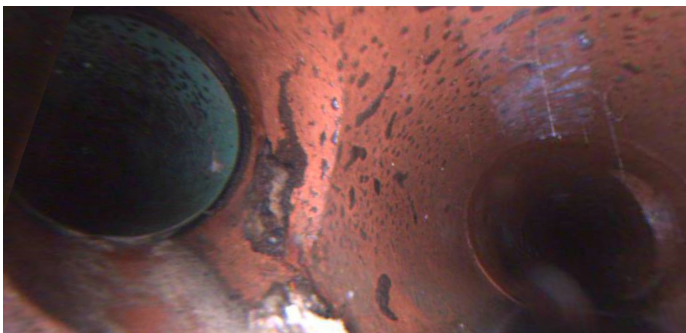
Code: **TF**
Description: **Tap Factory**

Distance (ft): **117.8**
Structural Grade: **0**
O&M Grade: **0**
Clock Start/From: **9**
Clock To:
1st Value: **4.000**
2nd Value:
Value Percent:
Continuous Index:
Within 8" of Joint:
Remarks:

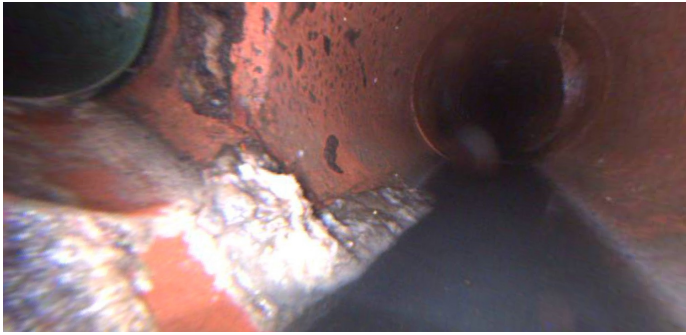
Code: **DAGS**
Description: **Deposits Attached Grease**

Distance (ft): **117.8**
Structural Grade: **0**
O&M Grade: **2**
Clock Start/From: **8**
Clock To: **9**
1st Value:
2nd Value:
Value Percent: **5.000**
Continuous Index:
Within 8" of Joint: **NO**
Remarks:

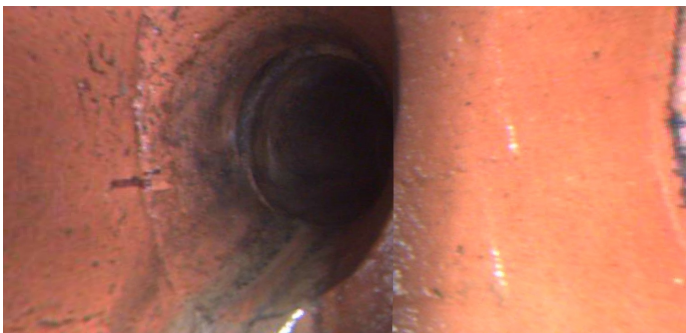
Code: **TFA**
Description: **Tap Factory Active**

Distance (ft): **119.9**
Structural Grade: **0**
O&M Grade: **0**
Clock Start/From: **3**
Clock To:
1st Value: **4.000**
2nd Value:
Value Percent:
Continuous Index:
Within 8" of Joint:
Remarks:

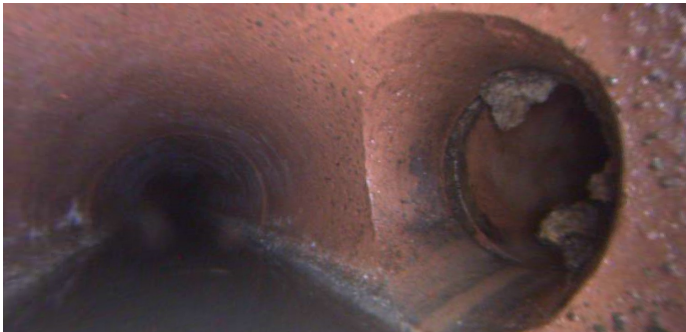
Code: **TF**
Description: **Tap Factory**

Distance (ft): **188.1**
Structural Grade: **0**
O&M Grade: **0**
Clock Start/From: **3**
Clock To:
1st Value: **4.000**
2nd Value:
Value Percent:
Continuous Index:
Within 8" of Joint:
Remarks:

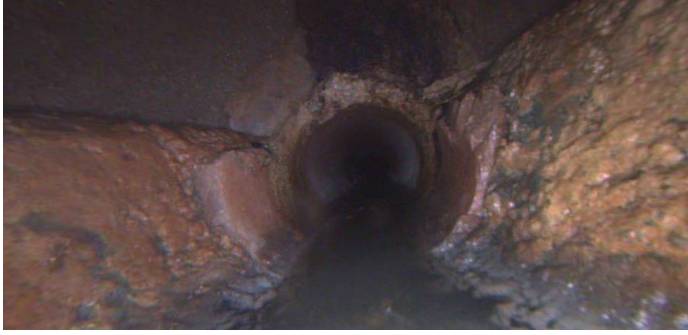
Code:	AMH
Description:	Manhole
Distance (ft):	215.7
Structural Grade:	0
O&M Grade:	0
Clock Start/From:	
Clock To:	
1st Value:	
2nd Value:	
Value Percent:	
Continuous Index:	
Within 8" of Joint:	NO
Remarks:	M-507-015
