Profile/Photo Observation Report

Date:	03/28/2018	Weather:		Coding:	PACP 6.0
Pipe Length (ft):	218.0	Owner:	NA	Pre Clean:	No Pre-Cleaning
P.O.#:		Surveyor:	Selasie Honu	PSR:	P-507-020-019
Customer:		Clean Date:	01/01/1900	Shape:	C

Street:	OFF COLORADO CT	Flow Control:	Not Controlled
City:	Hobart, IN	Year Renewed:	
Location:	Woods	Tape/Media #:	
Purpose:	Routine Assessment	Dia/Height:	12"
Use:	Sanitary	Material:	VCP
Drain Area:	NA	Lining:	
Category:	NA		
Comment:	P_C at 151 ft debris . Flow direction wrong		
Location Details:		Direction of Survey:	Upstream
US MH:	M-507-019	DS MH:	M-507-020
		Total Length Surveyed (ft):	152.8

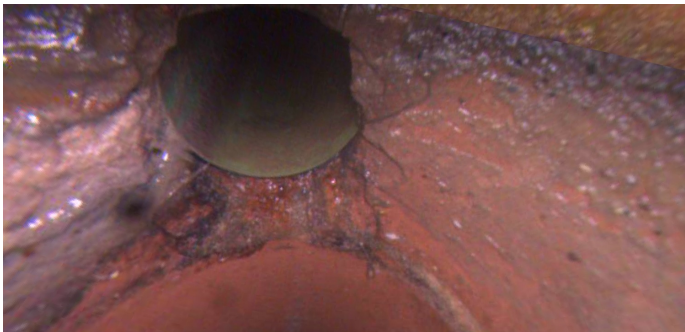
Code:	TB
Description:	Tap Break-in

Distance (ft):	39.7
Structural Grade:	0
O&M Grade:	0
Clock Start/From:	12
Clock To:	
1st Value:	4.000
2nd Value:	
Value Percent:	
Continuous Index:	
Within 8" of Joint:	
Remarks:

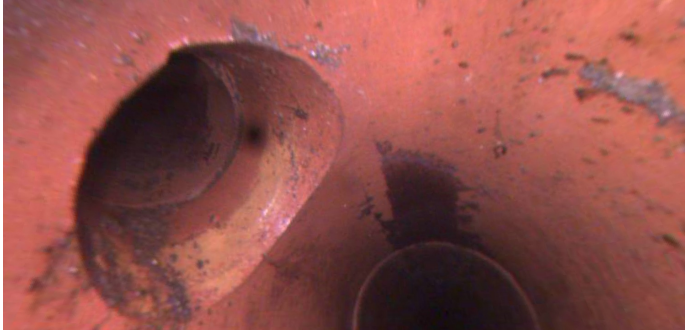
Code: **TF**
Description: **Tap Factory**

Distance (ft): **100.0**
Structural Grade: **0**
O&M Grade: **0**
Clock Start/From: **10**
Clock To:
1st Value: **4.000**
2nd Value:
Value Percent:
Continuous Index:
Within 8" of Joint:
Remarks:

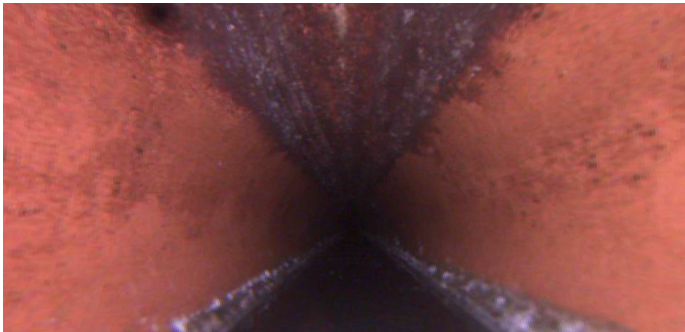
Code: **MSA**
Description: **Abandoned Survey**

Distance (ft): **152.8**
Structural Grade: **0**
O&M Grade: **0**
Clock Start/From:
Clock To:
1st Value:
2nd Value:
Value Percent:
Continuous Index:
Within 8" of Joint: **NO**
Remarks: **CAMERA STOPPED**
