Profile/Photo Observation Report

Street:	OFF COLORADO CT	Flow Control:	Not Controlled
City:	Hobart, IN	Year Renewed:	
Location:	Light Highway	Tape/Media #:	
Purpose:	Routine Assessment	Dia/Height:	8"
Use:	Sanitary	Material:	VCP
Drain Area:	NA	Lining:	
Category:	NA		
Comment:

Location Details:		Direction of Survey:	Downstream
US MH:	M-507-020	DS MH:	M-507-021
		Total Length Surveyed (ft):	133.8

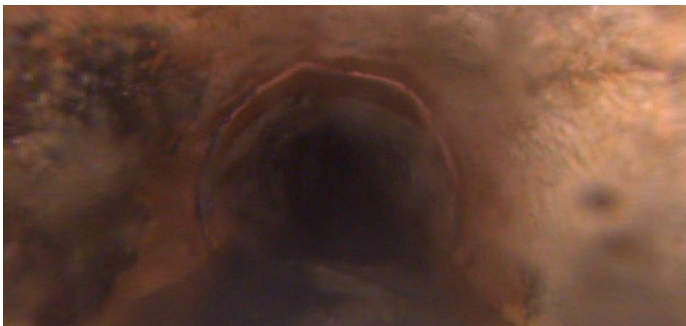
Code: **DAE**
Description: **Deposits Attached Encrustation**

Distance (ft): **40.2**
Structural Grade: **0**
O&M Grade: **2**
Clock Start/From: **8**
Clock To: **4**
1st Value:
2nd Value:
Value Percent: **5.000**
Continuous Index:
Within 8" of Joint: **YES**
Remarks:

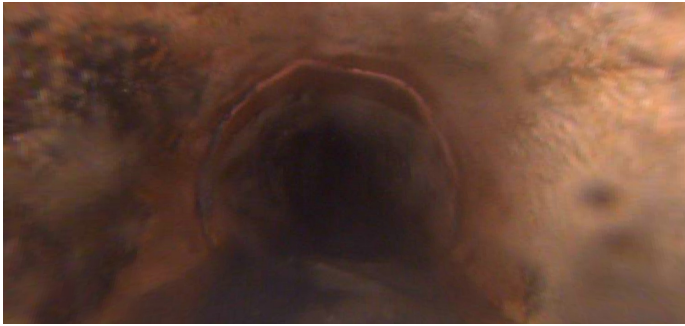
Code: **RFJ**
Description: **Roots Fine Joint**

Distance (ft): **40.2**
Structural Grade: **0**
O&M Grade: **1**
Clock Start/From: **8**
Clock To: **4**
1st Value:
2nd Value:
Value Percent:
Continuous Index:
Within 8" of Joint: **YES**
Remarks:

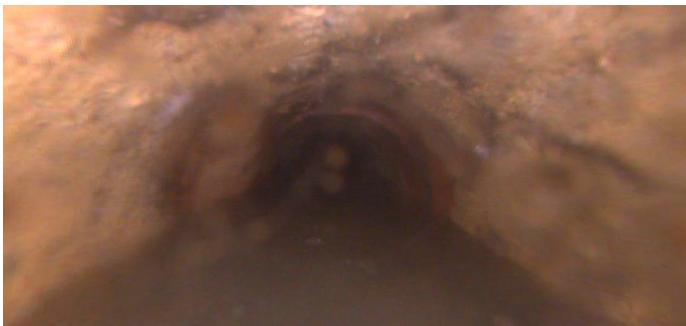
Code: **IS**
Description: **Infil Stain**

Distance (ft): **86.0**
Structural Grade: **0**
O&M Grade: **0**
Clock Start/From: **8**
Clock To: **4**
1st Value:
2nd Value:
Value Percent:
Continuous Index:
Within 8" of Joint: **YES**
Remarks:
