## Profile/Photo Observation Report

Street:	<b>Dekalb St.</b>	Flow Control:	<b>Not Controlled</b>
City:	<b>Hobart, IN</b>	Year Renewed:	
Location:	<b>Light Highway</b>	Tape/Media #:	
Purpose:	<b>Routine Assessment</b>	Dia/Height:	<b>8"</b>
Use:	<b>Sanitary</b>	Material:	<b>VCP</b>
Drain Area:	<b>NA</b>	Lining:	
Category:	<b>NA</b>		
Comment:

Location Details:		Direction of Survey:	<b>Downstream</b>
US MH:	<b>M-507-020</b>	DS MH:	<b>M-507-021</b>
		Total Length Surveyed (ft):	<b>133.8</b>

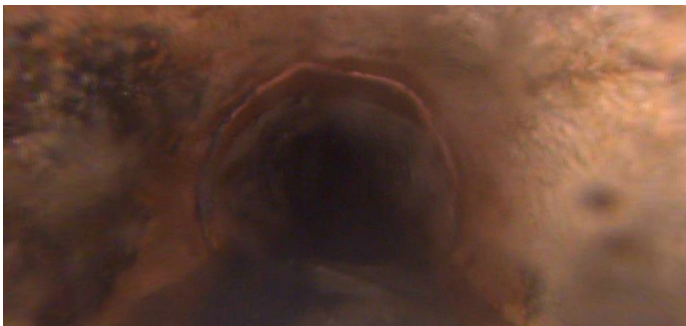
Code: **DAE**  
Description: **Deposits Attached Encrustation**

Distance (ft): **40.2**  
Structural Grade: **0**  
O&M Grade: **2**  
Clock Start/From: **8**  
Clock To: **4**  
1st Value:  
2nd Value:  
Value Percent: **5.000**  
Continuous Index:  
Within 8" of Joint: **YES**  
Remarks:

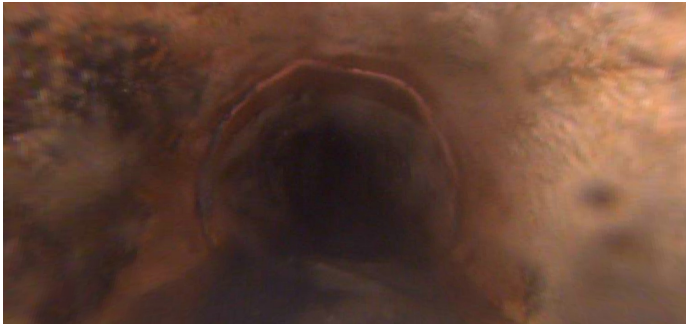
Code: **RFJ**  
Description: **Roots Fine Joint**

Distance (ft): **40.2**  
Structural Grade: **0**  
O&M Grade: **1**  
Clock Start/From: **8**  
Clock To: **4**  
1st Value:  
2nd Value:  
Value Percent:  
Continuous Index:  
Within 8" of Joint: **YES**  
Remarks:

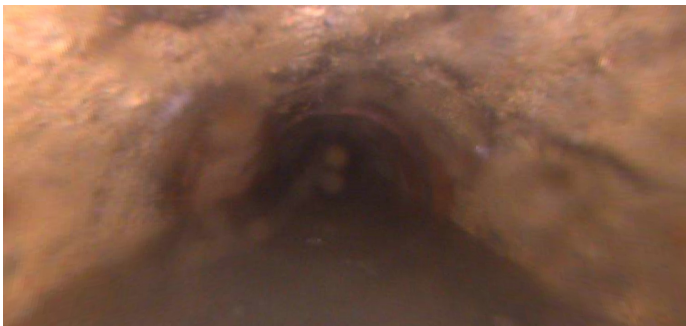
Code: **IS**  
Description: **Infil Stain**

Distance (ft): **86.0**  
Structural Grade: **0**  
O&M Grade: **0**  
Clock Start/From: **8**  
Clock To: **4**  
1st Value:  
2nd Value:  
Value Percent:  
Continuous Index:  
Within 8" of Joint: **YES**  
Remarks:
