## Profile/Photo Observation Report

Date:	10/09/2018	Weather:		Coding:	PACP 6.0
Pipe Length (ft):	299.6	Owner:	NA	Pre Clean:	Not Known
P.O.#:		Surveyor:	Selasie Honu	PSR:	P-507-029-020
Customer:		Clean Date:	01/01/1900	Shape:	C

Street:	OFF S DEKALB ST	Flow Control:	Not Controlled
City:	Hobart, IN	Year Renewed:	
Location:	Light Highway	Tape/Media #:	
Purpose:	Routine Assessment	Dia/Height:	12"
Use:	Sanitary	Material:	VCP
Drain Area:	NA	Lining:	
Category:	NA		
Comment:

Location Details:		Direction of Survey:	Upstream
US MH:	M-507-020	DS MH:	M-507-029
		Total Length Surveyed (ft):	252.8

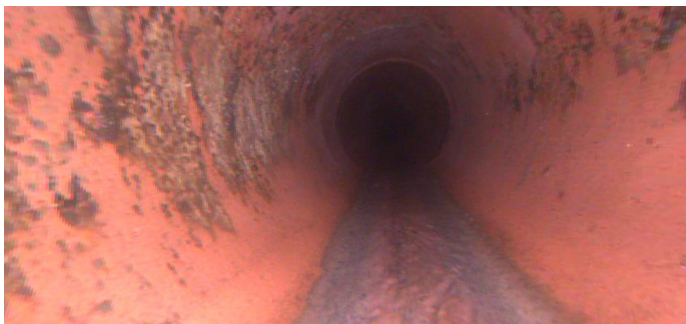
Code: **AMH**  
Description: **Manhole**

Distance (ft): **.0**  
Structural Grade: **0**  
O&M Grade: **0**  
Clock Start/From:  
Clock To:  
1st Value:  
2nd Value:  
Value Percent:  
Continuous Index:  
Within 8" of Joint: **NO**  
Remarks: **M-507-029**

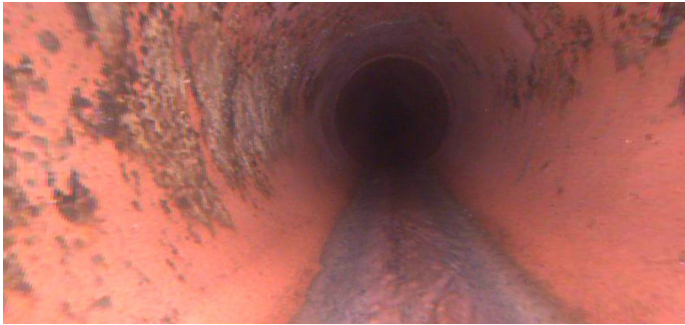
Code:	<b>MWL</b>
Description:	<b>Water Level</b>

Distance (ft):	<b>.0</b>
Structural Grade:	<b>0</b>
O&M Grade:	<b>0</b>
Clock Start/From:	
Clock To:	
1st Value:	
2nd Value:	
Value Percent:	<b>5.000</b>
Continuous Index:	
Within 8" of Joint:	<b>NO</b>
Remarks:

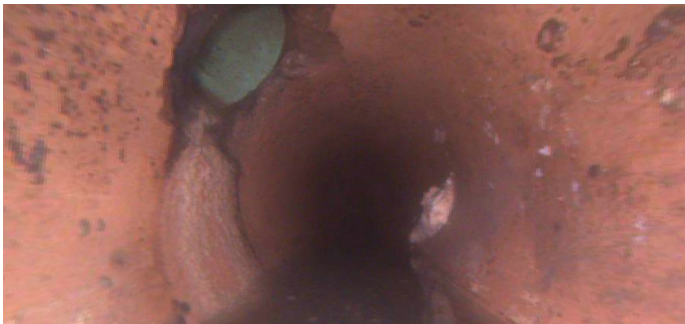
Code:	<b>TF</b>
Description:	<b>Tap Factory</b>

Distance (ft):	<b>62.9</b>
Structural Grade:	<b>0</b>
O&M Grade:	<b>0</b>
Clock Start/From:	<b>10</b>
Clock To:	
1st Value:	<b>4.000</b>
2nd Value:	
Value Percent:	
Continuous Index:	
Within 8" of Joint:	
Remarks:

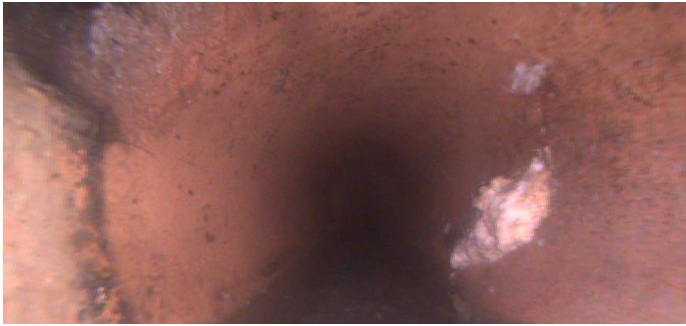
Code: **DAGS**  
Description: **Deposits Attached Grease**

Distance (ft): **63.6**  
Structural Grade: **0**  
O&M Grade: **2**  
Clock Start/From: **3**  
Clock To: **4**  
1st Value:  
2nd Value:  
Value Percent: **5.000**  
Continuous Index:  
Within 8" of Joint: **NO**  
Remarks:

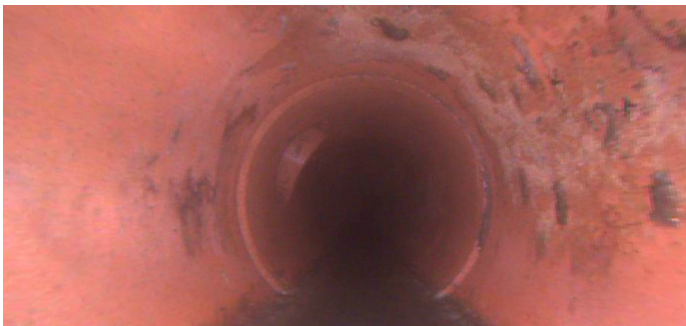
Code: **TF**  
Description: **Tap Factory**

Distance (ft): **73.0**  
Structural Grade: **0**  
O&M Grade: **0**  
Clock Start/From: **10**  
Clock To:  
1st Value: **4.000**  
2nd Value:  
Value Percent:  
Continuous Index:  
Within 8" of Joint:  
Remarks:

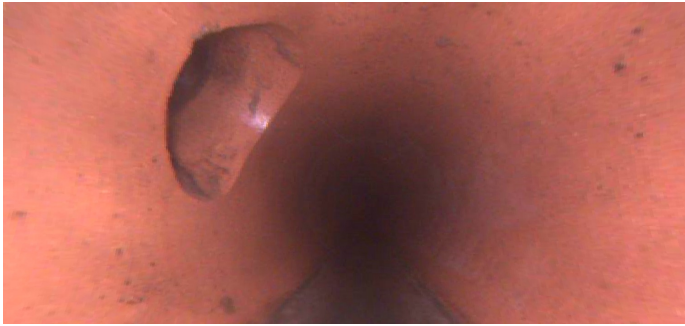
Code: **TF**  
Description: **Tap Factory**

Distance (ft): **73.8**  
Structural Grade: **0**  
O&M Grade: **0**  
Clock Start/From: **10**  
Clock To:  
1st Value: **4.000**  
2nd Value:  
Value Percent:  
Continuous Index:  
Within 8" of Joint:  
Remarks:

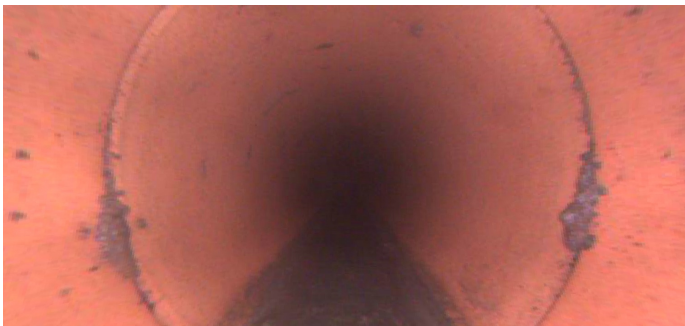
Code: **RFJ**  
Description: **Roots Fine Joint**

Distance (ft): **81.9**  
Structural Grade: **0**  
O&M Grade: **1**  
Clock Start/From: **8**  
Clock To: **4**  
1st Value:  
2nd Value:  
Value Percent:  
Continuous Index:  
Within 8" of Joint: **YES**  
Remarks:

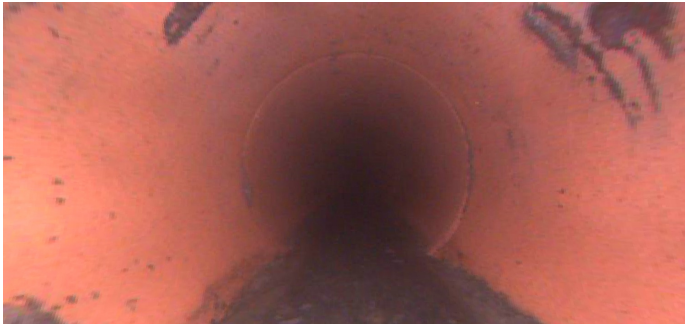
Code: **RFJ**  
Description: **Roots Fine Joint**

Distance (ft): **93.6**  
Structural Grade: **0**  
O&M Grade: **1**  
Clock Start/From: **8**  
Clock To: **4**  
1st Value:  
2nd Value:  
Value Percent:  
Continuous Index:  
Within 8" of Joint: **YES**  
Remarks:

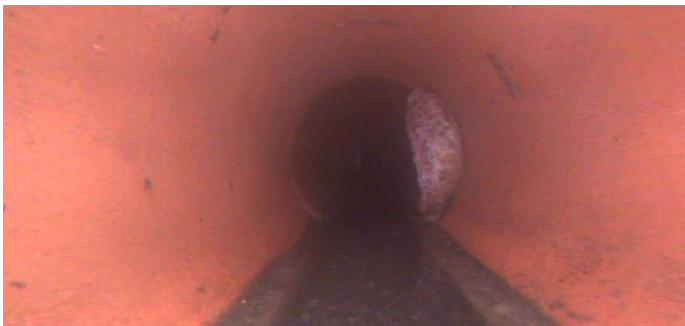
Code: **DAE**  
Description: **Deposits Attached Encrustation**

Distance (ft): **118.0**  
Structural Grade: **0**  
O&M Grade: **3**  
Clock Start/From: **1**  
Clock To: **4**  
1st Value:  
2nd Value:  
Value Percent: **20.000**  
Continuous Index:  
Within 8" of Joint: **YES**  
Remarks:

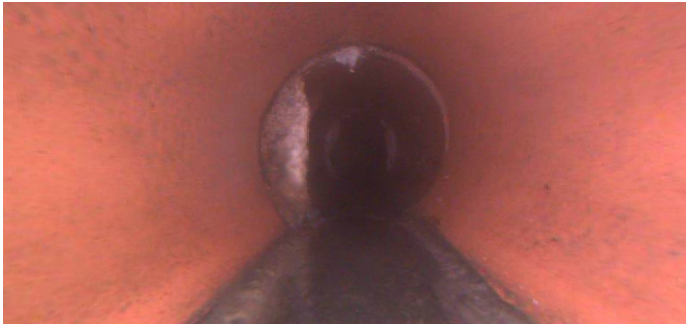
Code: **DAE**  
Description: **Deposits Attached Encrustation**

Distance (ft): **124.3**  
Structural Grade: **0**  
O&M Grade: **4**  
Clock Start/From: **7**  
Clock To: **12**  
1st Value:  
2nd Value:  
Value Percent: **30.000**  
Continuous Index:  
Within 8" of Joint: **YES**  
Remarks:

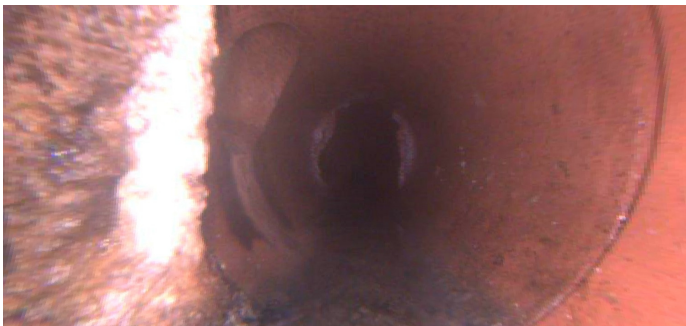
Code: **TF**  
Description: **Tap Factory**

Distance (ft): **125.5**  
Structural Grade: **0**  
O&M Grade: **0**  
Clock Start/From: **9**  
Clock To:  
1st Value: **4.000**  
2nd Value:  
Value Percent:  
Continuous Index:  
Within 8" of Joint:  
Remarks:

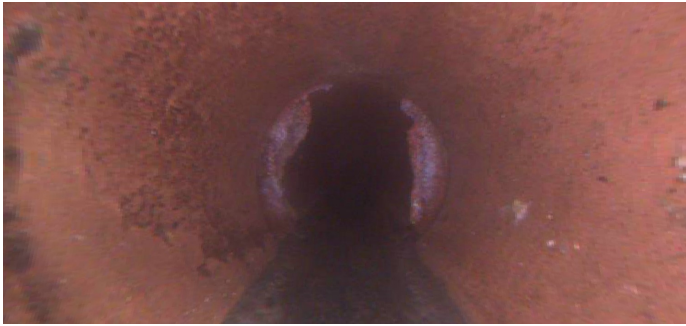
Code: **DAE**  
Description: **Deposits Attached Encrustation**

Distance (ft): **126.4**  
Structural Grade: **0**  
O&M Grade: **4**  
Clock Start/From: **8**  
Clock To: **4**  
1st Value:  
2nd Value:  
Value Percent: **30.000**  
Continuous Index:  
Within 8" of Joint: **YES**  
Remarks:

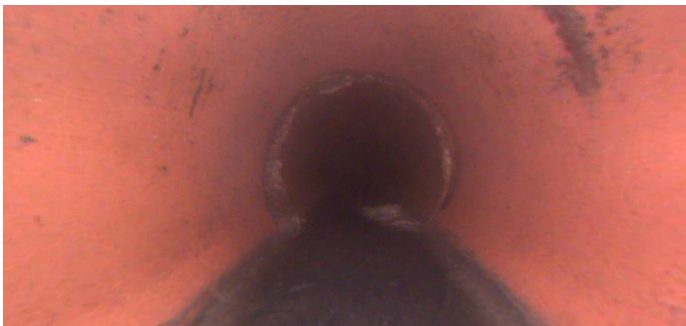
Code: **DAE**  
Description: **Deposits Attached Encrustation**

Distance (ft): **132.0**  
Structural Grade: **0**  
O&M Grade: **2**  
Clock Start/From: **8**  
Clock To: **4**  
1st Value:  
2nd Value:  
Value Percent: **10.000**  
Continuous Index:  
Within 8" of Joint: **YES**  
Remarks:

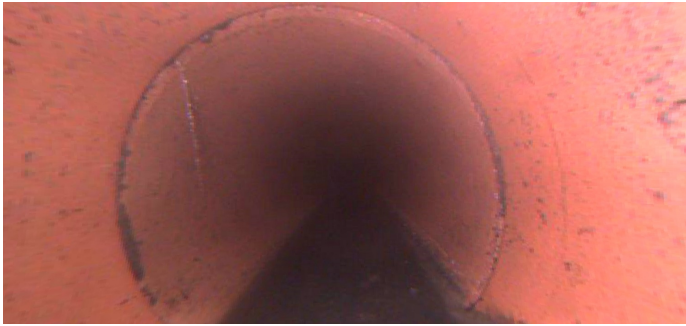
Code: **DAE**  
Description: **Deposits Attached Encrustation**

Distance (ft): **145.3**  
Structural Grade: **0**  
O&M Grade: **2**  
Clock Start/From: **8**  
Clock To: **4**  
1st Value:  
2nd Value:  
Value Percent: **5.000**  
Continuous Index:  
Within 8" of Joint: **YES**  
Remarks:

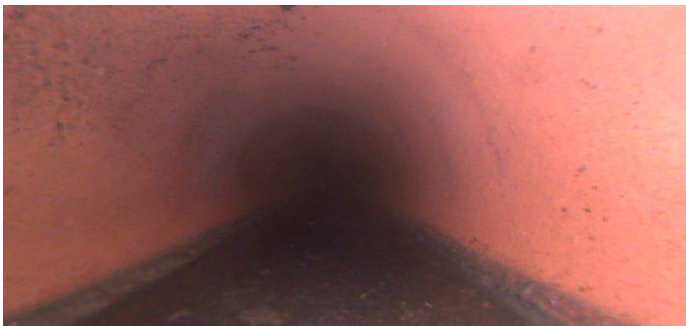
Code: **MSA**  
Description: **Abandoned Survey**

Distance (ft): **252.8**  
Structural Grade: **0**  
O&M Grade: **0**  
Clock Start/From:  
Clock To:  
1st Value:  
2nd Value:  
Value Percent:  
Continuous Index:  
Within 8" of Joint: **NO**  
Remarks: **M-507-020**
