Profile/Photo Observation Report

Street:	OFF S DEKALB ST	Flow Control:	Not Controlled
City:	Hobart, IN	Year Renewed:	
Location:	Light Highway	Tape/Media #:	
Purpose:	Routine Assessment	Dia/Height:	12"
Use:	Sanitary	Material:	VCP
Drain Area:	NA	Lining:	
Category:	NA		
Comment:

Location Details:		Direction of Survey:	Downstream
US MH:	M-507-020	DS MH:	M-507-029
		Total Length Surveyed (ft):	7.3

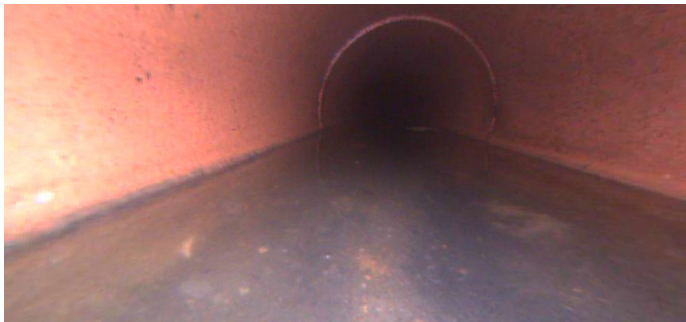
Code: **AMH**
Description: **Manhole**

Distance (ft): **.0**
Structural Grade: **0**
O&M Grade: **0**
Clock Start/From:
Clock To:
1st Value:
2nd Value:
Value Percent:
Continuous Index:
Within 8" of Joint: **NO**
Remarks: **M-507-020**

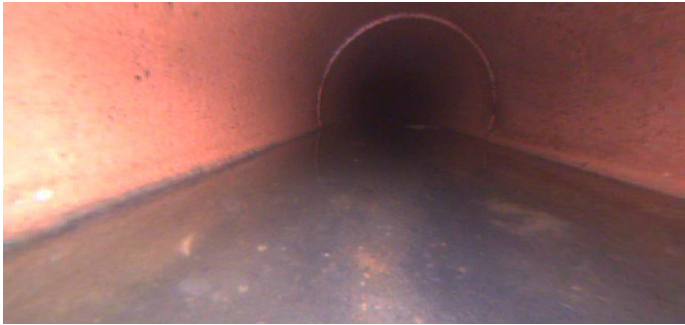
Code:	MWL
Description:	Water Level

Distance (ft):	.0
Structural Grade:	0
O&M Grade:	0
Clock Start/From:	
Clock To:	
1st Value:	
2nd Value:	
Value Percent:	5.000
Continuous Index:	
Within 8" of Joint:	NO
Remarks:
