Profile/Photo Observation Report

Date:	10/09/2018	Weather:		Coding:	PACP 6.0
Pipe Length (ft):	299.6	Owner:	NA	Pre Clean:	Not Known
P.O.#:		Surveyor:	Selasie Honu	PSR:	P-507-029-020
Customer:		Clean Date:	01/01/1900	Shape:	C

Street:	Dekalb St.	Flow Control:	Not Controlled
City:	Hobart, IN	Year Renewed:	
Location:	Light Highway	Tape/Media #:	
Purpose:	Routine Assessment	Dia/Height:	12"
Use:	Sanitary	Material:	VCP
Drain Area:	NA	Lining:	
Category:	NA		
Comment:

Location Details:		Direction of Survey:	Downstream
US MH:	M-507-020	DS MH:	M-507-029
		Total Length Surveyed (ft):	7.3

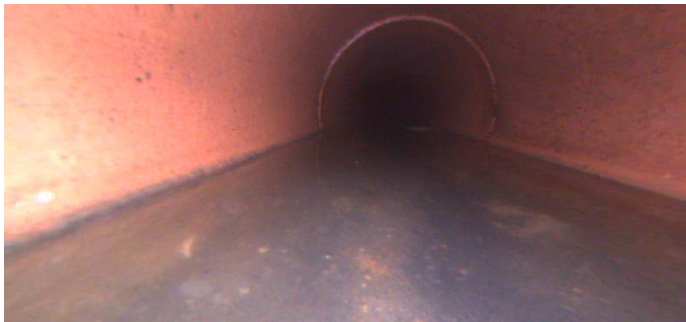
Code: **AMH**
Description: **Manhole**

Distance (ft): **.0**
Structural Grade: **0**
O&M Grade: **0**
Clock Start/From:
Clock To:
1st Value:
2nd Value:
Value Percent:
Continuous Index:
Within 8" of Joint: **NO**
Remarks: **M-507-020**

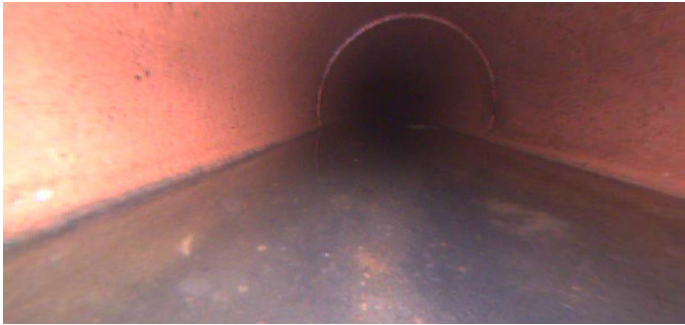
Code:	MWL
Description:	Water Level

Distance (ft):	.0
Structural Grade:	0
O&M Grade:	0
Clock Start/From:	
Clock To:	
1st Value:	
2nd Value:	
Value Percent:	5.000
Continuous Index:	
Within 8" of Joint:	NO
Remarks:
