## Profile/Photo Observation Report

Date:	<b>03/29/2018</b>	Weather:		Coding:	<b>PACP 6.0</b>
Pipe Length (ft):	<b>193.1</b>	Owner:	<b>NA</b>	Pre Clean:	<b>No Pre-Cleaning</b>
P.O.#:		Surveyor:	<b>Jen Costello</b>	PSR:	<b>P-507-022-021</b>
Customer:		Clean Date:	<b>01/01/1900</b>	Shape:	<b>C</b>

Street:	<b>FOXCROFT STREET</b>	Flow Control:	<b>Not Controlled</b>
City:	<b>Hobart, IN</b>	Year Renewed:	
Location:	<b>Yard</b>	Tape/Media #:	
Purpose:	<b>Routine Assessment</b>	Dia/Height:	<b>8"</b>
Use:	<b>Sanitary</b>	Material:	<b>VCP</b>
Drain Area:	<b>NA</b>	Lining:	
Category:	<b>NA</b>		
Comment:	<b>Flow direction wrong</b>

Location Details:		Direction of Survey:	<b>Upstream</b>
US MH:	<b>M-507-021</b>	DS MH:	<b>M-507-022</b>
		Total Length Surveyed (ft):	<b>185.7</b>

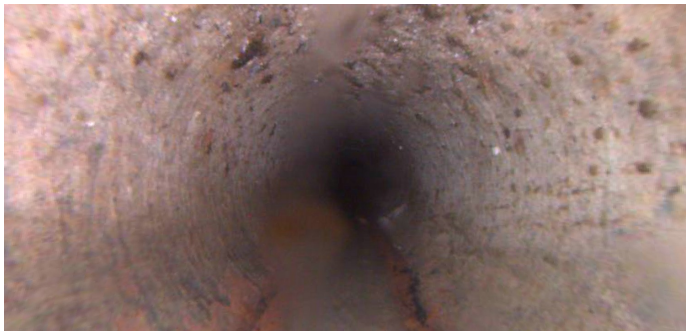
Code: **AMH**  
Description: **Manhole**

Distance (ft): **.0**  
Structural Grade: **0**  
O&M Grade: **0**  
Clock Start/From:  
Clock To:  
1st Value:  
2nd Value:  
Value Percent:  
Continuous Index:  
Within 8" of Joint: **NO**  
Remarks: **M-507-022**

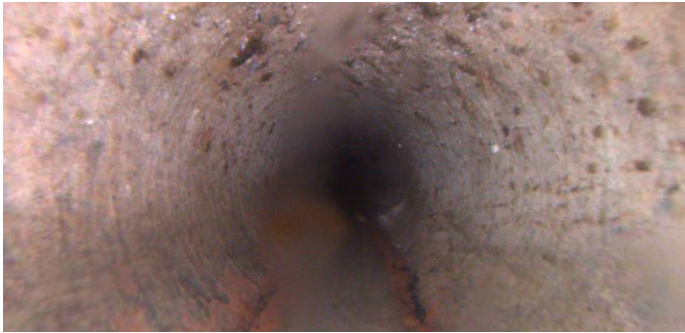
Code:	<b>MWL</b>
Description:	<b>Water Level</b>

Distance (ft):	<b>.0</b>
Structural Grade:	<b>0</b>
O&M Grade:	<b>0</b>
Clock Start/From:	
Clock To:	
1st Value:	
2nd Value:	
Value Percent:	<b>5.000</b>
Continuous Index:	
Within 8" of Joint:	<b>NO</b>
Remarks:

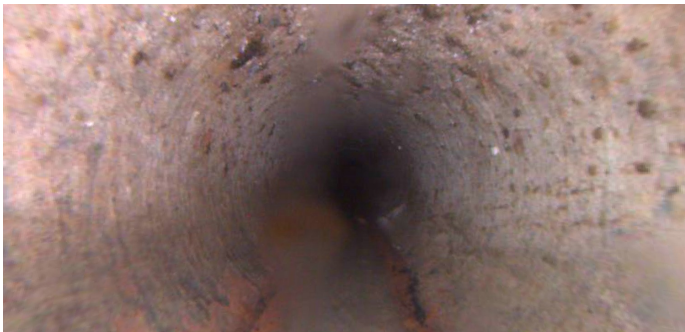
Code:	<b>DAE</b>
Description:	<b>Deposits Attached Encrustation</b>

Distance (ft):	<b>.0</b>
Structural Grade:	<b>0</b>
O&M Grade:	<b>2</b>
Clock Start/From:	<b>7</b>
Clock To:	<b>5</b>
1st Value:	
2nd Value:	
Value Percent:	<b>5.000</b>
Continuous Index:	<b>S01</b>
Within 8" of Joint:	<b>NO</b>
Remarks:

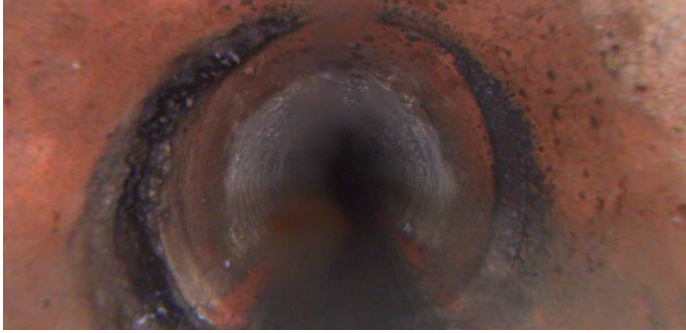
Code: **IW**  
Description: **Infil Weeper**

Distance (ft): **37.3**  
Structural Grade: **0**  
O&M Grade: **2**  
Clock Start/From: **8**  
Clock To: **4**  
1st Value:  
2nd Value:  
Value Percent:  
Continuous Index:  
Within 8" of Joint: **YES**  
Remarks:

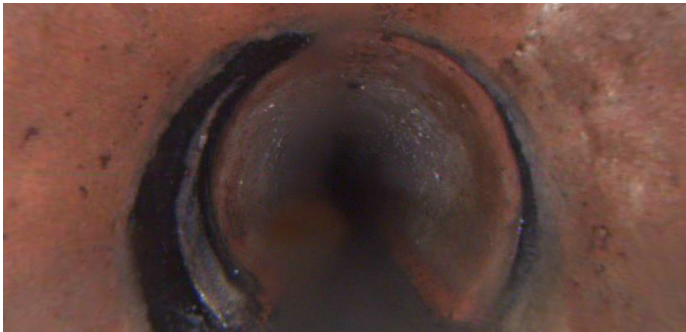
Code: **IW**  
Description: **Infil Weeper**

Distance (ft): **42.3**  
Structural Grade: **0**  
O&M Grade: **2**  
Clock Start/From: **8**  
Clock To: **4**  
1st Value:  
2nd Value:  
Value Percent:  
Continuous Index:  
Within 8" of Joint: **YES**  
Remarks:

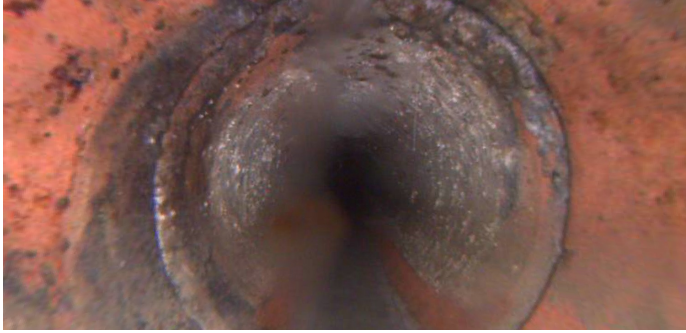
Code: **IW**  
Description: **Infil Weeper**

Distance (ft): **62.1**  
Structural Grade: **0**  
O&M Grade: **2**  
Clock Start/From: **8**  
Clock To: **4**  
1st Value:  
2nd Value:  
Value Percent:  
Continuous Index:  
Within 8" of Joint: **YES**  
Remarks:

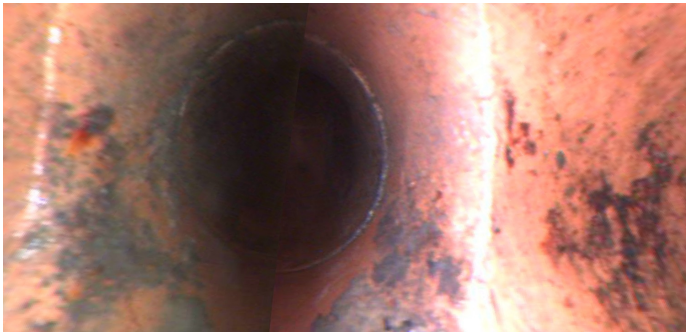
Code: **TF**  
Description: **Tap Factory**

Distance (ft): **68.1**  
Structural Grade: **0**  
O&M Grade: **0**  
Clock Start/From: **9**  
Clock To:  
1st Value: **4.000**  
2nd Value:  
Value Percent:  
Continuous Index:  
Within 8" of Joint:  
Remarks:

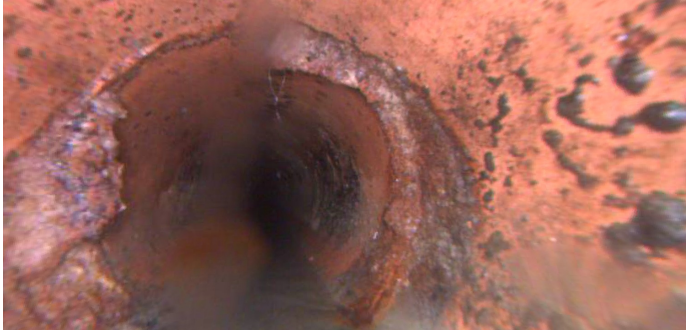
Code: **DAE**  
Description: **Deposits Attached Encrustation**

Distance (ft): **69.0**  
Structural Grade: **0**  
O&M Grade: **2**  
Clock Start/From: **8**  
Clock To: **4**  
1st Value:  
2nd Value:  
Value Percent: **10.000**  
Continuous Index: **S02**  
Within 8" of Joint: **YES**  
Remarks:

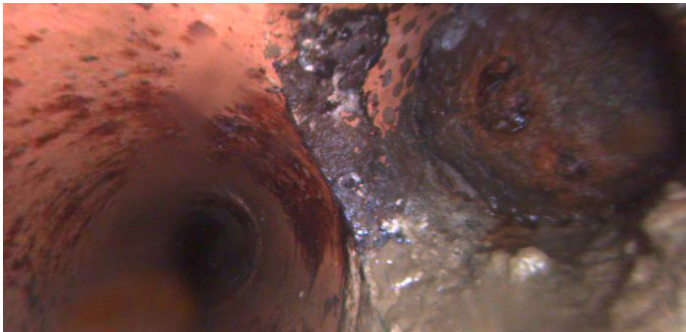
Code: **TFC**  
Description: **Tap Factory Capped**

Distance (ft): **79.8**  
Structural Grade: **0**  
O&M Grade: **0**  
Clock Start/From: **2**  
Clock To:  
1st Value: **4.000**  
2nd Value:  
Value Percent:  
Continuous Index:  
Within 8" of Joint:  
Remarks:

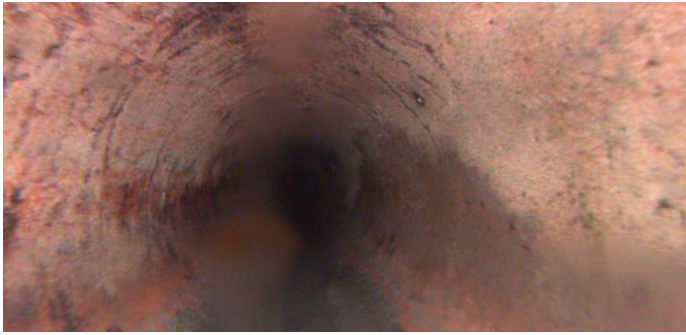
Code: **DAE**  
Description: **Deposits Attached Encrustation**

Distance (ft): **108.5**  
Structural Grade: **0**  
O&M Grade: **2**  
Clock Start/From: **7**  
Clock To: **5**  
1st Value:  
2nd Value:  
Value Percent: **5.000**  
Continuous Index: **F01**  
Within 8" of Joint: **NO**  
Remarks:

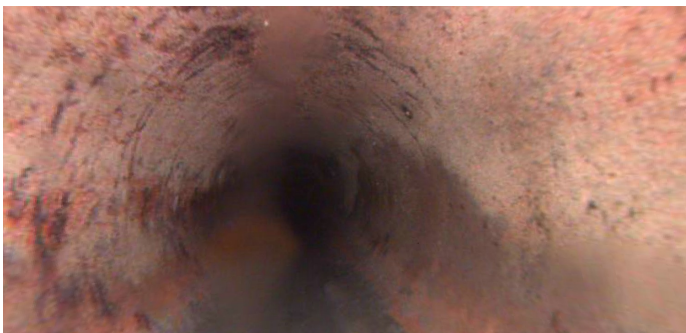
Code: **DAE**  
Description: **Deposits Attached Encrustation**

Distance (ft): **108.5**  
Structural Grade: **0**  
O&M Grade: **2**  
Clock Start/From: **8**  
Clock To: **4**  
1st Value:  
2nd Value:  
Value Percent: **10.000**  
Continuous Index: **F03**  
Within 8" of Joint: **NO**  
Remarks:

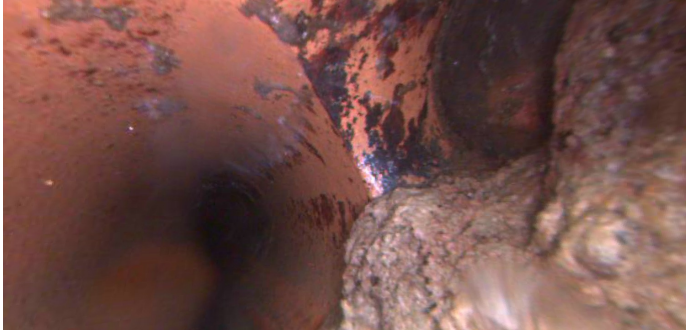
Code: **TFD**  
Description: **Tap Factory Defective**

Distance (ft): **116.4**  
Structural Grade: **0**  
O&M Grade: **2**  
Clock Start/From: **2**  
Clock To:  
1st Value: **4.000**  
2nd Value:  
Value Percent:  
Continuous Index:  
Within 8" of Joint:  
Remarks: **dae**

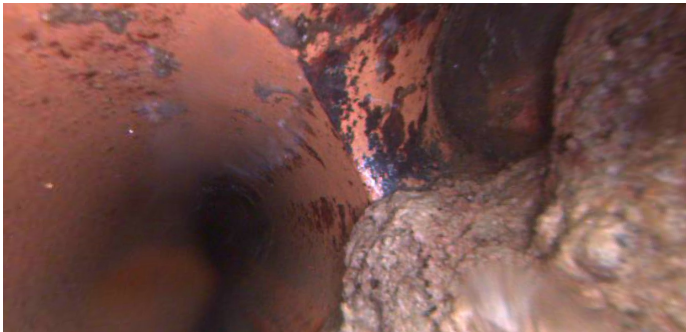
Code: **DAE**  
Description: **Deposits Attached Encrustation**

Distance (ft): **116.4**  
Structural Grade: **0**  
O&M Grade: **2**  
Clock Start/From: **2**  
Clock To: **4**  
1st Value:  
2nd Value:  
Value Percent: **10.000**  
Continuous Index:  
Within 8" of Joint: **NO**  
Remarks:

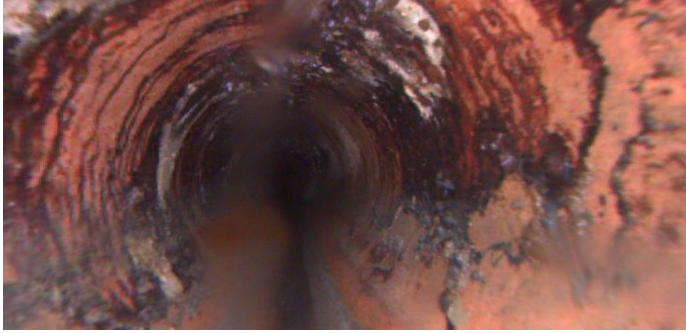
Code: **DAE**  
Description: **Deposits Attached Encrustation**

Distance (ft): **118.2**  
Structural Grade: **0**  
O&M Grade: **2**  
Clock Start/From: **8**  
Clock To: **4**  
1st Value:  
2nd Value:  
Value Percent: **5.000**  
Continuous Index: **S03**  
Within 8" of Joint: **NO**  
Remarks:

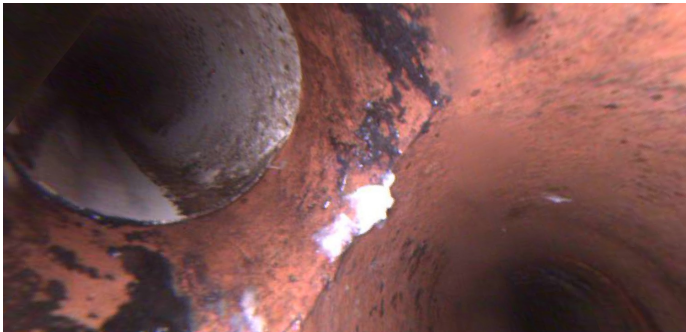
Code: **TF**  
Description: **Tap Factory**

Distance (ft): **138.4**  
Structural Grade: **0**  
O&M Grade: **0**  
Clock Start/From: **10**  
Clock To:  
1st Value: **4.000**  
2nd Value:  
Value Percent:  
Continuous Index:  
Within 8" of Joint:  
Remarks:

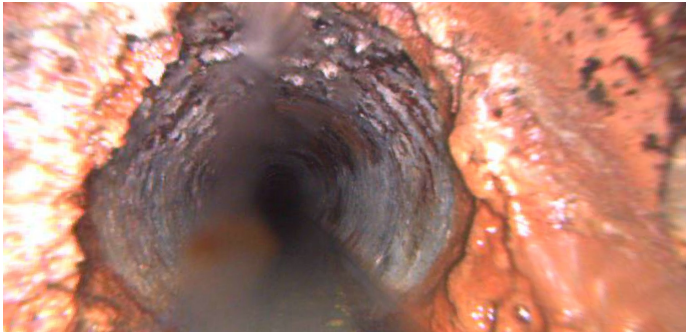
Code: **DAE**  
Description: **Deposits Attached Encrustation**

Distance (ft): **154.4**  
Structural Grade: **0**  
O&M Grade: **3**  
Clock Start/From: **8**  
Clock To: **4**  
1st Value:  
2nd Value:  
Value Percent: **15.000**  
Continuous Index:  
Within 8" of Joint: **YES**  
Remarks:

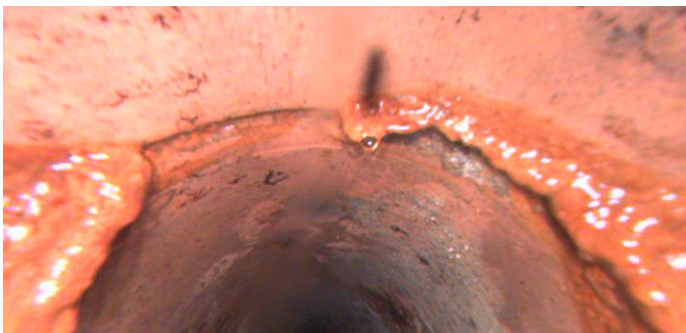
Code: **ID**  
Description: **Infil Dripper**

Distance (ft): **164.6**  
Structural Grade: **0**  
O&M Grade: **3**  
Clock Start/From: **12**  
Clock To:  
1st Value:  
2nd Value:  
Value Percent:  
Continuous Index:  
Within 8" of Joint: **YES**  
Remarks:

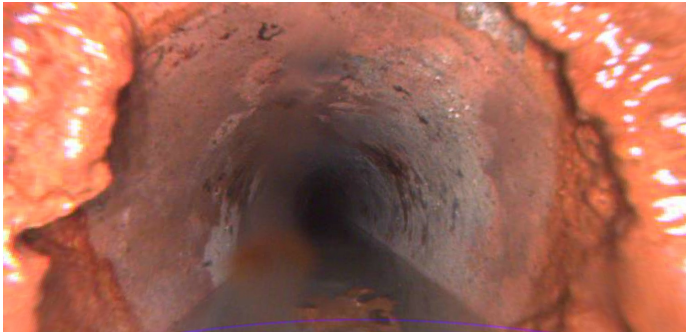
Code: **DAE**  
Description: **Deposits Attached Encrustation**

Distance (ft): **164.6**  
Structural Grade: **0**  
O&M Grade: **3**  
Clock Start/From: **8**  
Clock To: **4**  
1st Value:  
2nd Value:  
Value Percent: **15.000**  
Continuous Index:  
Within 8" of Joint: **YES**  
Remarks:

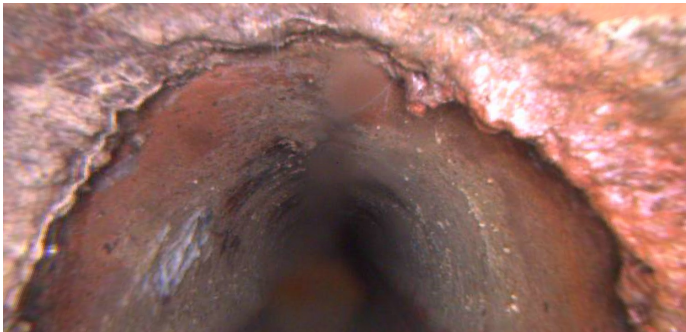
Code: **DAE**  
Description: **Deposits Attached Encrustation**

Distance (ft): **169.4**  
Structural Grade: **0**  
O&M Grade: **2**  
Clock Start/From: **8**  
Clock To: **4**  
1st Value:  
2nd Value:  
Value Percent: **10.000**  
Continuous Index:  
Within 8" of Joint: **YES**  
Remarks:

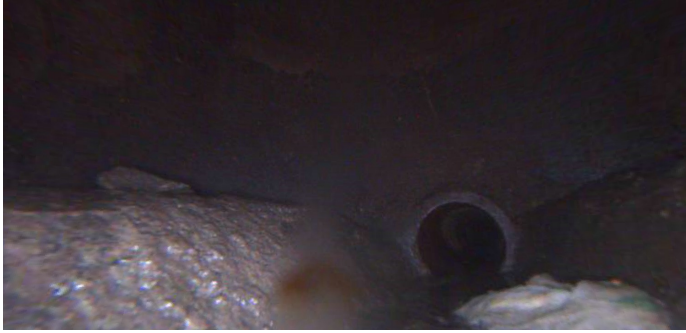
Code: **DAE**  
Description: **Deposits Attached Encrustation**

Distance (ft): **185.7**  
Structural Grade: **0**  
O&M Grade: **2**  
Clock Start/From: **8**  
Clock To: **4**  
1st Value:  
2nd Value:  
Value Percent: **10.000**  
Continuous Index: **F02**  
Within 8" of Joint: **YES**  
Remarks:

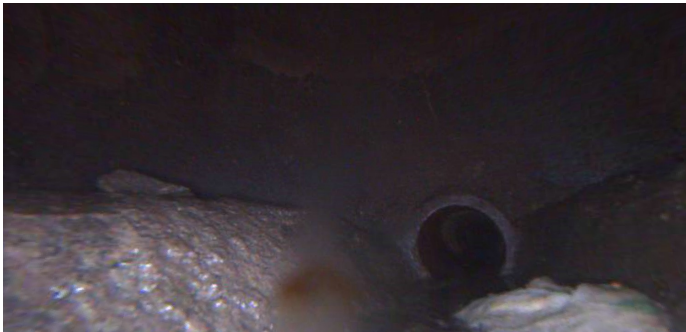
Code: **AMH**  
Description: **Manhole**

Distance (ft): **185.7**  
Structural Grade: **0**  
O&M Grade: **0**  
Clock Start/From:  
Clock To:  
1st Value:  
2nd Value:  
Value Percent:  
Continuous Index:  
Within 8" of Joint: **NO**  
Remarks: **M-507-021**
