Profile/Photo Observation Report

| Street: | CSOKASY LN | Flow Control: | Not Controlled |
| City: | Hobart, IN | Year Renewed: | |

| US MH: | M-507-023 | DS MH: | M-507-024 |

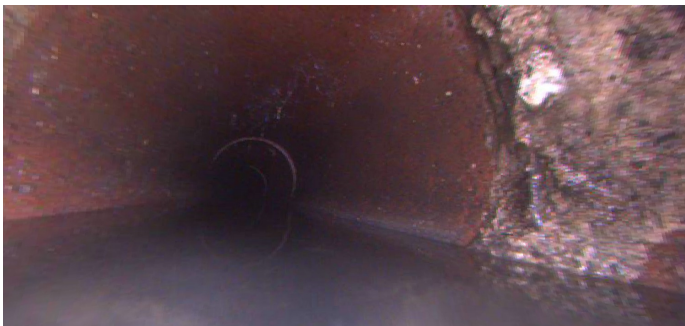
Code: **MWL**
Description: **Water Level**

Distance (ft): **.0**
Structural Grade: **0**
O&M Grade: **0**
Clock Start/From:
Clock To:
1st Value:
2nd Value:
Value Percent: **5.000**
Continuous Index:
Within 8" of Joint: **NO**
Remarks:

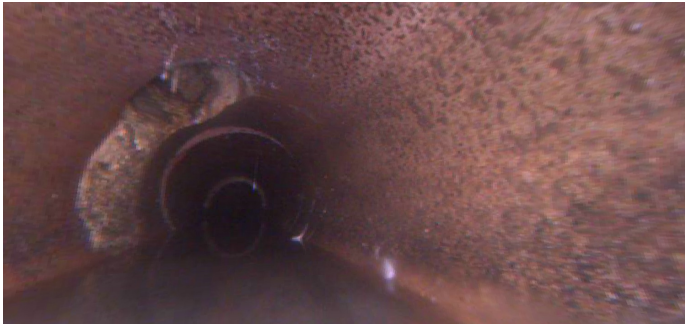
Code: **TF**
Description: **Tap Factory**

Distance (ft): **30.2**
Structural Grade: **0**
O&M Grade: **0**
Clock Start/From: **11**
Clock To:
1st Value: **4.000**
2nd Value:
Value Percent:
Continuous Index:
Within 8" of Joint:
Remarks:

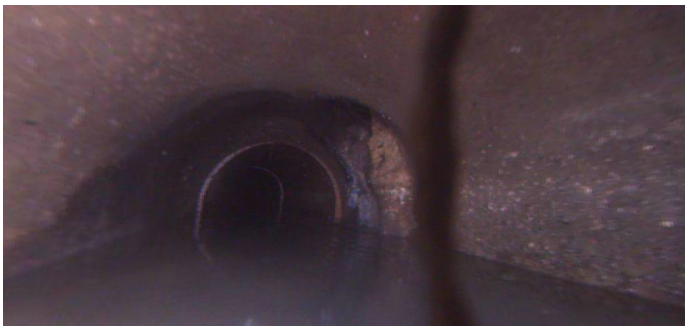
Code: **TF**
Description: **Tap Factory**

Distance (ft): **96.4**
Structural Grade: **0**
O&M Grade: **0**
Clock Start/From: **2**
Clock To:
1st Value: **4.000**
2nd Value:
Value Percent:
Continuous Index:
Within 8" of Joint:
Remarks:

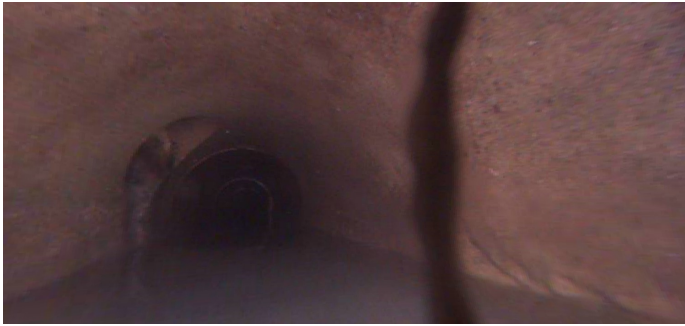
Code: **TF**
Description: **Tap Factory**

Distance (ft): **105.5**
Structural Grade: **0**
O&M Grade: **0**
Clock Start/From: **10**
Clock To:
1st Value: **4.000**
2nd Value:
Value Percent:
Continuous Index:
Within 8" of Joint:
Remarks:

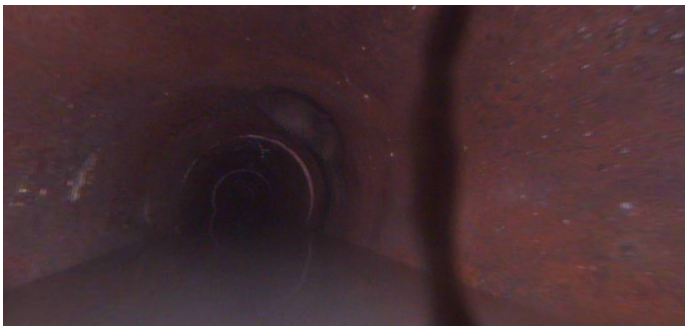
Code: **TF**
Description: **Tap Factory**

Distance (ft): **161.8**
Structural Grade: **0**
O&M Grade: **0**
Clock Start/From: **2**
Clock To:
1st Value: **4.000**
2nd Value:
Value Percent:
Continuous Index:
Within 8" of Joint:
Remarks:

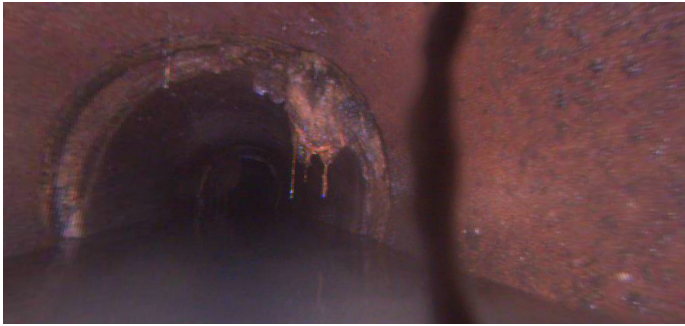
Code: **DAE**
Description: **Deposits Attached Encrustation**

Distance (ft): **175.6**
Structural Grade: **0**
O&M Grade: **3**
Clock Start/From: **8**
Clock To: **4**
1st Value:
2nd Value:
Value Percent: **20.000**
Continuous Index:
Within 8" of Joint: **YES**
Remarks:

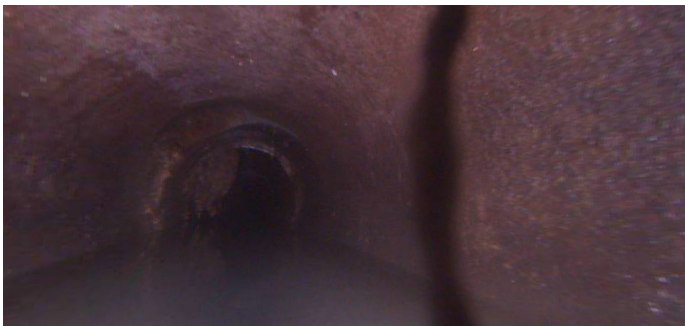
Code: **TF**
Description: **Tap Factory**

Distance (ft): **177.2**
Structural Grade: **0**
O&M Grade: **0**
Clock Start/From: **11**
Clock To:
1st Value: **4.000**
2nd Value:
Value Percent:
Continuous Index:
Within 8" of Joint:
Remarks:

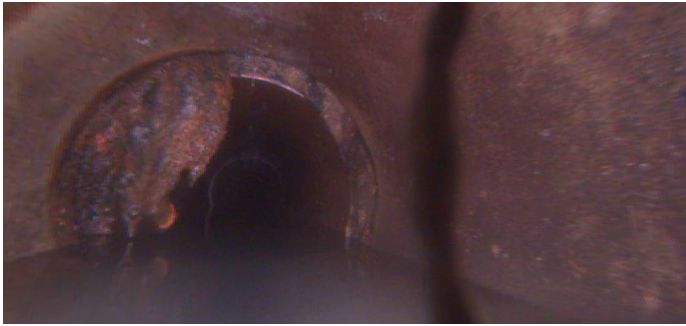
Code: **DAE**
Description: **Deposits Attached Encrustation**

Distance (ft): **178.7**
Structural Grade: **0**
O&M Grade: **5**
Clock Start/From: **8**
Clock To: **4**
1st Value:
2nd Value:
Value Percent: **45.000**
Continuous Index:
Within 8" of Joint: **YES**
Remarks:

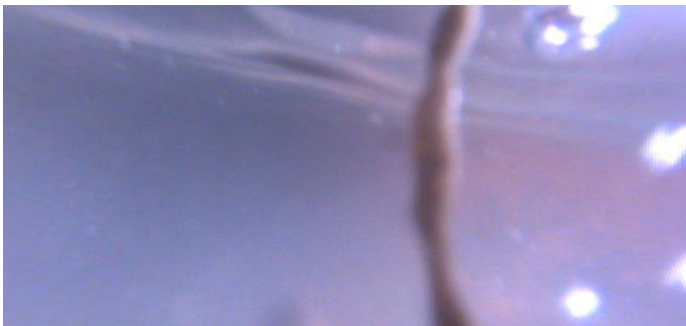
Code: **MWLS**
Description: **Water Level Sag**

Distance (ft): **200.1**
Structural Grade: **2**
O&M Grade: **3**
Clock Start/From:
Clock To:
1st Value:
2nd Value:
Value Percent: **10.000**
Continuous Index:
Within 8" of Joint: **NO**
Remarks:

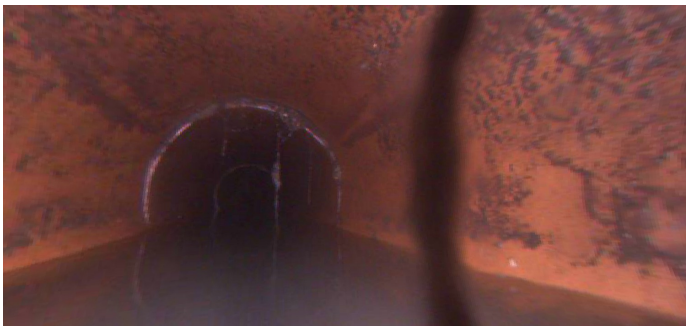
Code: **RFJ**
Description: **Roots Fine Joint**

Distance (ft): **206.3**
Structural Grade: **0**
O&M Grade: **1**
Clock Start/From: **8**
Clock To: **4**
1st Value:
2nd Value:
Value Percent:
Continuous Index:
Within 8" of Joint: **YES**
Remarks:

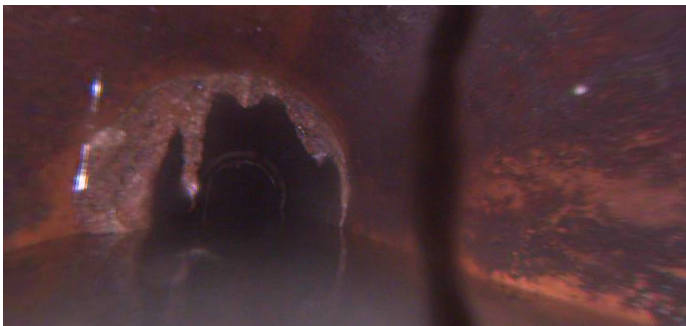
Code: **DAE**
Description: **Deposits Attached Encrustation**

Distance (ft): **215.9**
Structural Grade: **0**
O&M Grade: **5**
Clock Start/From: **8**
Clock To: **4**
1st Value:
2nd Value:
Value Percent: **40.000**
Continuous Index:
Within 8" of Joint: **YES**
Remarks:

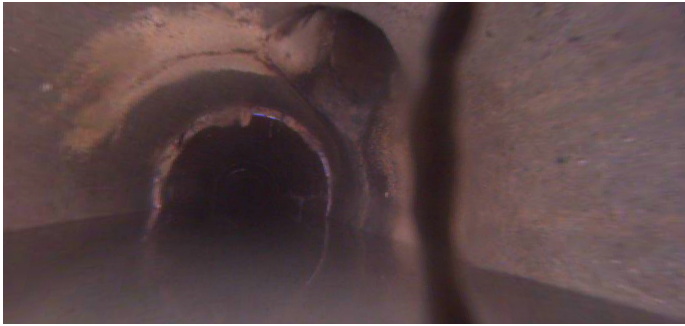
Code: **TF**
Description: **Tap Factory**

Distance (ft): **218.6**
Structural Grade: **0**
O&M Grade: **0**
Clock Start/From: **2**
Clock To:
1st Value: **4.000**
2nd Value:
Value Percent:
Continuous Index:
Within 8" of Joint:
Remarks:

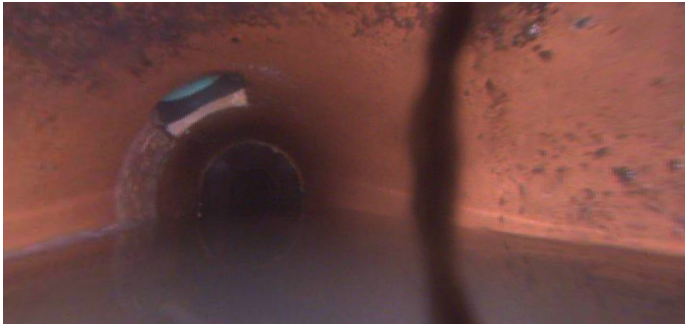
Code: **TF**
Description: **Tap Factory**

Distance (ft): **223.6**
Structural Grade: **0**
O&M Grade: **0**
Clock Start/From: **11**
Clock To:
1st Value: **4.000**
2nd Value:
Value Percent:
Continuous Index:
Within 8" of Joint:
Remarks:

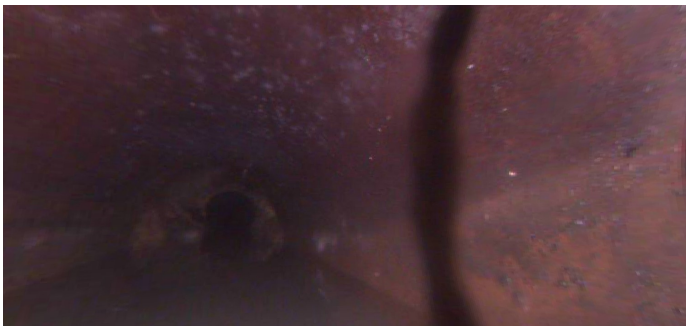
Code: **AMH**
Description: **Manhole**

Distance (ft): **239.9**
Structural Grade: **0**
O&M Grade: **0**
Clock Start/From:
Clock To:
1st Value:
2nd Value:
Value Percent:
Continuous Index:
Within 8" of Joint: **NO**
Remarks: **M-507-024**
