Profile/Photo Observation Report

Date:	10/08/2018	Weather:		Coding:	PACP 6.0
Pipe Length (ft):	235.0	Owner:	NA	Pre Clean:	Not Known
P.O.#:		Surveyor:	Selasie Honu	PSR:	P-507-024-023
Customer:		Clean Date:	01/01/1900	Shape:	C

Street:	Csokasy Ln.	Flow Control:	Not Controlled
City:	Hobart, IN	Year Renewed:	
Location:	Light Highway	Tape/Media #:	
Purpose:	Routine Assessment	Dia/Height:	12"
Use:	Sanitary	Material:	VCP
Drain Area:	NA	Lining:	
Category:	NA		
Comment:

Location Details:		Direction of Survey:	Downstream
US MH:	M-507-023	DS MH:	M-507-024
		Total Length Surveyed (ft):	239.9

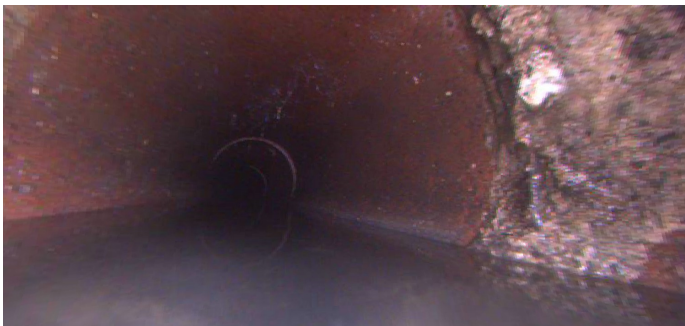
Code: **MWL**
Description: **Water Level**

Distance (ft): **.0**
Structural Grade: **0**
O&M Grade: **0**
Clock Start/From:
Clock To:
1st Value:
2nd Value:
Value Percent: **5.000**
Continuous Index:
Within 8" of Joint: **NO**
Remarks:

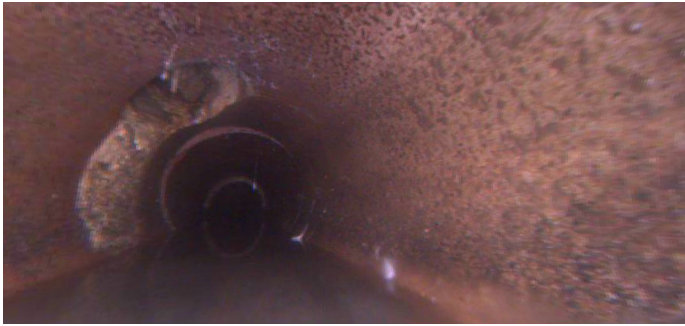
Code: **TF**
Description: **Tap Factory**

Distance (ft): **30.2**
Structural Grade: **0**
O&M Grade: **0**
Clock Start/From: **11**
Clock To:
1st Value: **4.000**
2nd Value:
Value Percent:
Continuous Index:
Within 8" of Joint:
Remarks:

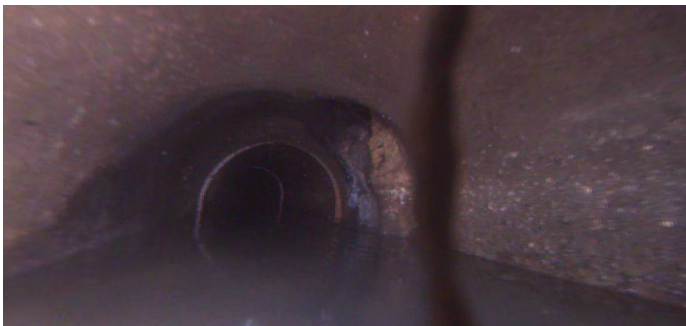
Code: **TF**
Description: **Tap Factory**

Distance (ft): **96.4**
Structural Grade: **0**
O&M Grade: **0**
Clock Start/From: **2**
Clock To:
1st Value: **4.000**
2nd Value:
Value Percent:
Continuous Index:
Within 8" of Joint:
Remarks:

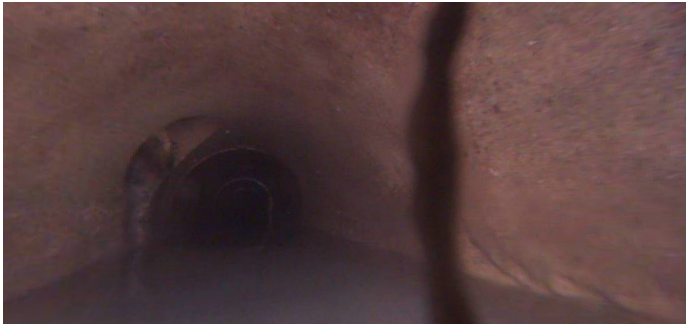
Code: **TF**
Description: **Tap Factory**

Distance (ft): **105.5**
Structural Grade: **0**
O&M Grade: **0**
Clock Start/From: **10**
Clock To:
1st Value: **4.000**
2nd Value:
Value Percent:
Continuous Index:
Within 8" of Joint:
Remarks:

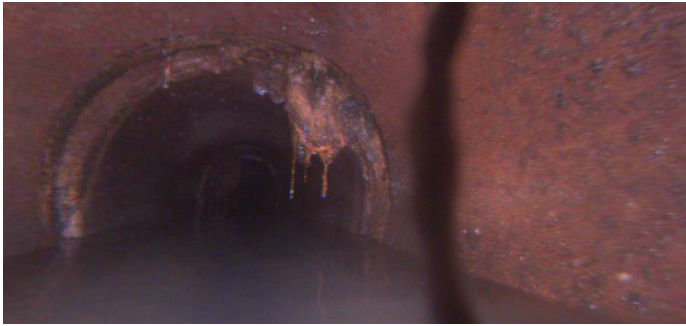
Code: **DAE**
Description: **Deposits Attached Encrustation**

Distance (ft): **175.6**
Structural Grade: **0**
O&M Grade: **3**
Clock Start/From: **8**
Clock To: **4**
1st Value:
2nd Value:
Value Percent: **20.000**
Continuous Index:
Within 8" of Joint: **YES**
Remarks:

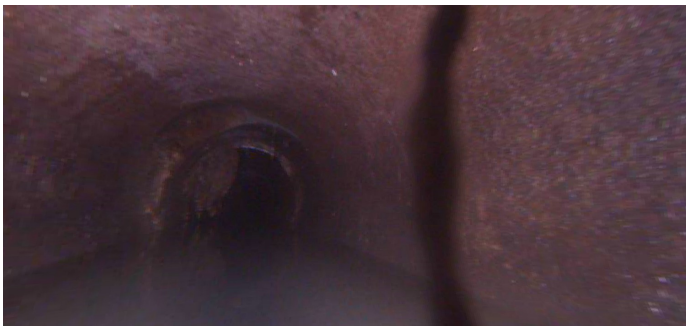
Code: **TF**
Description: **Tap Factory**

Distance (ft): **177.2**
Structural Grade: **0**
O&M Grade: **0**
Clock Start/From: **11**
Clock To:
1st Value: **4.000**
2nd Value:
Value Percent:
Continuous Index:
Within 8" of Joint:
Remarks:

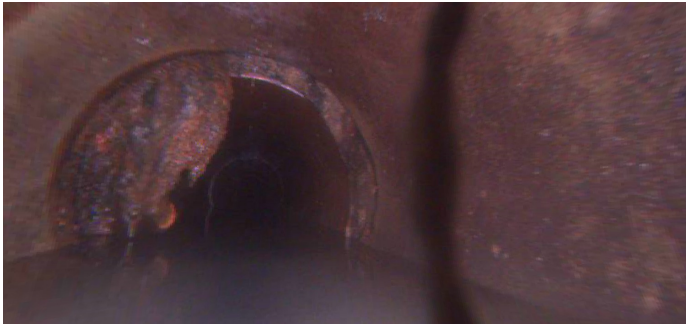
Code: **DAE**
Description: **Deposits Attached Encrustation**

Distance (ft): **178.7**
Structural Grade: **0**
O&M Grade: **5**
Clock Start/From: **8**
Clock To: **4**
1st Value:
2nd Value:
Value Percent: **45.000**
Continuous Index:
Within 8" of Joint: **YES**
Remarks:

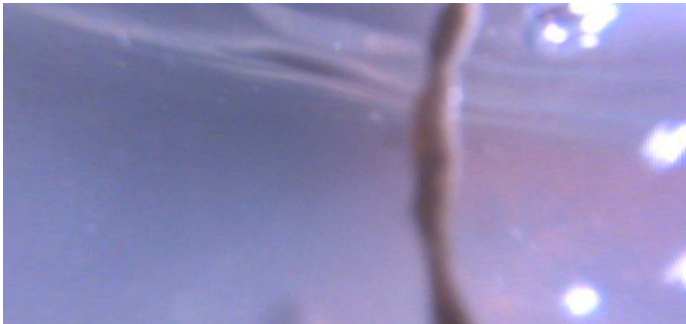
Code: **MWLS**
Description: **Water Level Sag**

Distance (ft): **200.1**
Structural Grade: **2**
O&M Grade: **3**
Clock Start/From:
Clock To:
1st Value:
2nd Value:
Value Percent: **10.000**
Continuous Index:
Within 8" of Joint: **NO**
Remarks:

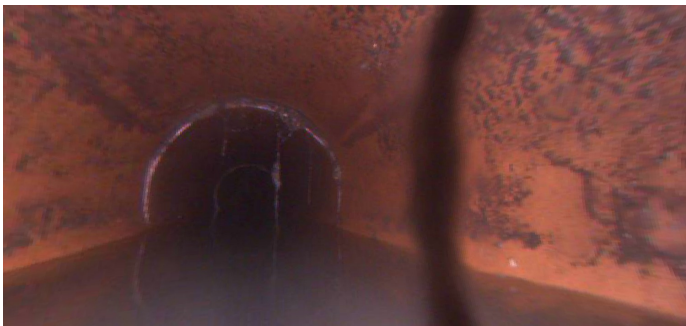
Code: **RFJ**
Description: **Roots Fine Joint**

Distance (ft): **206.3**
Structural Grade: **0**
O&M Grade: **1**
Clock Start/From: **8**
Clock To: **4**
1st Value:
2nd Value:
Value Percent:
Continuous Index:
Within 8" of Joint: **YES**
Remarks:

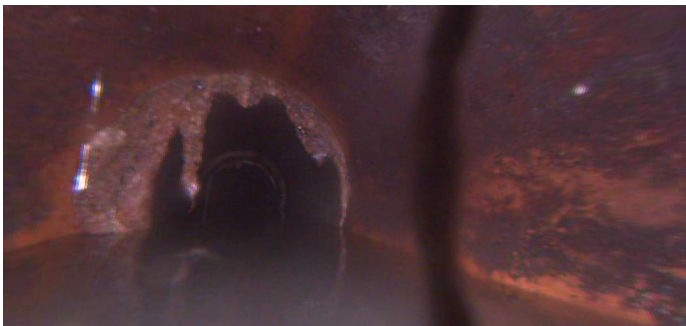
Code: **DAE**
Description: **Deposits Attached Encrustation**

Distance (ft): **215.9**
Structural Grade: **0**
O&M Grade: **5**
Clock Start/From: **8**
Clock To: **4**
1st Value:
2nd Value:
Value Percent: **40.000**
Continuous Index:
Within 8" of Joint: **YES**
Remarks:

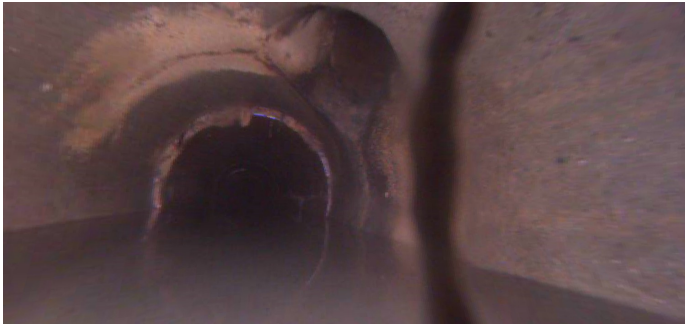
Code: **TF**
Description: **Tap Factory**

Distance (ft): **218.6**
Structural Grade: **0**
O&M Grade: **0**
Clock Start/From: **2**
Clock To:
1st Value: **4.000**
2nd Value:
Value Percent:
Continuous Index:
Within 8" of Joint:
Remarks:

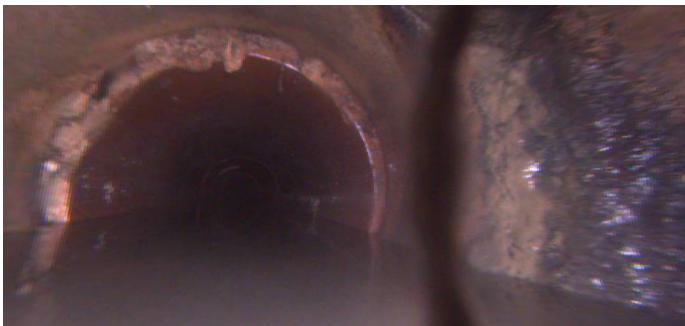
Code: **DAE**
Description: **Deposits Attached Encrustation**

Distance (ft): **219.4**
Structural Grade: **0**
O&M Grade: **2**
Clock Start/From: **8**
Clock To: **4**
1st Value:
2nd Value:
Value Percent: **5.000**
Continuous Index:
Within 8" of Joint: **YES**
Remarks:

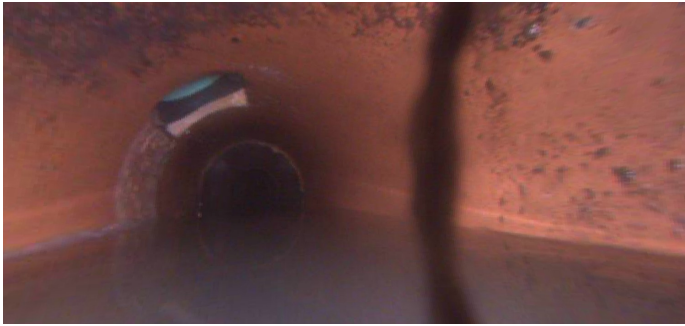
Code: **TF**
Description: **Tap Factory**

Distance (ft): **223.6**
Structural Grade: **0**
O&M Grade: **0**
Clock Start/From: **11**
Clock To:
1st Value: **4.000**
2nd Value:
Value Percent:
Continuous Index:
Within 8" of Joint:
Remarks:

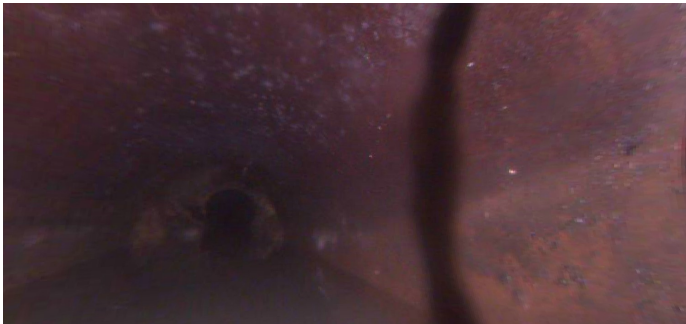
Code: **AMH**
Description: **Manhole**

Distance (ft): **239.9**
Structural Grade: **0**
O&M Grade: **0**
Clock Start/From:
Clock To:
1st Value:
2nd Value:
Value Percent:
Continuous Index:
Within 8" of Joint: **NO**
Remarks: **M-507-024**
