Profile/Photo Observation Report

Date:	10/10/2018	Weather:		Coding:	PACP 6.0
Pipe Length (ft):	235.0	Owner:	NA	Pre Clean:	Not Known
P.O.#:		Surveyor:	Selasie Honu	PSR:	P-507-024-023
Customer:		Clean Date:	01/01/1900	Shape:	C

Street:	Csokasy Ln.	Flow Control:	Not Controlled
City:	Hobart, IN	Year Renewed:	
Location:	Light Highway	Tape/Media #:	
Purpose:	Routine Assessment	Dia/Height:	12"
Use:	Sanitary	Material:	VCP
Drain Area:	NA	Lining:	
Category:	NA		
Comment:	NULL - DC @ MH-M-507-059		
Location Details:		Direction of Survey:	Upstream
US MH:	M-507-023	DS MH:	M-507-024
		Total Length Surveyed (ft):	2.7

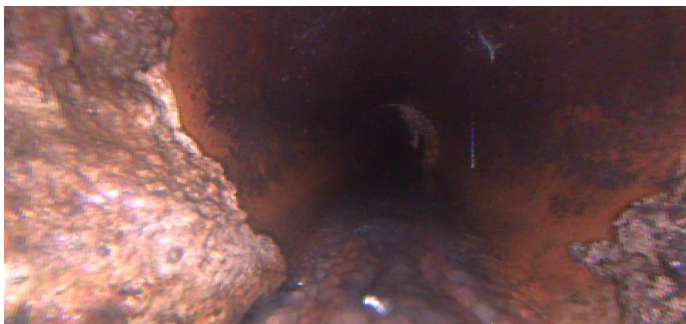
Code: **AMH**
Description: **Manhole**

Distance (ft): **.0**
Structural Grade: **0**
O&M Grade: **0**
Clock Start/From:
Clock To:
1st Value:
2nd Value:
Value Percent:
Continuous Index:
Within 8" of Joint: **NO**
Remarks: **M-507-024**

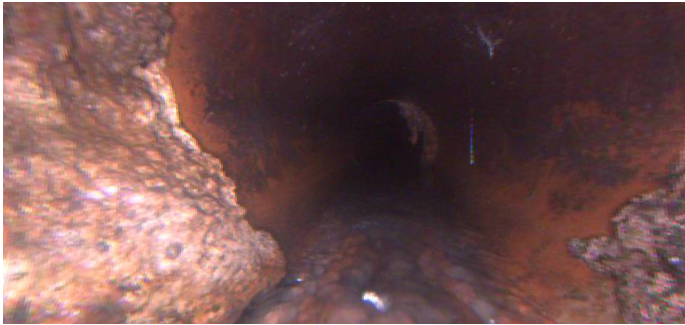
Code:	MWL
Description:	Water Level

Distance (ft):	.0
Structural Grade:	0
O&M Grade:	0
Clock Start/From:	
Clock To:	
1st Value:	
2nd Value:	
Value Percent:	5.000
Continuous Index:	
Within 8" of Joint:	NO
Remarks:

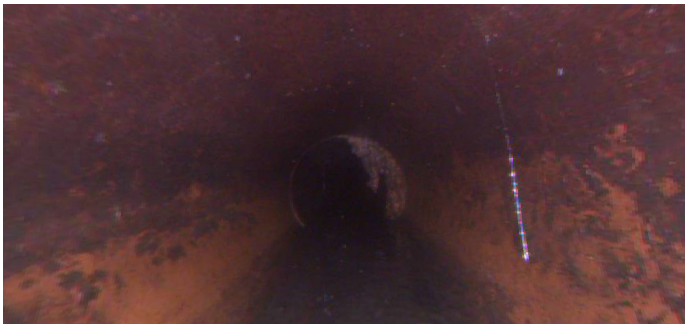
Code:	MSA
Description:	Abandoned Survey

Distance (ft):	2.7
Structural Grade:	0
O&M Grade:	0
Clock Start/From:	
Clock To:	
1st Value:	
2nd Value:	
Value Percent:	
Continuous Index:	
Within 8" of Joint:	NO
Remarks:	camera stoppe
