Profile/Photo Observation Report

Date:	10/10/2018	Weather:		Coding:	PACP 6.0
Pipe Length (ft):	210.4	Owner:	NA	Pre Clean:	Not Known
P.O.#:		Surveyor:	Selasie Honu	PSR:	P-507-026-025
Customer:		Clean Date:	01/01/1900	Shape:	C

Street:	ALLEY BETWEEN S DEKALB ST & S C	Flow Control:	Not Controlled
City:	Hobart, IN	Year Renewed:	
Location:	Light Highway	Tape/Media #:	
Purpose:	Routine Assessment	Dia/Height:	12"
Use:	Sanitary	Material:	VCP
Drain Area:	NA	Lining:	
Category:	NA		
Comment:	NULL - DC @ MH-M-507-059		
Location Details:		Direction of Survey:	Upstream
US MH:	M-507-025	DS MH:	M-507-026
		Total Length Surveyed (ft):	51.9

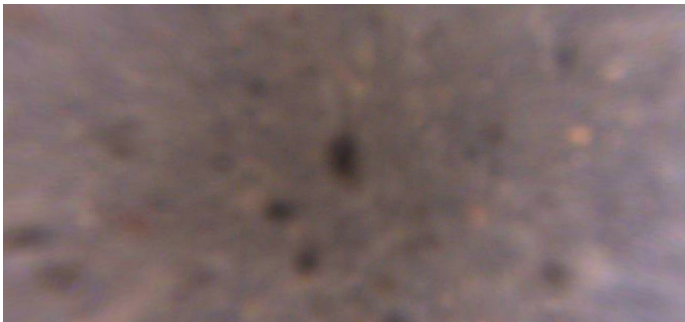
Code: **AMH**
Description: **Manhole**

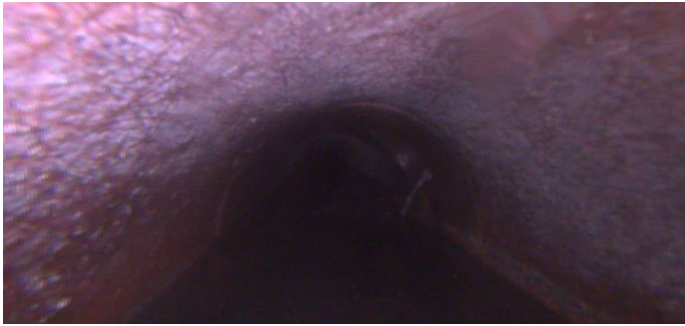
Code: **TFA**
Description: **Tap Factory Active**

Distance (ft): **40.0**
Structural Grade: **0**
O&M Grade: **0**
Clock Start/From: **2**
Clock To:
1st Value: **4.000**
2nd Value:
Value Percent:
Continuous Index:
Within 8" of Joint:
Remarks:
