Profile/Photo Observation Report

Date:	03/29/2018	Weather:		Coding:	PACP 6.0
Pipe Length (ft):	192.9	Owner:	NA	Pre Clean:	No Pre-Cleaning
P.O.#:		Surveyor:	Jen Costello	PSR:	P-507-030-029
Customer:		Clean Date:	01/01/1900	Shape:	C

Street:	FOXCROFT STREET	Flow Control:	Not Controlled
City:	Hobart, IN	Year Renewed:	
Location:	Yard	Tape/Media #:	
Purpose:	Routine Assessment	Dia/Height:	8"
Use:	Sanitary	Material:	VCP
Drain Area:	NA	Lining:	
Category:	NA		
Comment:	P_C at O_C 155 ft build up at O_C . Flow direction wrong		
Location Details:		Direction of Survey:	Upstream
US MH:	M-507-029	DS MH:	M-507-030
		Total Length Surveyed (ft):	157.1

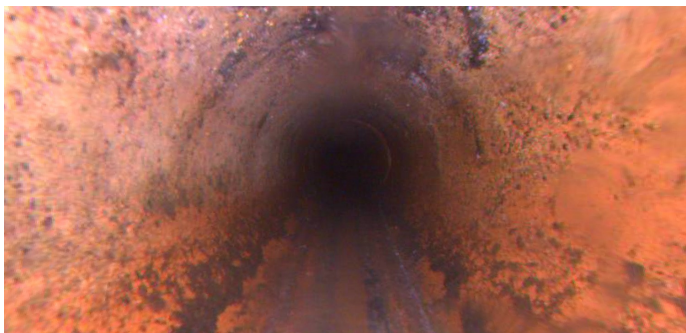
Code: **AMH**
Description: **Manhole**

Distance (ft): **.0**
Structural Grade: **0**
O&M Grade: **0**
Clock Start/From:
Clock To:
1st Value:
2nd Value:
Value Percent:
Continuous Index:
Within 8" of Joint: **NO**
Remarks: **M-507-030**

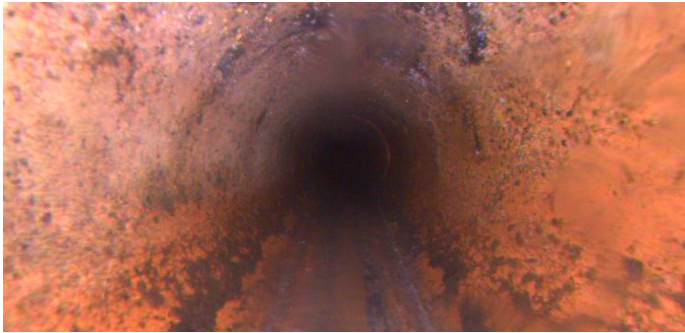
Code:	MWL
Description:	Water Level

Distance (ft):	.0
Structural Grade:	0
O&M Grade:	0
Clock Start/From:	
Clock To:	
1st Value:	
2nd Value:	
Value Percent:	5.000
Continuous Index:	
Within 8" of Joint:	NO
Remarks:

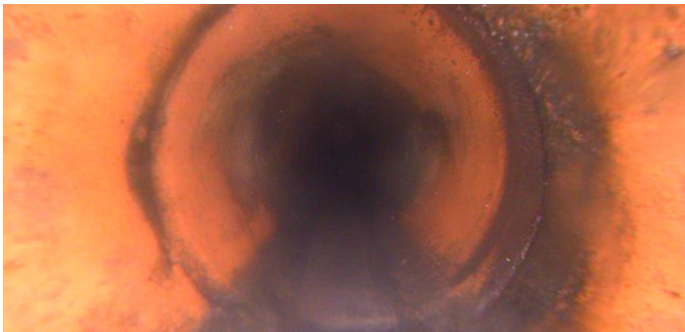
Code:	IW
Description:	Infil Weeper

Distance (ft):	33.1
Structural Grade:	0
O&M Grade:	2
Clock Start/From:	8
Clock To:	4
1st Value:	
2nd Value:	
Value Percent:	
Continuous Index:	
Within 8" of Joint:	YES
Remarks:

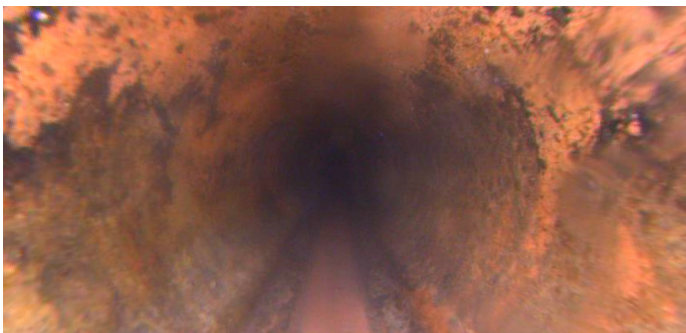
Code: **DAE**
Description: **Deposits Attached Encrustation**

Distance (ft): **39.4**
Structural Grade: **0**
O&M Grade: **2**
Clock Start/From: **7**
Clock To: **5**
1st Value:
2nd Value:
Value Percent: **5.000**
Continuous Index: **S01**
Within 8" of Joint: **NO**
Remarks:

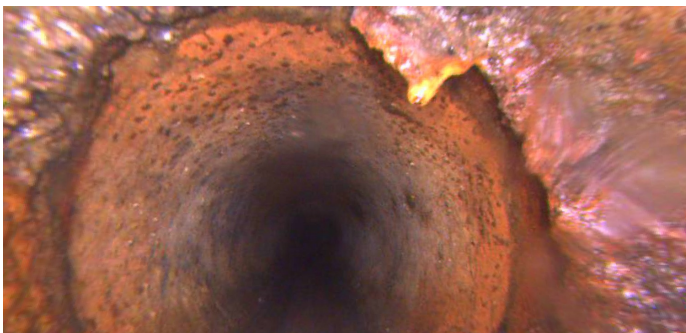
Code: **ID**
Description: **Infil Dripper**

Distance (ft): **53.4**
Structural Grade: **0**
O&M Grade: **3**
Clock Start/From: **1**
Clock To:
1st Value:
2nd Value:
Value Percent:
Continuous Index:
Within 8" of Joint: **YES**
Remarks:

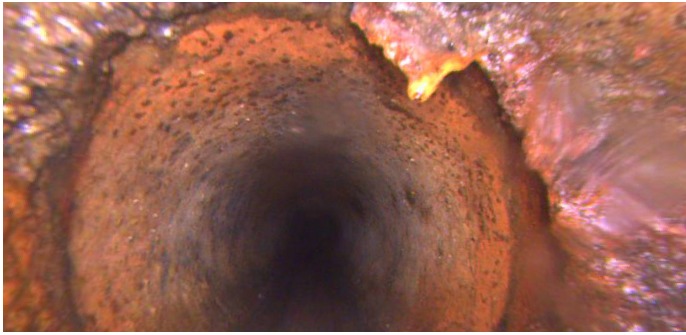
Code: **DAE**
Description: **Deposits Attached Encrustation**

Distance (ft): **53.4**
Structural Grade: **0**
O&M Grade: **2**
Clock Start/From: **8**
Clock To: **4**
1st Value:
2nd Value:
Value Percent: **10.000**
Continuous Index:
Within 8" of Joint: **YES**
Remarks:

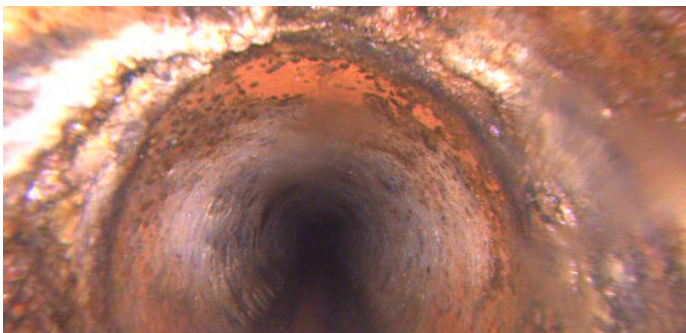
Code: **DAE**
Description: **Deposits Attached Encrustation**

Distance (ft): **63.5**
Structural Grade: **0**
O&M Grade: **2**
Clock Start/From: **8**
Clock To: **4**
1st Value:
2nd Value:
Value Percent: **5.000**
Continuous Index:
Within 8" of Joint: **YES**
Remarks:

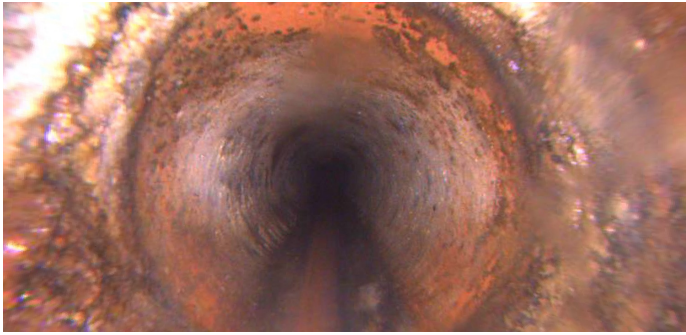
Code: **IW**
Description: **Infil Weeper**

Distance (ft): **63.5**
Structural Grade: **0**
O&M Grade: **2**
Clock Start/From: **8**
Clock To: **4**
1st Value:
2nd Value:
Value Percent:
Continuous Index:
Within 8" of Joint: **YES**
Remarks:

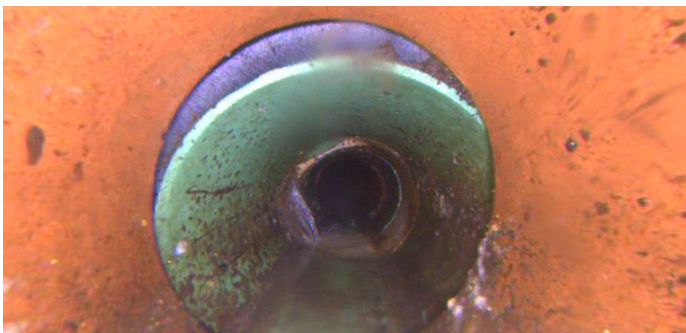
Code: **DAE**
Description: **Deposits Attached Encrustation**

Distance (ft): **88.4**
Structural Grade: **0**
O&M Grade: **2**
Clock Start/From: **7**
Clock To: **5**
1st Value:
2nd Value:
Value Percent: **5.000**
Continuous Index: **F01**
Within 8" of Joint: **NO**
Remarks:

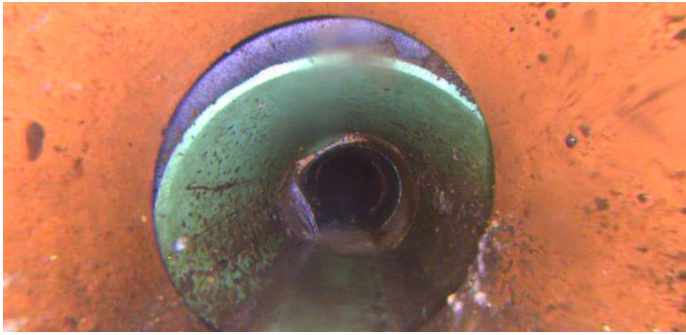
Code: **JOL**
Description: **Joint Offset Large**

Distance (ft): **88.4**
Structural Grade: **2**
O&M Grade: **0**
Clock Start/From:
Clock To:
1st Value:
2nd Value:
Value Percent:
Continuous Index:
Within 8" of Joint: **NO**
Remarks:

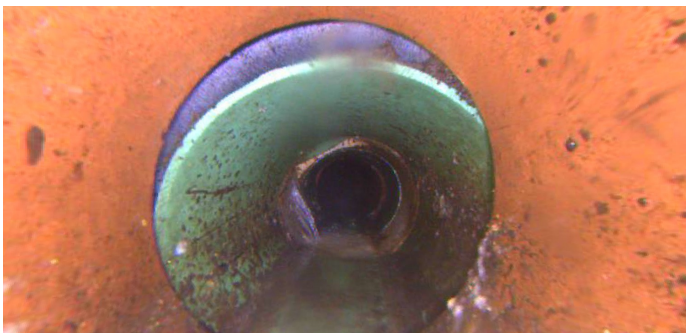
Code: **MMC**
Description: **Material Change**

Distance (ft): **88.4**
Structural Grade: **0**
O&M Grade: **0**
Clock Start/From:
Clock To:
1st Value:
2nd Value:
Value Percent:
Continuous Index:
Within 8" of Joint: **NO**
Remarks: **PVC**

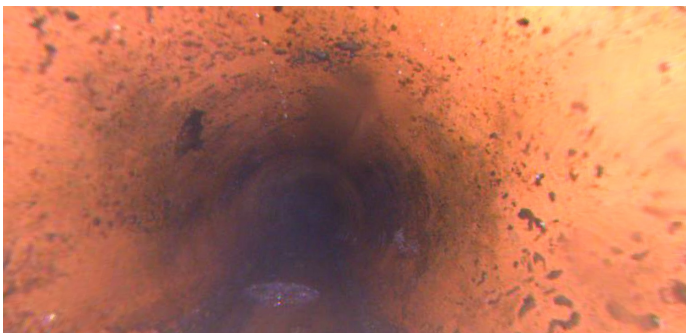
Code: **MMC**
Description: **Material Change**

Distance (ft): **91.1**
Structural Grade: **0**
O&M Grade: **0**
Clock Start/From:
Clock To:
1st Value:
2nd Value:
Value Percent:
Continuous Index:
Within 8" of Joint: **NO**
Remarks: **vcp**

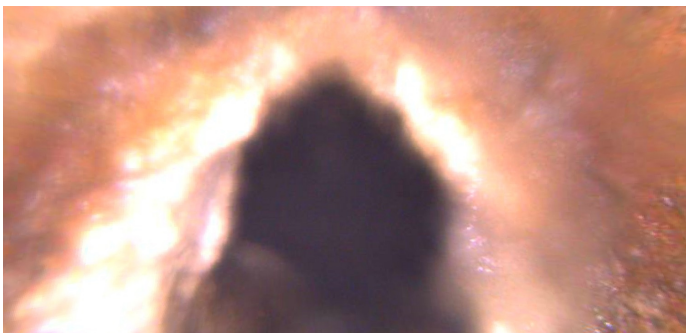
Code: **DAE**
Description: **Deposits Attached Encrustation**

Distance (ft): **155.9**
Structural Grade: **0**
O&M Grade: **5**
Clock Start/From: **8**
Clock To: **4**
1st Value:
2nd Value:
Value Percent: **40.000**
Continuous Index:
Within 8" of Joint: **NO**
Remarks: **at MH**

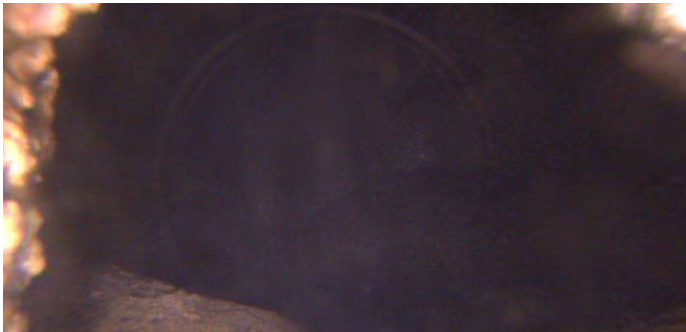
Code: **AMH**
Description: **Manhole**

Distance (ft): **157.1**
Structural Grade: **0**
O&M Grade: **0**
Clock Start/From:
Clock To:
1st Value:
2nd Value:
Value Percent:
Continuous Index:
Within 8" of Joint: **NO**
Remarks: **M-507-029**
