## Profile/Photo Observation Report

Street:	<b>FOXCROFT STREET</b>	Flow Control:	<b>Not Controlled</b>
City:	<b>Hobart, IN</b>	Year Renewed:	
Location:	<b>Yard</b>	Tape/Media #:	
Purpose:	<b>Routine Assessment</b>	Dia/Height:	<b>10"</b>
Use:	<b>Sanitary</b>	Material:	<b>VCP</b>
Drain Area:	<b>NA</b>	Lining:	
Category:	<b>NA</b>		
Comment:	<b>Flow direction wrong</b>

Location Details:		Direction of Survey:	<b>Downstream</b>
US MH:	<b>M-507-031</b>	DS MH:	<b>M-507-032</b>
		Total Length Surveyed (ft):	<b>150.0</b>

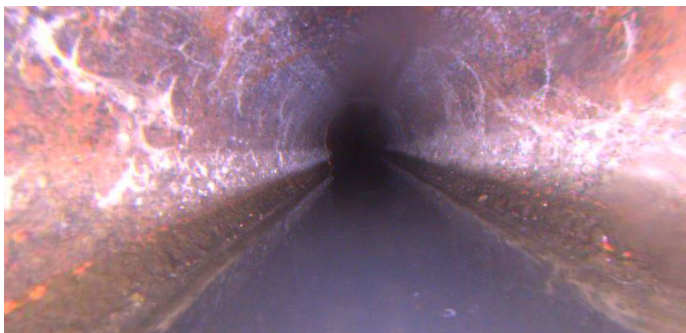
Code: **AMH**  
Description: **Manhole**

Distance (ft): **.0**  
Structural Grade: **0**  
O&M Grade: **0**  
Clock Start/From:  
Clock To:  
1st Value:  
2nd Value:  
Value Percent:  
Continuous Index:  
Within 8" of Joint: **NO**  
Remarks: **M-507-031**

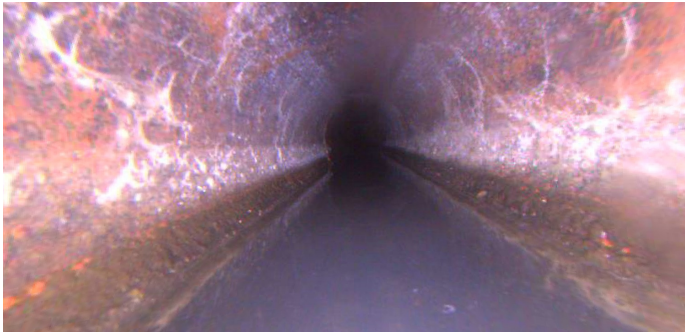
Code:	<b>MWL</b>
Description:	<b>Water Level</b>

Distance (ft):	<b>.0</b>
Structural Grade:	<b>0</b>
O&M Grade:	<b>0</b>
Clock Start/From:	
Clock To:	
1st Value:	
2nd Value:	
Value Percent:	<b>20.000</b>
Continuous Index:	
Within 8" of Joint:	<b>NO</b>
Remarks:

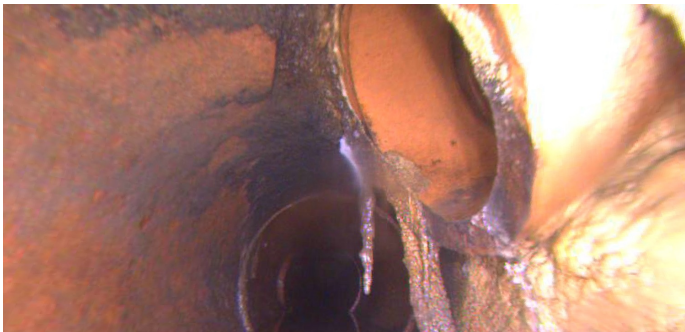
Code:	<b>TBI</b>
Description:	<b>Tap Break-in Intruding</b>

Distance (ft):	<b>43.2</b>
Structural Grade:	<b>0</b>
O&M Grade:	<b>2</b>
Clock Start/From:	<b>2</b>
Clock To:	
1st Value:	<b>4.000</b>
2nd Value:	<b>3.000</b>
Value Percent:	
Continuous Index:	
Within 8" of Joint:	
Remarks:	<b>ROOTS</b>

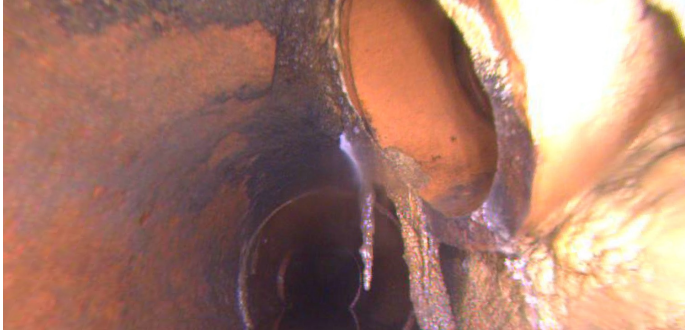
Code: **RFC**  
Description: **Roots Fine Connection**

Distance (ft): **43.2**  
Structural Grade: **0**  
O&M Grade: **1**  
Clock Start/From: **1**  
Clock To: **2**  
1st Value:  
2nd Value:  
Value Percent:  
Continuous Index:  
Within 8" of Joint: **NO**  
Remarks:

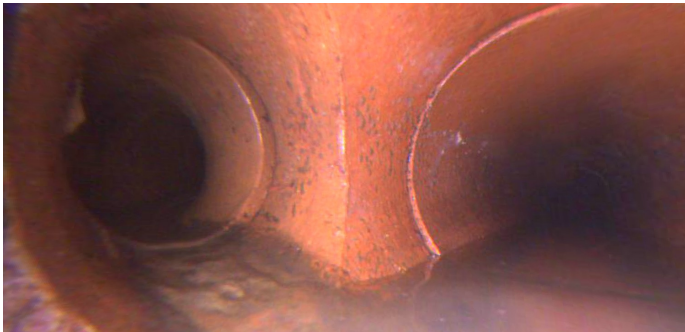
Code: **TFA**  
Description: **Tap Factory Active**

Distance (ft): **45.7**  
Structural Grade: **0**  
O&M Grade: **0**  
Clock Start/From: **9**  
Clock To:  
1st Value: **4.000**  
2nd Value:  
Value Percent:  
Continuous Index:  
Within 8" of Joint:  
Remarks:

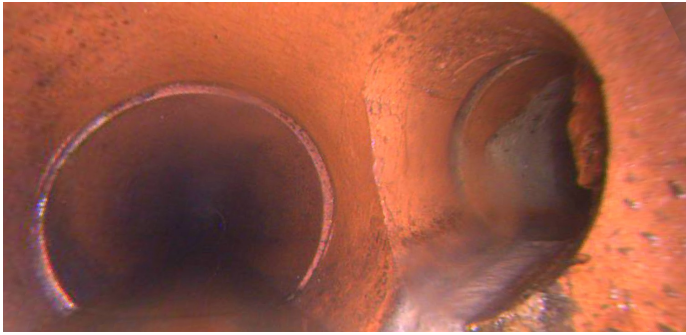
Code: **TFA**  
Description: **Tap Factory Active**

Distance (ft): **88.1**  
Structural Grade: **0**  
O&M Grade: **0**  
Clock Start/From: **3**  
Clock To:  
1st Value: **4.000**  
2nd Value:  
Value Percent:  
Continuous Index:  
Within 8" of Joint:  
Remarks:

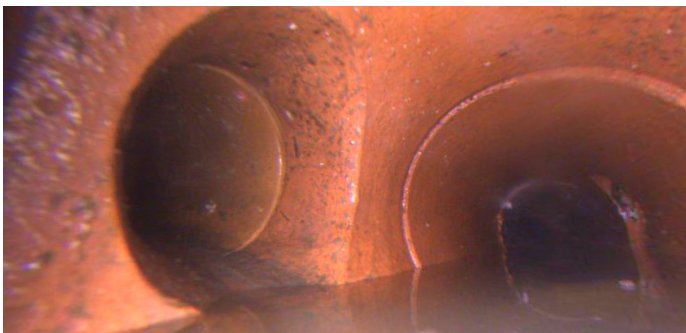
Code: **TF**  
Description: **Tap Factory**

Distance (ft): **140.5**  
Structural Grade: **0**  
O&M Grade: **0**  
Clock Start/From: **9**  
Clock To:  
1st Value: **4.000**  
2nd Value:  
Value Percent:  
Continuous Index:  
Within 8" of Joint:  
Remarks:

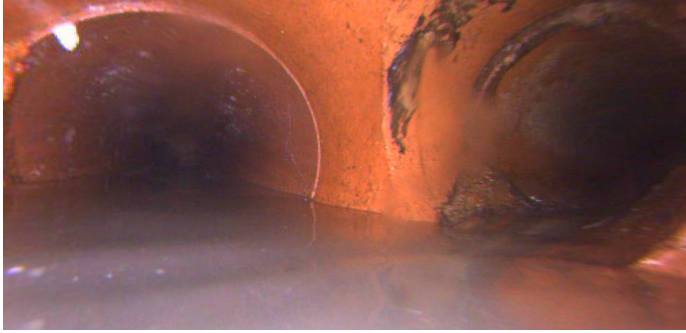
Code: **TFA**  
Description: **Tap Factory Active**

Distance (ft): **142.6**  
Structural Grade: **0**  
O&M Grade: **0**  
Clock Start/From: **3**  
Clock To:  
1st Value: **4.000**  
2nd Value:  
Value Percent:  
Continuous Index:  
Within 8" of Joint:  
Remarks:

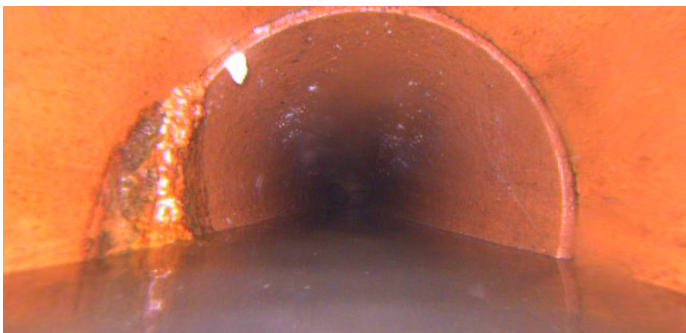
Code: **DAE**  
Description: **Deposits Attached Encrustation**

Distance (ft): **143.0**  
Structural Grade: **0**  
O&M Grade: **2**  
Clock Start/From: **9**  
Clock To: **10**  
1st Value:  
2nd Value:  
Value Percent: **5.000**  
Continuous Index:  
Within 8" of Joint: **YES**  
Remarks:

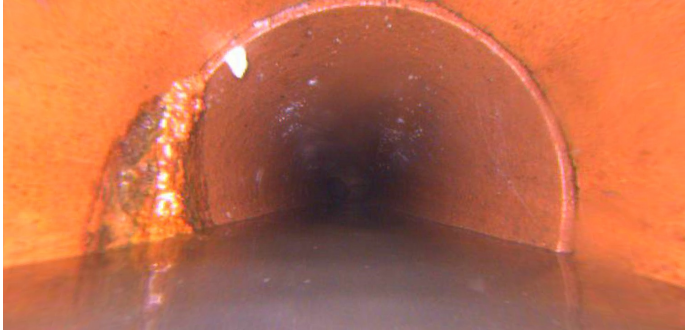
Code: **IW**  
Description: **Infil Weeper**

Distance (ft): **143.0**  
Structural Grade: **0**  
O&M Grade: **2**  
Clock Start/From: **9**  
Clock To: **10**  
1st Value:  
2nd Value:  
Value Percent:  
Continuous Index:  
Within 8" of Joint: **YES**  
Remarks:

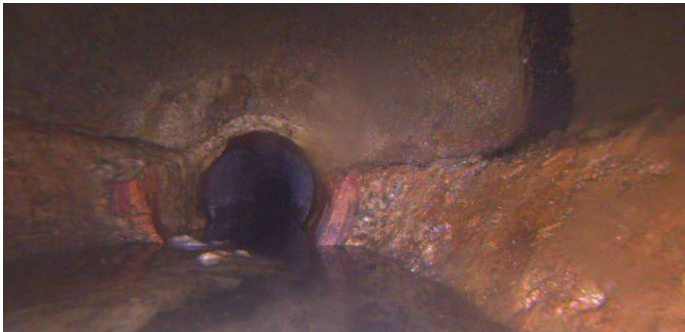
Code: **AMH**  
Description: **Manhole**

Distance (ft): **150.0**  
Structural Grade: **0**  
O&M Grade: **0**  
Clock Start/From:  
Clock To:  
1st Value:  
2nd Value:  
Value Percent:  
Continuous Index:  
Within 8" of Joint: **NO**  
Remarks: **M-507-032**
