Profile/Photo Observation Report

Date:	03/29/2018	Weather:		Coding:	PACP 6.0
Pipe Length (ft):	205.9	Owner:	NA	Pre Clean:	No Pre-Cleaning
P.O.#:		Surveyor:	JUSTIN GONZALES	PSR:	P-507-034-033
Customer:		Clean Date:	01/01/1900	Shape:	C

Street:	ALLEY BETWEEN S DECATUR ST & S	Flow Control:	Not Controlled
City:	Hobart, IN	Year Renewed:	
Location:	Yard	Tape/Media #:	
Purpose:	Routine Assessment	Dia/Height:	10"
Use:	Sanitary	Material:	VCP
Drain Area:	NA	Lining:	
Category:	NA		
Comment:	Flow direction wrong

Location Details:		Direction of Survey:	Downstream
US MH:	M-507-033	DS MH:	M-507-034
		Total Length Surveyed (ft):	202.3

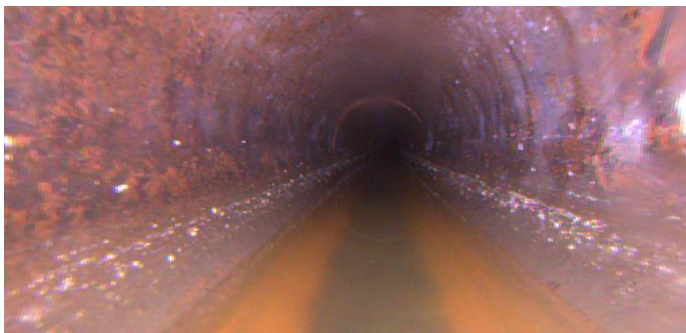
Code: **AMH**
Description: **Manhole**

Distance (ft): **.0**
Structural Grade: **0**
O&M Grade: **0**
Clock Start/From:
Clock To:
1st Value:
2nd Value:
Value Percent:
Continuous Index:
Within 8" of Joint: **NO**
Remarks: **M-507-033**

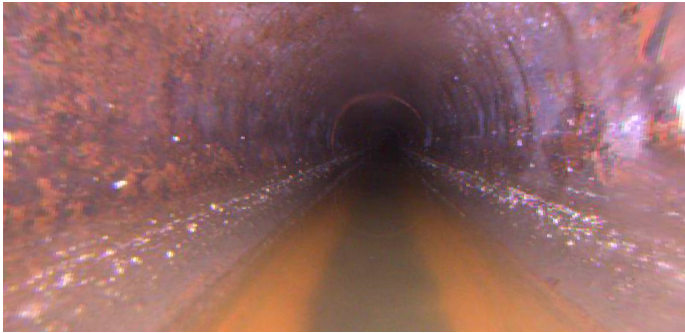
Code:	MWL
Description:	Water Level

Distance (ft):	.0
Structural Grade:	0
O&M Grade:	0
Clock Start/From:	
Clock To:	
1st Value:	
2nd Value:	
Value Percent:	10.000
Continuous Index:	
Within 8" of Joint:	NO
Remarks:

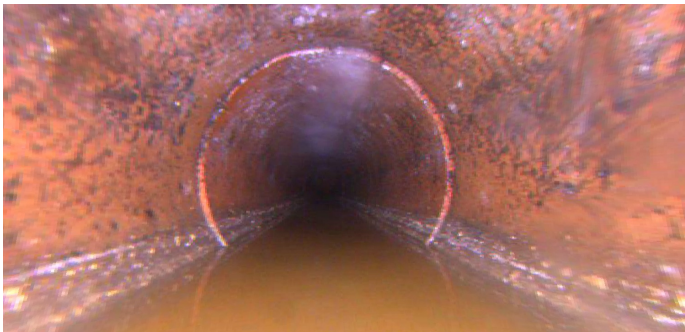
Code:	DAGS
Description:	Deposits Attached Grease

Distance (ft):	27.9
Structural Grade:	0
O&M Grade:	2
Clock Start/From:	10
Clock To:	2
1st Value:	
2nd Value:	
Value Percent:	5.000
Continuous Index:	
Within 8" of Joint:	YES
Remarks:

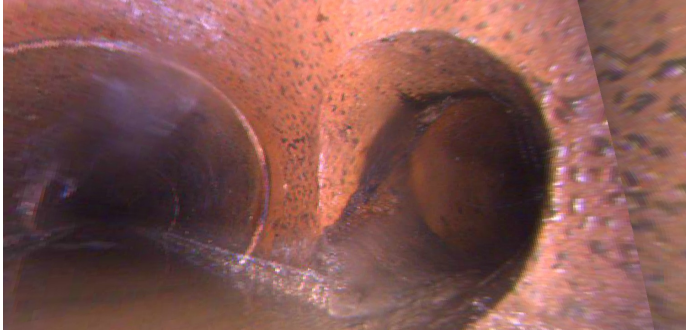
Code: **TFC**
Description: **Tap Factory Capped**

Distance (ft): **40.0**
Structural Grade: **0**
O&M Grade: **0**
Clock Start/From: **3**
Clock To:
1st Value: **4.000**
2nd Value:
Value Percent:
Continuous Index:
Within 8" of Joint:
Remarks:

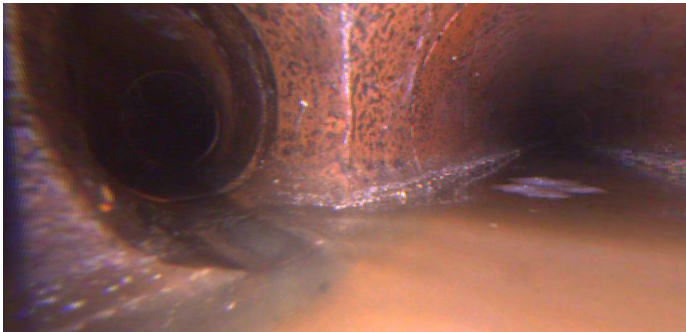
Code: **TF**
Description: **Tap Factory**

Distance (ft): **42.2**
Structural Grade: **0**
O&M Grade: **0**
Clock Start/From: **9**
Clock To:
1st Value: **6.000**
2nd Value:
Value Percent:
Continuous Index:
Within 8" of Joint:
Remarks:

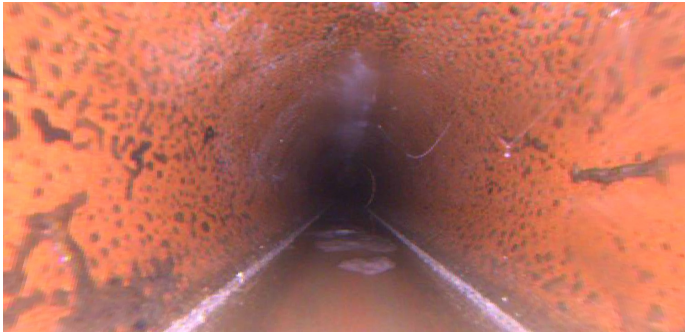
Code: **DAGS**
Description: **Deposits Attached Grease**

Distance (ft): **59.0**
Structural Grade: **0**
O&M Grade: **2**
Clock Start/From: **7**
Clock To: **5**
1st Value:
2nd Value:
Value Percent: **5.000**
Continuous Index: **S02**
Within 8" of Joint: **YES**
Remarks: **WANDER**

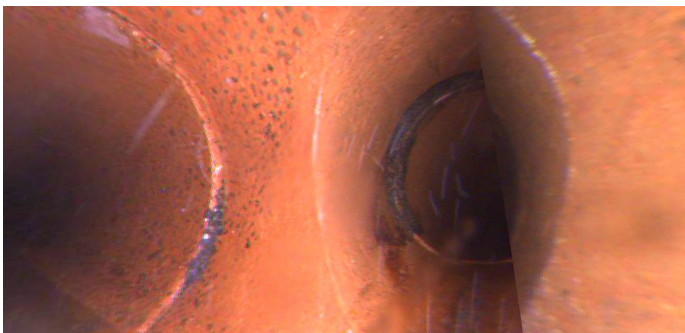
Code: **TF**
Description: **Tap Factory**

Distance (ft): **100.0**
Structural Grade: **0**
O&M Grade: **0**
Clock Start/From: **3**
Clock To:
1st Value: **6.000**
2nd Value:
Value Percent:
Continuous Index:
Within 8" of Joint:
Remarks:

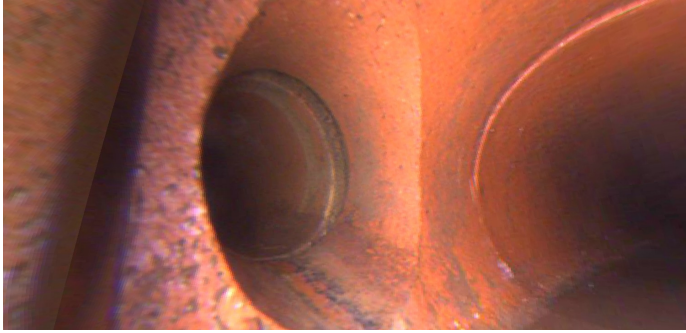
Code: **TF**
Description: **Tap Factory**

Distance (ft): **123.6**
Structural Grade: **0**
O&M Grade: **0**
Clock Start/From: **9**
Clock To:
1st Value: **6.000**
2nd Value:
Value Percent:
Continuous Index:
Within 8" of Joint:
Remarks:

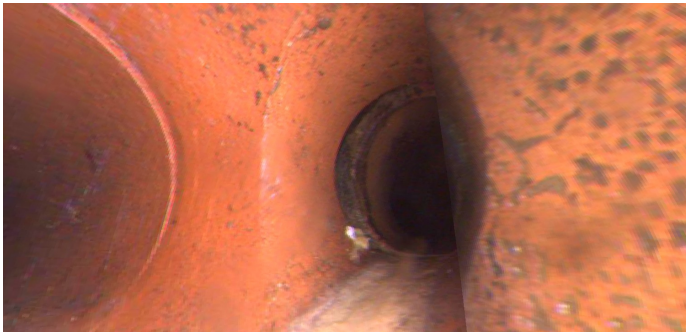
Code: **TF**
Description: **Tap Factory**

Distance (ft): **151.0**
Structural Grade: **0**
O&M Grade: **0**
Clock Start/From: **3**
Clock To:
1st Value: **4.000**
2nd Value:
Value Percent:
Continuous Index:
Within 8" of Joint:
Remarks:

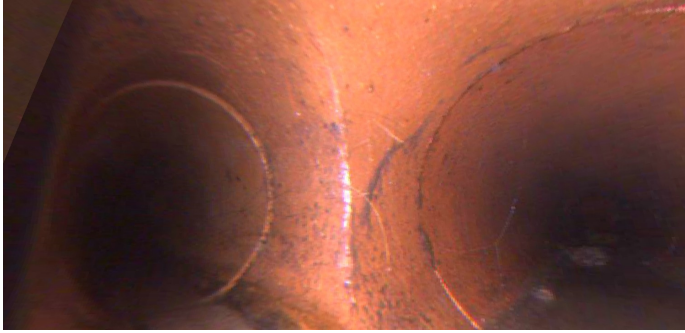
Code: **TF**
Description: **Tap Factory**

Distance (ft): **183.1**
Structural Grade: **0**
O&M Grade: **0**
Clock Start/From: **9**
Clock To:
1st Value: **4.000**
2nd Value:
Value Percent:
Continuous Index:
Within 8" of Joint:
Remarks:

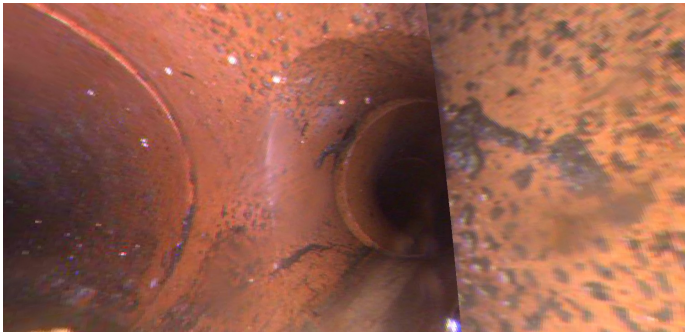
Code: **TF**
Description: **Tap Factory**

Distance (ft): **195.2**
Structural Grade: **0**
O&M Grade: **0**
Clock Start/From: **3**
Clock To:
1st Value: **4.000**
2nd Value:
Value Percent:
Continuous Index:
Within 8" of Joint:
Remarks:

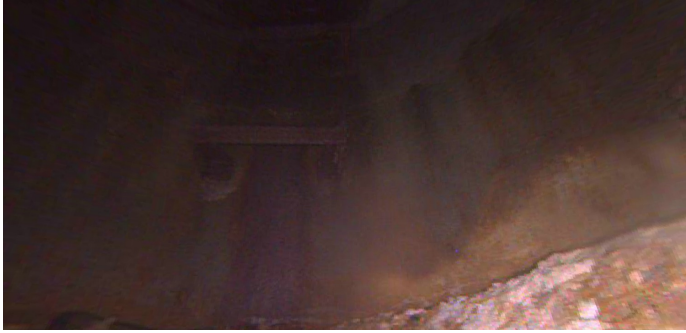
Code: **AMH**
Description: **Manhole**

Distance (ft): **202.3**
Structural Grade: **0**
O&M Grade: **0**
Clock Start/From:
Clock To:
1st Value:
2nd Value:
Value Percent:
Continuous Index:
Within 8" of Joint: **NO**
Remarks: **M-507-034**

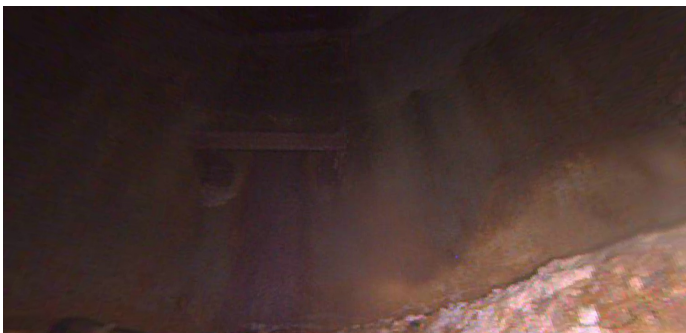
Code: **DAGS**
Description: **Deposits Attached Grease**

Distance (ft): **202.3**
Structural Grade: **0**
O&M Grade: **2**
Clock Start/From: **7**
Clock To: **5**
1st Value:
2nd Value:
Value Percent: **5.000**
Continuous Index: **F02**
Within 8" of Joint: **YES**
Remarks: **WANDER**
