Profile/Photo Observation Report

Street:	FOXCROFT STREET	Flow Control:	Not Controlled
City:	Hobart, IN	Year Renewed:	
Location:	Yard	Tape/Media #:	
Purpose:	Routine Assessment	Dia/Height:	10"
Use:	Sanitary	Material:	VCP
Drain Area:	NA	Lining:	
Category:	NA		
Comment:	Flow direction wrong

Location Details:		Direction of Survey:	Downstream
US MH:	M-507-033	DS MH:	M-507-034
		Total Length Surveyed (ft):	202.3

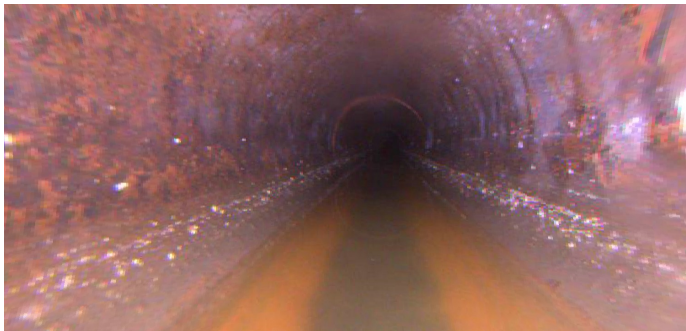
Code: **AMH**
Description: **Manhole**

Distance (ft): **.0**
Structural Grade: **0**
O&M Grade: **0**
Clock Start/From:
Clock To:
1st Value:
2nd Value:
Value Percent:
Continuous Index:
Within 8" of Joint: **NO**
Remarks: **M-507-033**

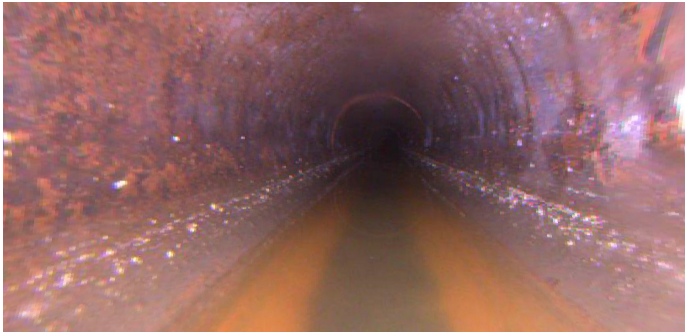
Code:	MWL
Description:	Water Level

Distance (ft):	.0
Structural Grade:	0
O&M Grade:	0
Clock Start/From:	
Clock To:	
1st Value:	
2nd Value:	
Value Percent:	10.000
Continuous Index:	
Within 8" of Joint:	NO
Remarks:

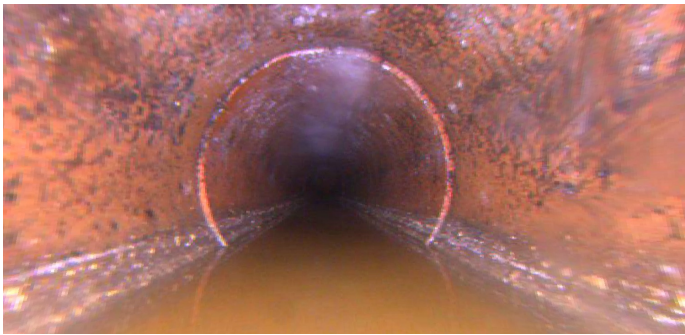
Code:	DAGS
Description:	Deposits Attached Grease

Distance (ft):	27.9
Structural Grade:	0
O&M Grade:	2
Clock Start/From:	10
Clock To:	2
1st Value:	
2nd Value:	
Value Percent:	5.000
Continuous Index:	
Within 8" of Joint:	YES
Remarks:

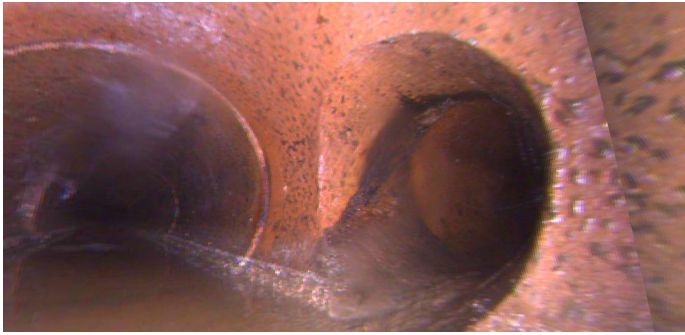
Code: **TFC**
Description: **Tap Factory Capped**

Distance (ft): **40.0**
Structural Grade: **0**
O&M Grade: **0**
Clock Start/From: **3**
Clock To:
1st Value: **4.000**
2nd Value:
Value Percent:
Continuous Index:
Within 8" of Joint:
Remarks:

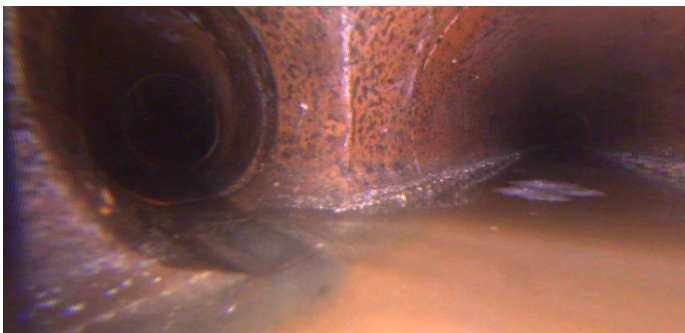
Code: **TF**
Description: **Tap Factory**

Distance (ft): **42.2**
Structural Grade: **0**
O&M Grade: **0**
Clock Start/From: **9**
Clock To:
1st Value: **6.000**
2nd Value:
Value Percent:
Continuous Index:
Within 8" of Joint:
Remarks:

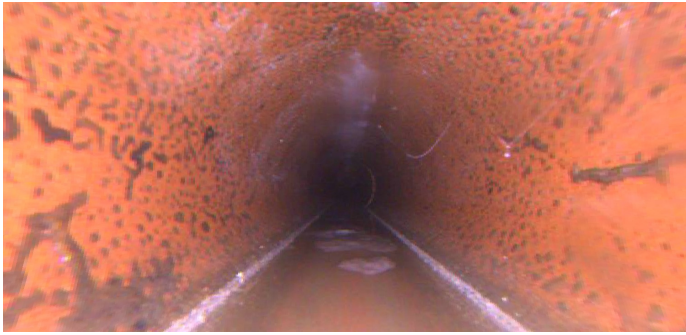
Code: **DAGS**
Description: **Deposits Attached Grease**

Distance (ft): **59.0**
Structural Grade: **0**
O&M Grade: **2**
Clock Start/From: **7**
Clock To: **5**
1st Value:
2nd Value:
Value Percent: **5.000**
Continuous Index: **S02**
Within 8" of Joint: **YES**
Remarks: **WANDER**

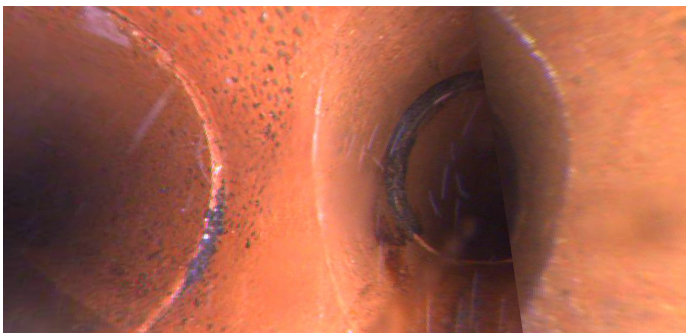
Code: **TF**
Description: **Tap Factory**

Distance (ft): **100.0**
Structural Grade: **0**
O&M Grade: **0**
Clock Start/From: **3**
Clock To:
1st Value: **6.000**
2nd Value:
Value Percent:
Continuous Index:
Within 8" of Joint:
Remarks:

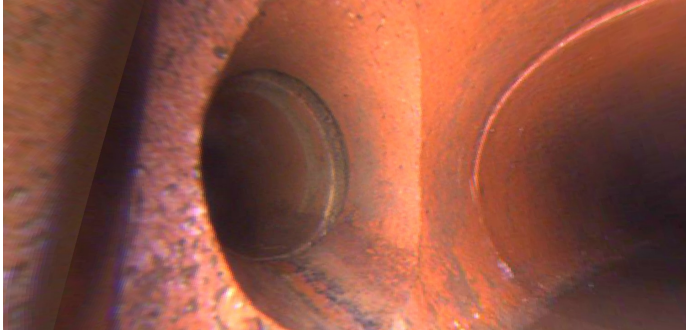
Code: **TF**
Description: **Tap Factory**

Distance (ft): **123.6**
Structural Grade: **0**
O&M Grade: **0**
Clock Start/From: **9**
Clock To:
1st Value: **6.000**
2nd Value:
Value Percent:
Continuous Index:
Within 8" of Joint:
Remarks:

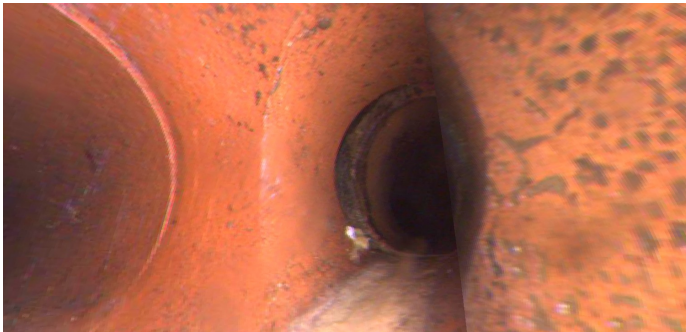
Code: **TF**
Description: **Tap Factory**

Distance (ft): **151.0**
Structural Grade: **0**
O&M Grade: **0**
Clock Start/From: **3**
Clock To:
1st Value: **4.000**
2nd Value:
Value Percent:
Continuous Index:
Within 8" of Joint:
Remarks:

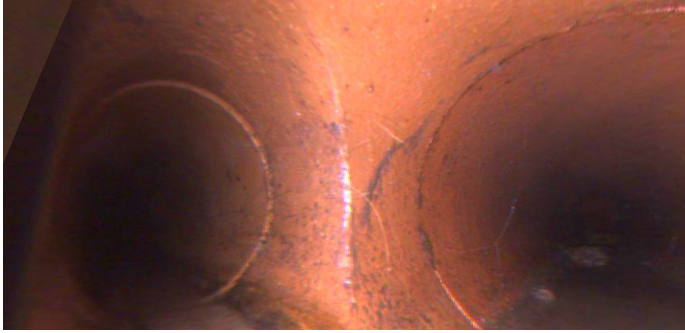
Code: **TF**
Description: **Tap Factory**

Distance (ft): **183.1**
Structural Grade: **0**
O&M Grade: **0**
Clock Start/From: **9**
Clock To:
1st Value: **4.000**
2nd Value:
Value Percent:
Continuous Index:
Within 8" of Joint:
Remarks:

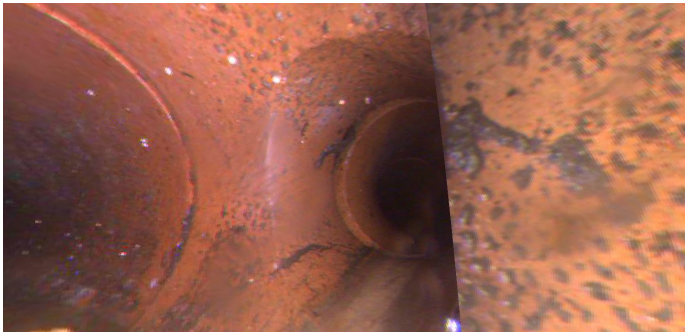
Code: **TF**
Description: **Tap Factory**

Distance (ft): **195.2**
Structural Grade: **0**
O&M Grade: **0**
Clock Start/From: **3**
Clock To:
1st Value: **4.000**
2nd Value:
Value Percent:
Continuous Index:
Within 8" of Joint:
Remarks:

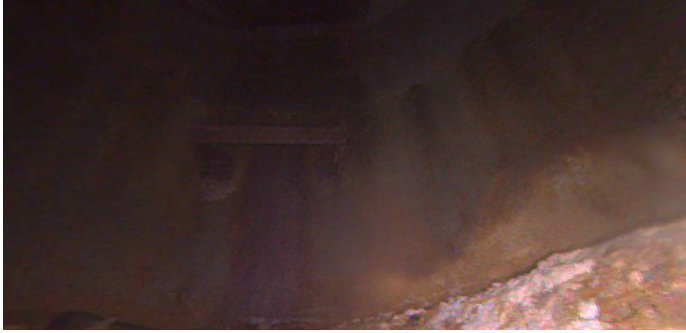
Code: **AMH**
Description: **Manhole**

Distance (ft): **202.3**
Structural Grade: **0**
O&M Grade: **0**
Clock Start/From:
Clock To:
1st Value:
2nd Value:
Value Percent:
Continuous Index:
Within 8" of Joint: **NO**
Remarks: **M-507-034**

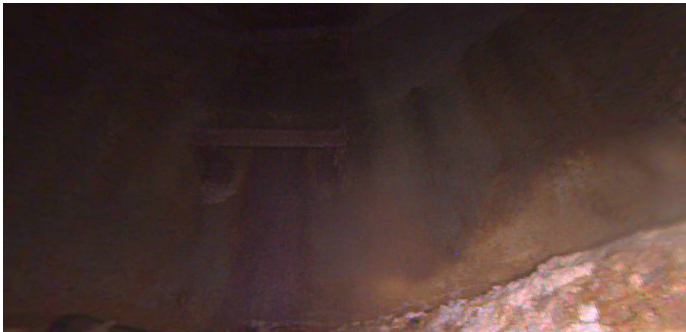
Code: **DAGS**
Description: **Deposits Attached Grease**

Distance (ft): **202.3**
Structural Grade: **0**
O&M Grade: **2**
Clock Start/From: **7**
Clock To: **5**
1st Value:
2nd Value:
Value Percent: **5.000**
Continuous Index: **F02**
Within 8" of Joint: **YES**
Remarks: **WANDER**
