Profile/Photo Observation Report

Date:	05/02/2018	Weather:		Coding:	PACP 6.0
Pipe Length (ft):		Owner:	City of Hobart	Pre Clean:	Not Known
P.O.#:	283	Surveyor:	B. Helbling	PSR:	P-507-036.1-036.2
Customer:	City of Hobart	Clean Date:		Shape:	C

Street:	West 10th Street	Flow Control:	Not Controlled
City:	Hobart, IN	Year Renewed:	
Location:	Light Highway	Tape/Media #:	DEP283
Purpose:	Routine Assessment	Dia/Height:	12"
Use:	Sanitary	Material:	PVC
Drain Area:		Lining:	
Category:	NA		
Comment:	5-21-2018		
Location Details:		Direction of Survey:	Downstream
US MH:	M-507-036.1	DS MH:	M-507-036.2
		Total Length Surveyed (ft):	395.8

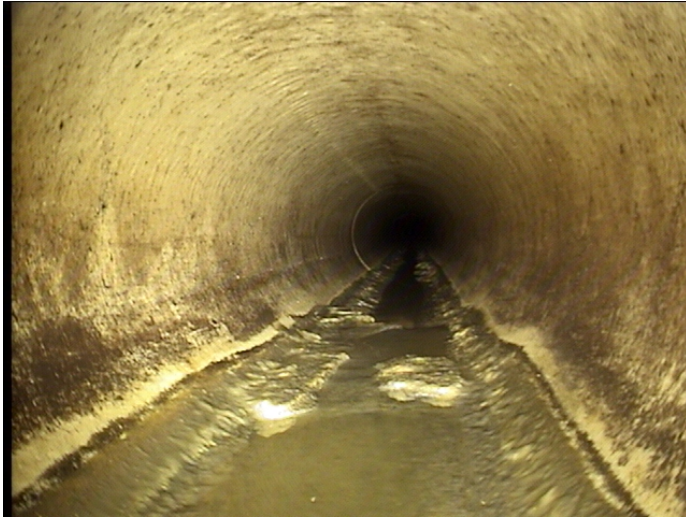
Code:	MWL
Description:	Water Level
Distance (ft):	.0
Structural Grade:	0
O&M Grade:	0
Clock Start/From:	
Clock To:	
1st Value:	
2nd Value:	
Value Percent:	5.000
Continuous Index:	
Within 8" of Joint:	NO
Remarks:

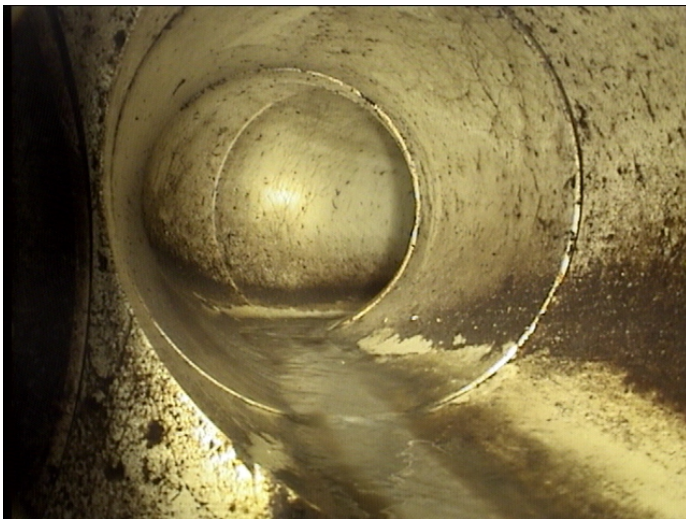
Code:	TF
Description:	Tap Factory
Distance (ft):	46.3
Structural Grade:	0
O&M Grade:	0
Clock Start/From:	9
Clock To:	
1st Value:	6.000
2nd Value:	
Value Percent:	
Continuous Index:	
Within 8" of Joint:	NO
Remarks:

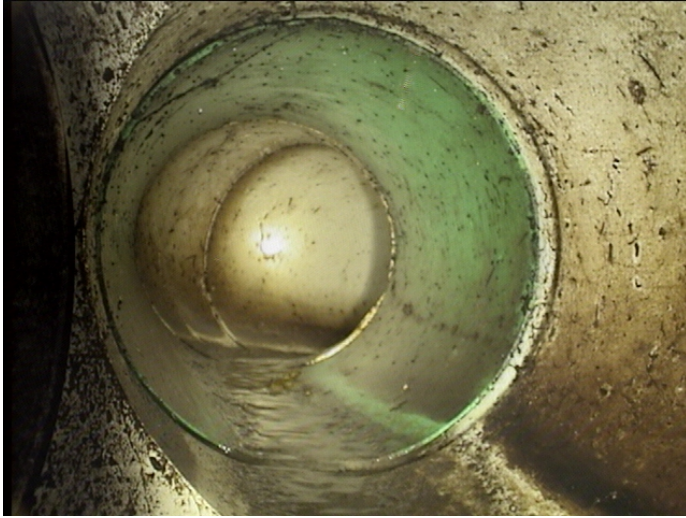
Code: **TF**
Description: **Tap Factory**

Distance (ft): **139.9**
Structural Grade: **0**
O&M Grade: **0**
Clock Start/From: **9**
Clock To:
1st Value: **6.000**
2nd Value:
Value Percent:
Continuous Index:
Within 8" of Joint: **NO**
Remarks:

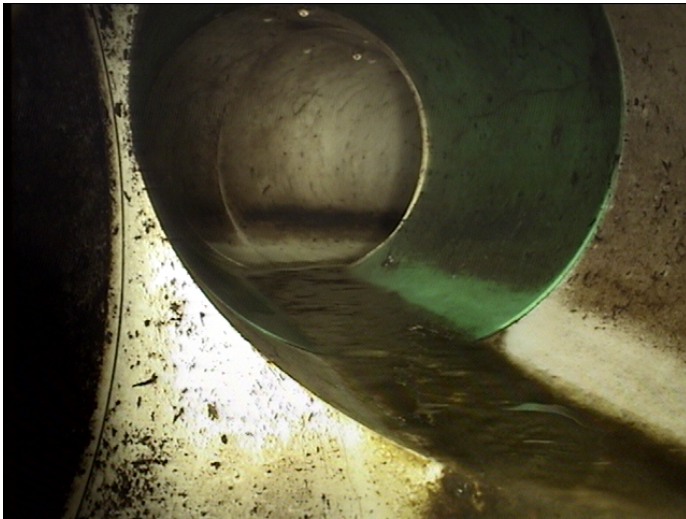
Code: **TF**
Description: **Tap Factory**

Distance (ft): **214.5**
Structural Grade: **0**
O&M Grade: **0**
Clock Start/From: **9**
Clock To:
1st Value: **6.000**
2nd Value:
Value Percent:
Continuous Index:
Within 8" of Joint: **NO**
Remarks:

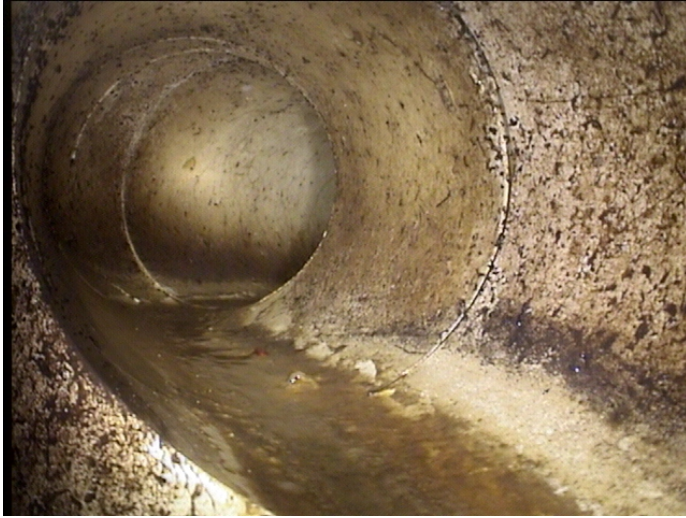
Code: **TF**
Description: **Tap Factory**

Distance (ft): **356.4**
Structural Grade: **0**
O&M Grade: **0**
Clock Start/From: **9**
Clock To:
1st Value: **6.000**
2nd Value:
Value Percent:
Continuous Index:
Within 8" of Joint: **NO**
Remarks:

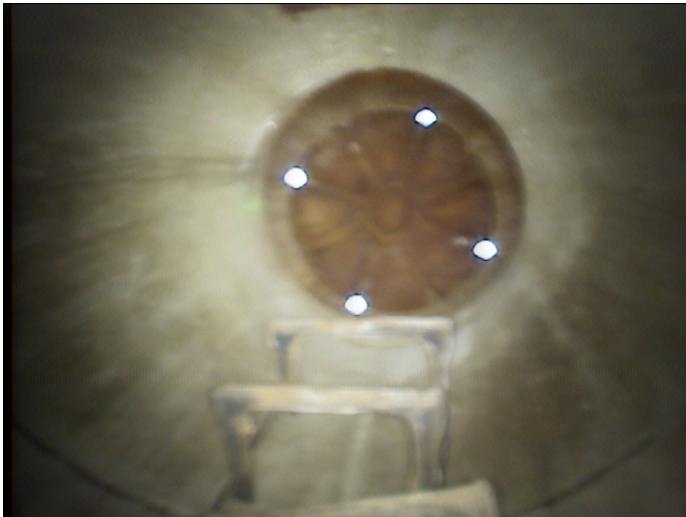
Code: **AMH**
Description: **Manhole**

Distance (ft): **395.8**
Structural Grade: **0**
O&M Grade: **0**
Clock Start/From:
Clock To:
1st Value:
2nd Value:
Value Percent:
Continuous Index:
Within 8" of Joint: **NO**
Remarks: **M-507-036.2**
