Profile/Photo Observation Report

Date:	05/02/2018	Weather:		Coding:	PACP 6.0
Pipe Length (ft):		Owner:	City of Hobart	Pre Clean:	Not Known
P.O.#:	284	Surveyor:	B. Helbling	PSR:	P-507-036.2-036.3
Customer:	City of Hobart	Clean Date:		Shape:	C

Street:	West 10th Street	Flow Control:	Not Controlled
City:	Hobart, IN	Year Renewed:	
Location:	Light Highway	Tape/Media #:	DEP284
Purpose:	Routine Assessment	Dia/Height:	12"
Use:	Sanitary	Material:	PVC
Drain Area:		Lining:	
Category:	NA		
Comment:	5-21-2018

Location Details:		Direction of Survey:	Downstream
US MH:	M-507-036.2	DS MH:	M-507-036.3
		Total Length Surveyed (ft):	398.3

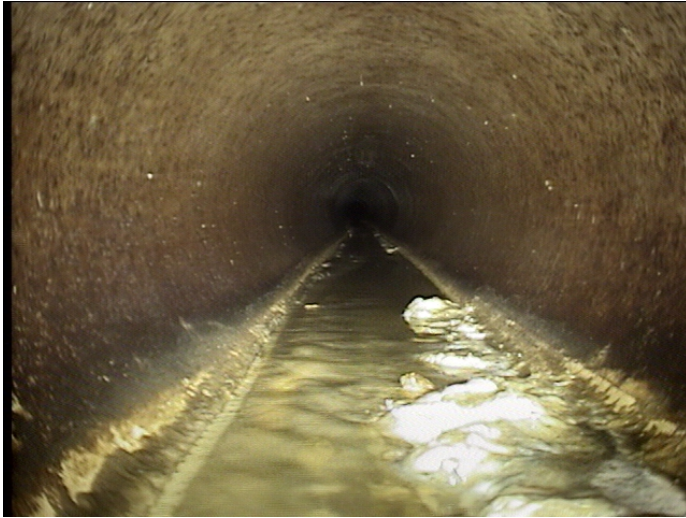
Code:	MWL
Description:	Water Level
Distance (ft):	.0
Structural Grade:	0
O&M Grade:	0
Clock Start/From:	
Clock To:	
1st Value:	
2nd Value:	
Value Percent:	5.000
Continuous Index:	
Within 8" of Joint:	NO
Remarks:

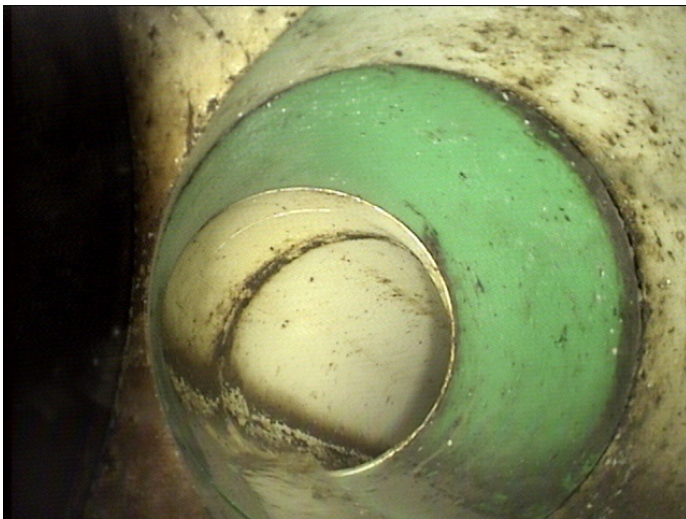
Code:	TF
Description:	Tap Factory
Distance (ft):	37.4
Structural Grade:	0
O&M Grade:	0
Clock Start/From:	10
Clock To:	
1st Value:	6.000
2nd Value:	
Value Percent:	
Continuous Index:	
Within 8" of Joint:	NO
Remarks:

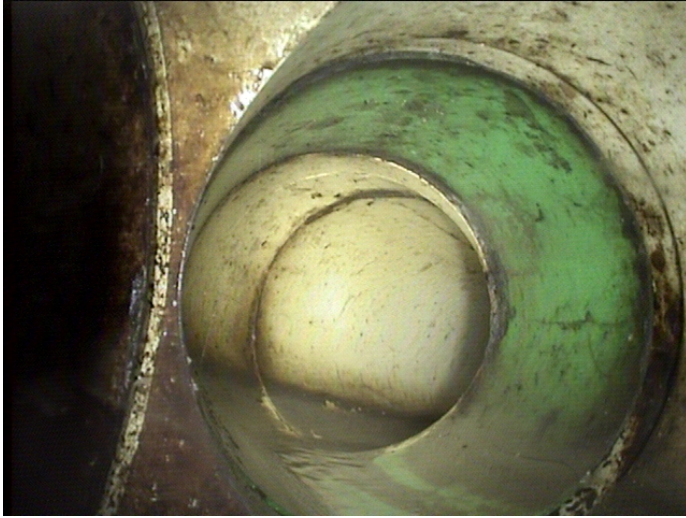
Code:	TF
Description:	Tap Factory
Distance (ft):	176.8
Structural Grade:	0
O&M Grade:	0
Clock Start/From:	10
Clock To:	
1st Value:	6.000
2nd Value:	
Value Percent:	
Continuous Index:	
Within 8" of Joint:	NO
Remarks:

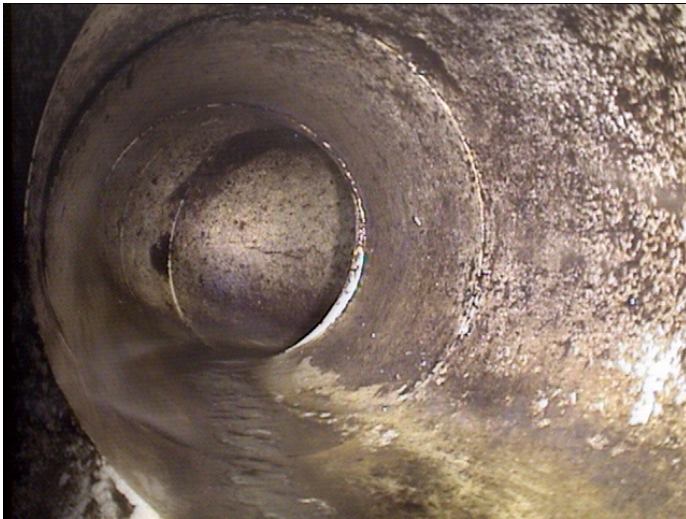
Code:	TF
Description:	Tap Factory
Distance (ft):	250.2
Structural Grade:	0
O&M Grade:	0
Clock Start/From:	9
Clock To:	
1st Value:	6.000
2nd Value:	
Value Percent:	
Continuous Index:	
Within 8" of Joint:	NO
Remarks:

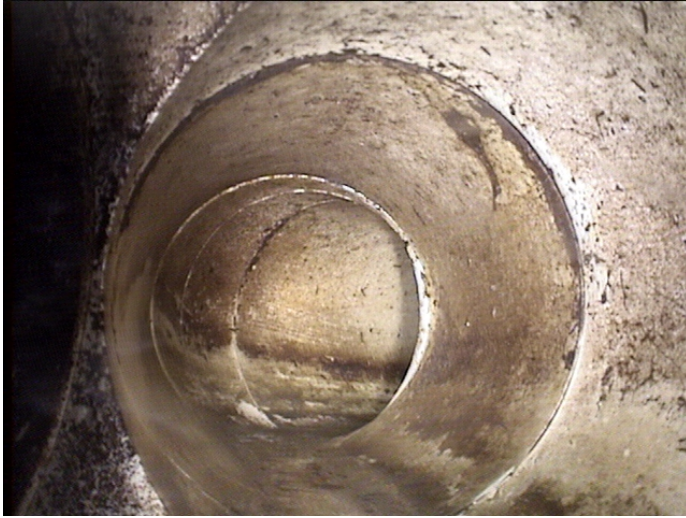
Code: **TF**
Description: **Tap Factory**

Distance (ft): **296.0**
Structural Grade: **0**
O&M Grade: **0**
Clock Start/From: **9**
Clock To:
1st Value: **6.000**
2nd Value:
Value Percent:
Continuous Index:
Within 8" of Joint: **NO**
Remarks:

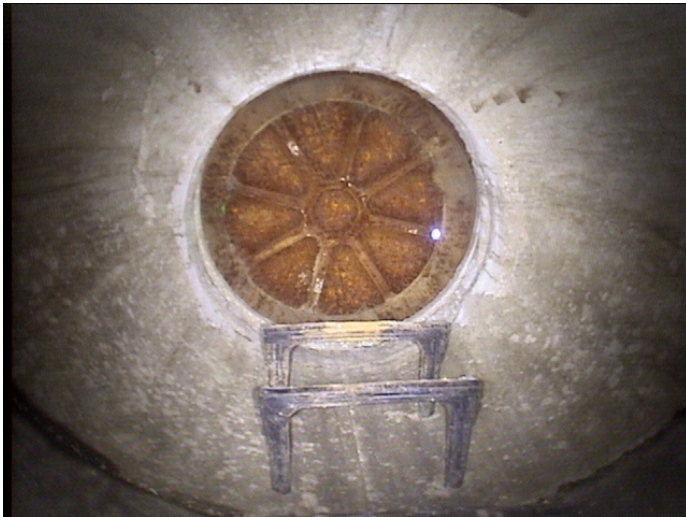
Code: **AMH**
Description: **Manhole**

Distance (ft): **398.3**
Structural Grade: **0**
O&M Grade: **0**
Clock Start/From:
Clock To:
1st Value:
2nd Value:
Value Percent:
Continuous Index:
Within 8" of Joint: **NO**
Remarks: **M-507-036.3**
