## Profile/Photo Observation Report

Date:	<b>05/02/2018</b>	Weather:		Coding:	<b>PACP 6.0</b>
Pipe Length (ft):		Owner:	<b>City of Hobart</b>	Pre Clean:	<b>Not Known</b>
P.O.#:	<b>285</b>	Surveyor:	<b>B. Helbling</b>	PSR:	<b>P-507-036.3-039.1</b>
Customer:	<b>City of Hobart</b>	Clean Date:		Shape:	<b>C</b>

Street:	<b>West 10th Street</b>	Flow Control:	<b>Not Controlled</b>
City:	<b>Hobart, IN</b>	Year Renewed:	
Location:	<b>Light Highway</b>	Tape/Media #:	<b>DEP285</b>
Purpose:	<b>Routine Assessment</b>	Dia/Height:	<b>12"</b>
Use:	<b>Sanitary</b>	Material:	<b>PVC</b>
Drain Area:		Lining:	
Category:	<b>NA</b>		
Comment:	<b>5-21-2018</b>		
Location Details:		Direction of Survey:	<b>Upstream</b>
US MH:	<b>M-507-036.3</b>	DS MH:	<b>M-507-039.1</b>
		Total Length Surveyed (ft):	<b>345.5</b>

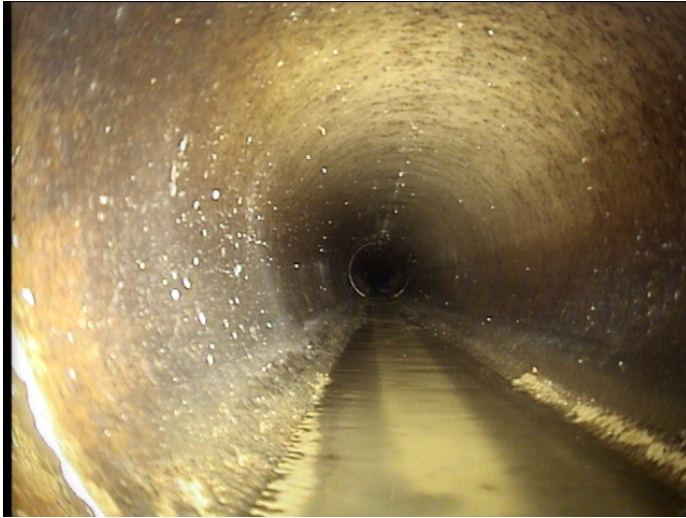
Code: **MWL**  
Description: **Water Level**

Distance (ft): **.0**  
Structural Grade: **0**  
O&M Grade: **0**  
Clock Start/From:  
Clock To:  
1st Value:  
2nd Value:  
Value Percent: **5.000**  
Continuous Index:  
Within 8" of Joint: **NO**  
Remarks:

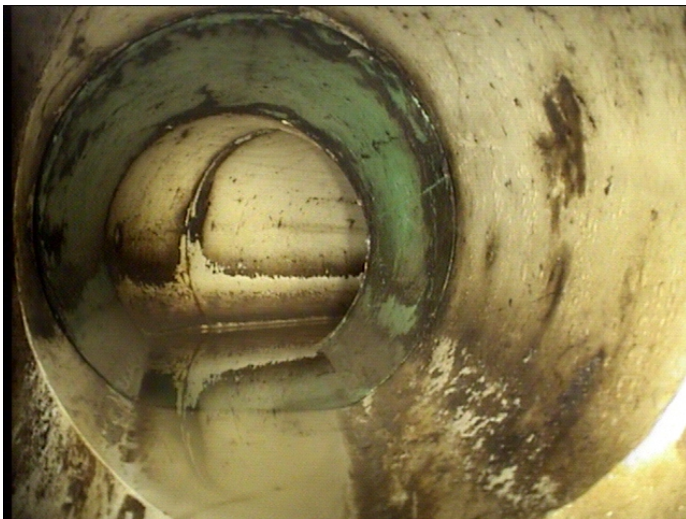
Code: **TF**  
Description: **Tap Factory**

Distance (ft): **135.7**  
Structural Grade: **0**  
O&M Grade: **0**  
Clock Start/From: **3**  
Clock To:  
1st Value: **6.000**  
2nd Value:  
Value Percent:  
Continuous Index:  
Within 8" of Joint: **NO**  
Remarks:

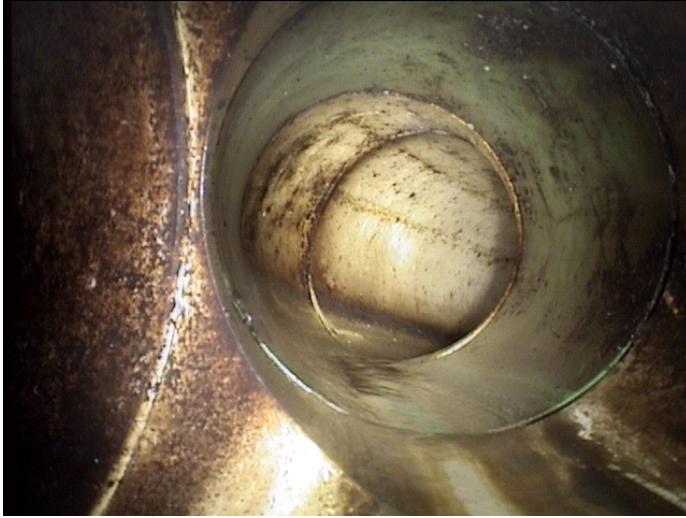
Code: **TF**  
Description: **Tap Factory**

Distance (ft): **239.3**  
Structural Grade: **0**  
O&M Grade: **0**  
Clock Start/From: **2**  
Clock To:  
1st Value: **6.000**  
2nd Value:  
Value Percent:  
Continuous Index:  
Within 8" of Joint: **NO**  
Remarks:

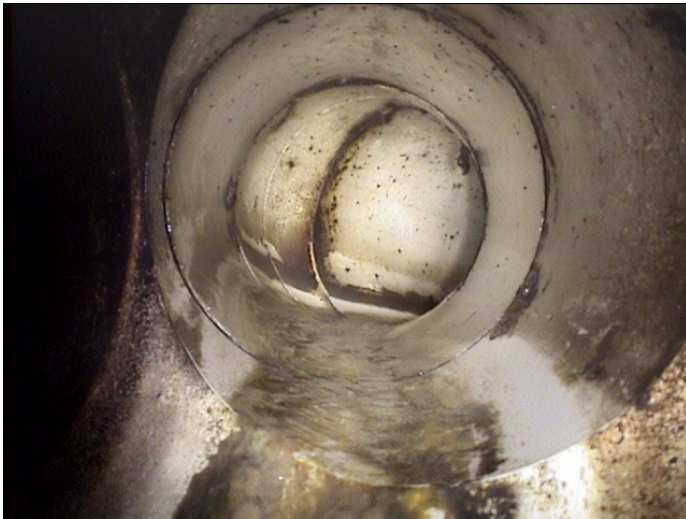
Code: **TF**  
Description: **Tap Factory**

Distance (ft): **290.8**  
Structural Grade: **0**  
O&M Grade: **0**  
Clock Start/From: **2**  
Clock To:  
1st Value: **6.000**  
2nd Value:  
Value Percent:  
Continuous Index:  
Within 8" of Joint: **NO**  
Remarks:

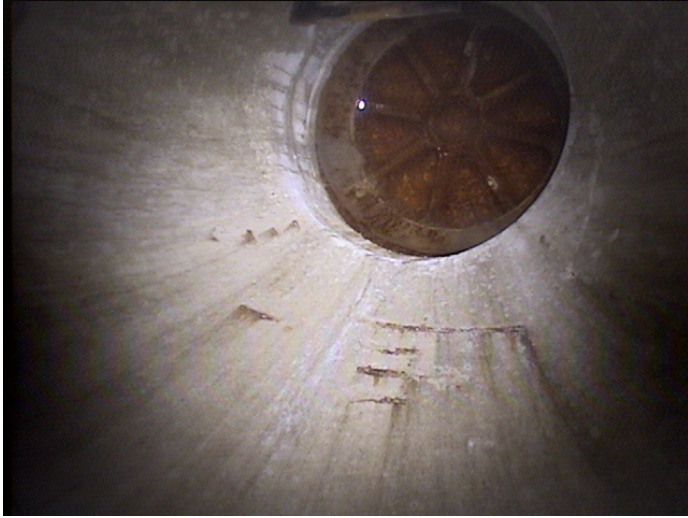
Code:	<b>AMH</b>
Description:	<b>Manhole</b>
Distance (ft):	<b>345.5</b>
Structural Grade:	<b>0</b>
O&M Grade:	<b>0</b>
Clock Start/From:	
Clock To:	
1st Value:	
2nd Value:	
Value Percent:	
Continuous Index:	
Within 8" of Joint:	<b>NO</b>
Remarks:	<b>M-507-036.3</b>
