## Profile/Photo Observation Report

Street:	<b>ALLEY BETWEEN W 10TH ST &amp; W 10</b>	Flow Control:	<b>Not Controlled</b>
City:	<b>Hobart, IN</b>	Year Renewed:	
Location:	<b>Yard</b>	Tape/Media #:	
Purpose:	<b>Routine Assessment</b>	Dia/Height:	<b>10"</b>
Use:	<b>Sanitary</b>	Material:	<b>VCP</b>
Drain Area:	<b>NA</b>	Lining:	
Category:	<b>NA</b>		
Comment:

Location Details:		Direction of Survey:	<b>Upstream</b>
US MH:	<b>M-507-039.4</b>	DS MH:	<b>M-507-039.6</b>
		Total Length Surveyed (ft):	<b>178.0</b>

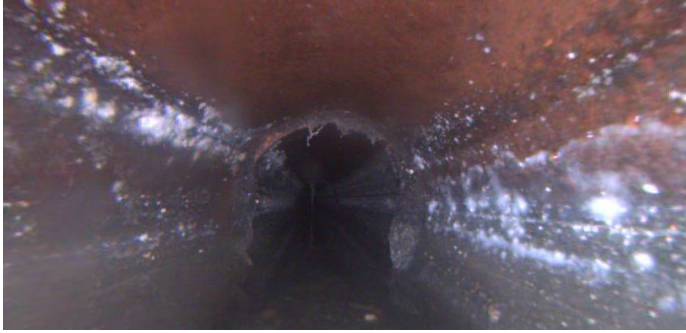
Code: **AMH**  
Description: **Manhole**

Distance (ft): **.0**  
Structural Grade: **0**  
O&M Grade: **0**  
Clock Start/From:  
Clock To:  
1st Value:  
2nd Value:  
Value Percent:  
Continuous Index:  
Within 8" of Joint: **NO**  
Remarks: **M-507-039.6**

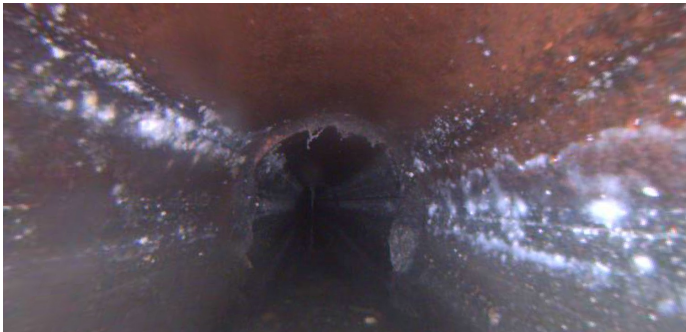
Code: **MWL**  
Description: **Water Level**

Distance (ft): **.0**  
Structural Grade: **0**  
O&M Grade: **0**  
Clock Start/From:  
Clock To:  
1st Value:  
2nd Value:  
Value Percent: **10.000**  
Continuous Index:  
Within 8" of Joint: **NO**  
Remarks:

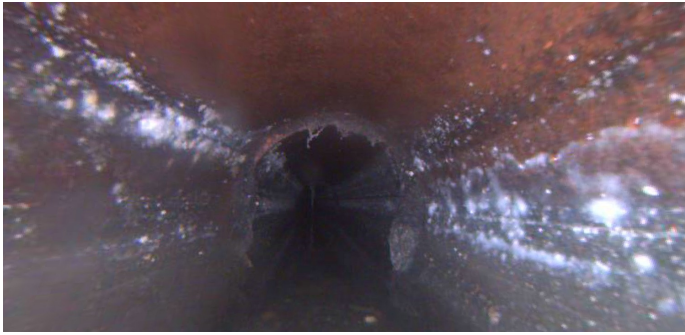
Code: **DAGS**  
Description: **Deposits Attached Grease**

Distance (ft): **.0**  
Structural Grade: **0**  
O&M Grade: **2**  
Clock Start/From: **8**  
Clock To: **4**  
1st Value:  
2nd Value:  
Value Percent: **5.000**  
Continuous Index: **S01**  
Within 8" of Joint: **NO**  
Remarks:

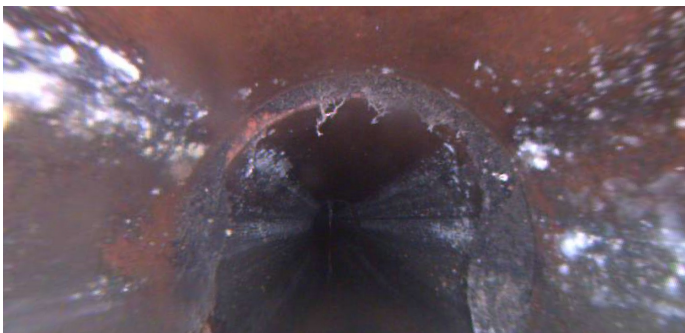
Code: **RMJ**  
Description: **Roots Medium Joint**

Distance (ft): **1.4**  
Structural Grade: **0**  
O&M Grade: **3**  
Clock Start/From: **8**  
Clock To: **4**  
1st Value:  
2nd Value:  
Value Percent: **10.000**  
Continuous Index:  
Within 8" of Joint: **YES**  
Remarks:

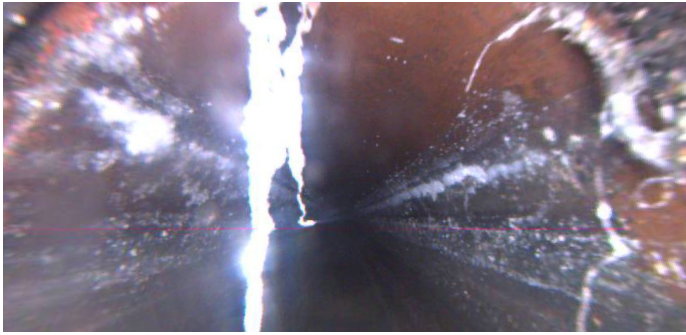
Code: **RFJ**  
Description: **Roots Fine Joint**

Distance (ft): **5.9**  
Structural Grade: **0**  
O&M Grade: **1**  
Clock Start/From: **8**  
Clock To: **4**  
1st Value:  
2nd Value:  
Value Percent:  
Continuous Index:  
Within 8" of Joint: **YES**  
Remarks:

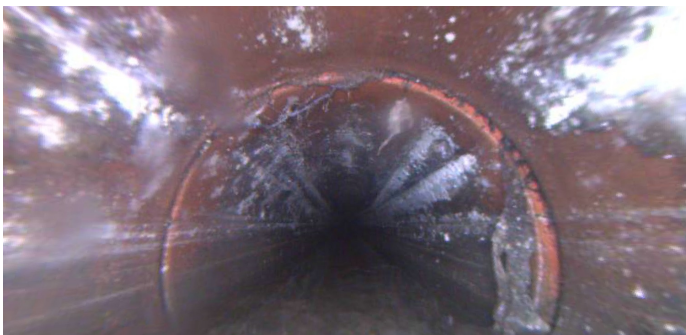
Code: **RFJ**  
Description: **Roots Fine Joint**

Distance (ft): **17.3**  
Structural Grade: **0**  
O&M Grade: **1**  
Clock Start/From: **8**  
Clock To: **4**  
1st Value:  
2nd Value:  
Value Percent:  
Continuous Index:  
Within 8" of Joint: **YES**  
Remarks:

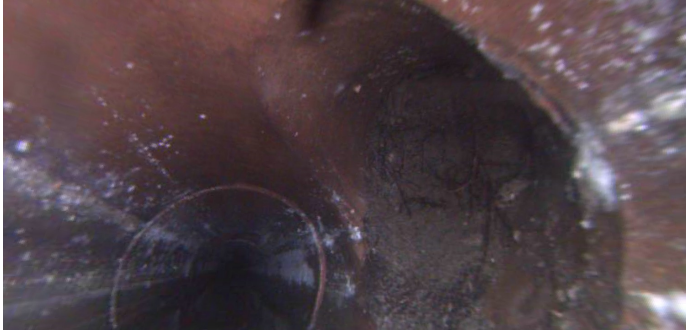
Code: **TFC**  
Description: **Tap Factory Capped**

Distance (ft): **35.6**  
Structural Grade: **0**  
O&M Grade: **0**  
Clock Start/From: **2**  
Clock To:  
1st Value: **4.000**  
2nd Value:  
Value Percent:  
Continuous Index:  
Within 8" of Joint:  
Remarks:

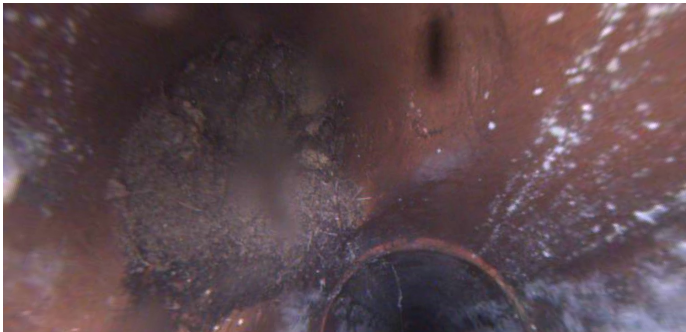
Code: **TFD**  
Description: **Tap Factory Defective**

Distance (ft): **38.7**  
Structural Grade: **0**  
O&M Grade: **2**  
Clock Start/From: **10**  
Clock To:  
1st Value: **4.000**  
2nd Value:  
Value Percent:  
Continuous Index:  
Within 8" of Joint:  
Remarks: **rfl**

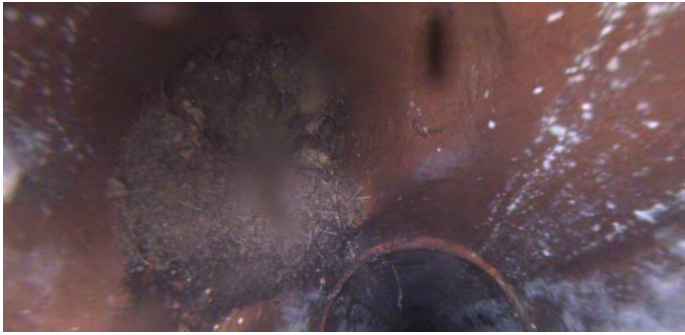
Code: **RFL**  
Description: **Roots Fine Lateral**

Distance (ft): **38.7**  
Structural Grade: **0**  
O&M Grade: **1**  
Clock Start/From: **10**  
Clock To:  
1st Value:  
2nd Value:  
Value Percent:  
Continuous Index:  
Within 8" of Joint: **NO**  
Remarks:

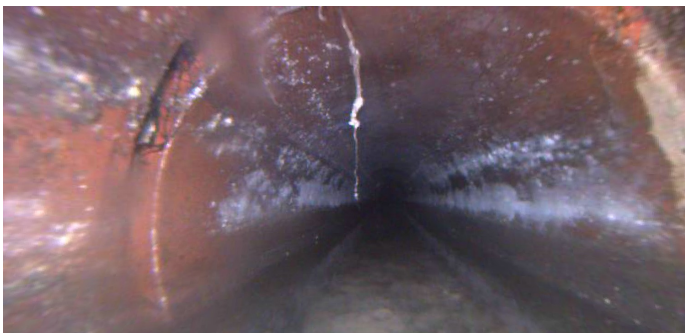
Code: **RFJ**  
Description: **Roots Fine Joint**

Distance (ft): **39.7**  
Structural Grade: **0**  
O&M Grade: **1**  
Clock Start/From: **12**  
Clock To:  
1st Value:  
2nd Value:  
Value Percent:  
Continuous Index:  
Within 8" of Joint: **YES**  
Remarks:

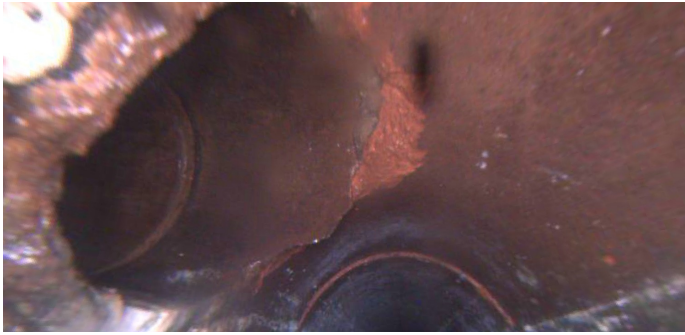
Code: **TBI**  
Description: **Tap Break-in Intruding**

Distance (ft): **46.8**  
Structural Grade: **0**  
O&M Grade: **2**  
Clock Start/From: **10**  
Clock To:  
1st Value: **4.000**  
2nd Value: **1.000**  
Value Percent:  
Continuous Index:  
Within 8" of Joint:  
Remarks:

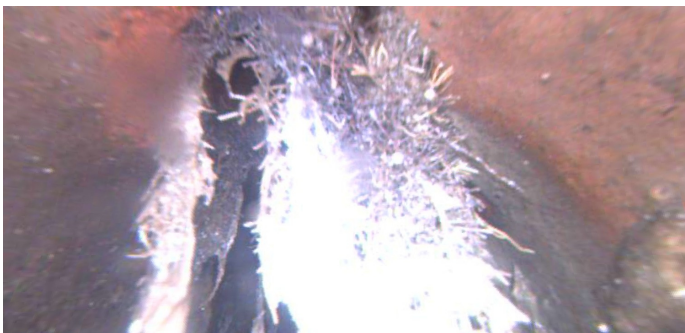
Code: **TFD**  
Description: **Tap Factory Defective**

Distance (ft): **79.0**  
Structural Grade: **0**  
O&M Grade: **2**  
Clock Start/From: **2**  
Clock To:  
1st Value: **4.000**  
2nd Value:  
Value Percent:  
Continuous Index:  
Within 8" of Joint:  
Remarks: **ROOTS**

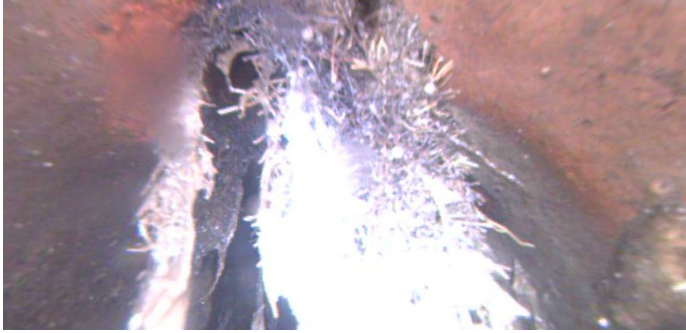
Code: **RMC**  
Description: **Roots Medium Connection**

Distance (ft): **79.0**  
Structural Grade: **0**  
O&M Grade: **3**  
Clock Start/From: **11**  
Clock To: **1**  
1st Value:  
2nd Value:  
Value Percent: **20.000**  
Continuous Index:  
Within 8" of Joint: **NO**  
Remarks:

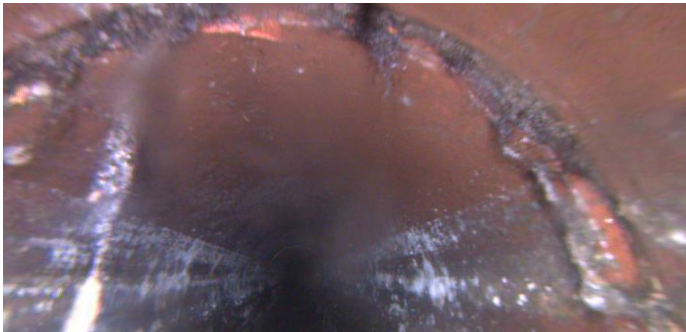
Code: **RFJ**  
Description: **Roots Fine Joint**

Distance (ft): **87.7**  
Structural Grade: **0**  
O&M Grade: **1**  
Clock Start/From: **11**  
Clock To:  
1st Value:  
2nd Value:  
Value Percent:  
Continuous Index:  
Within 8" of Joint: **YES**  
Remarks:

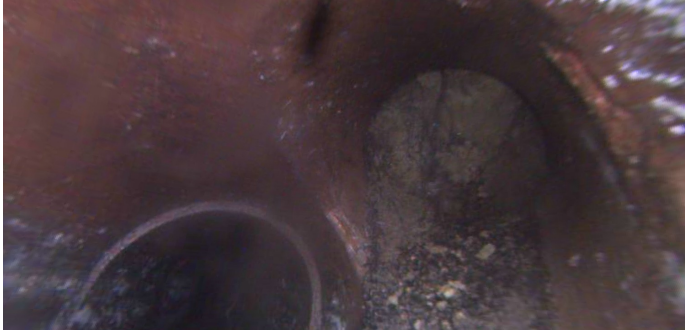
Code: **TFC**  
Description: **Tap Factory Capped**

Distance (ft): **101.7**  
Structural Grade: **0**  
O&M Grade: **0**  
Clock Start/From: **2**  
Clock To:  
1st Value: **4.000**  
2nd Value:  
Value Percent:  
Continuous Index:  
Within 8" of Joint:  
Remarks:

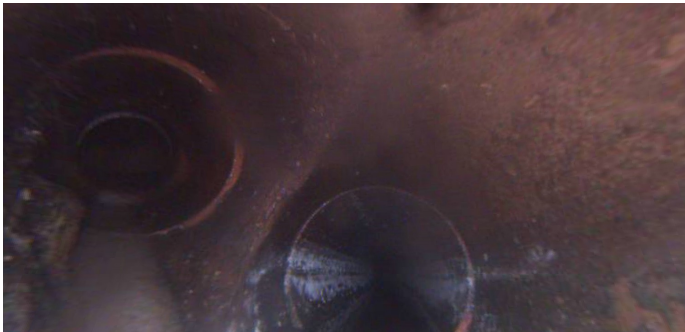
Code: **TF**  
Description: **Tap Factory**

Distance (ft): **104.6**  
Structural Grade: **0**  
O&M Grade: **0**  
Clock Start/From: **10**  
Clock To:  
1st Value: **4.000**  
2nd Value:  
Value Percent:  
Continuous Index:  
Within 8" of Joint:  
Remarks:

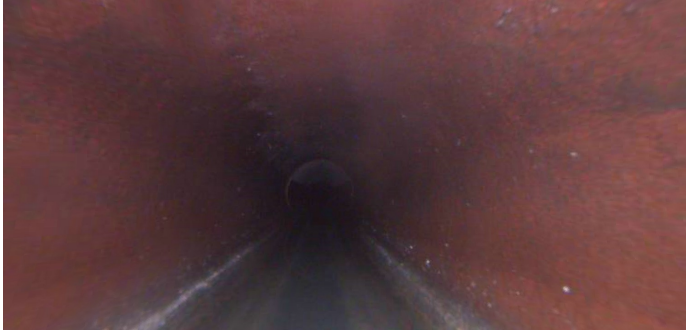
Code: **DAGS**  
Description: **Deposits Attached Grease**

Distance (ft): **134.5**  
Structural Grade: **0**  
O&M Grade: **2**  
Clock Start/From: **8**  
Clock To: **4**  
1st Value:  
2nd Value:  
Value Percent: **5.000**  
Continuous Index: **F01**  
Within 8" of Joint: **NO**  
Remarks:

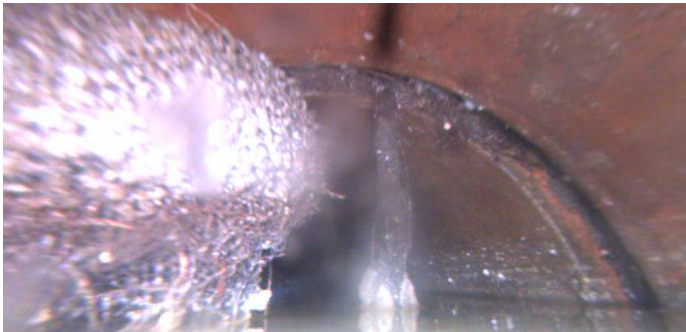
Code: **RMJ**  
Description: **Roots Medium Joint**

Distance (ft): **161.1**  
Structural Grade: **0**  
O&M Grade: **3**  
Clock Start/From: **8**  
Clock To: **12**  
1st Value:  
2nd Value:  
Value Percent: **40.000**  
Continuous Index:  
Within 8" of Joint: **YES**  
Remarks:

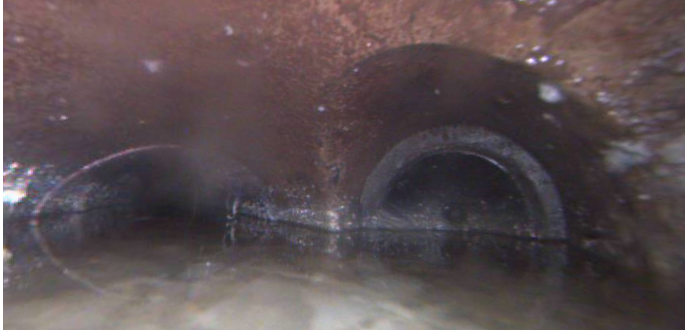
Code: **TFA**  
Description: **Tap Factory Active**

Distance (ft): **163.4**  
Structural Grade: **0**  
O&M Grade: **0**  
Clock Start/From: **3**  
Clock To:  
1st Value: **4.000**  
2nd Value:  
Value Percent:  
Continuous Index:  
Within 8" of Joint:  
Remarks:

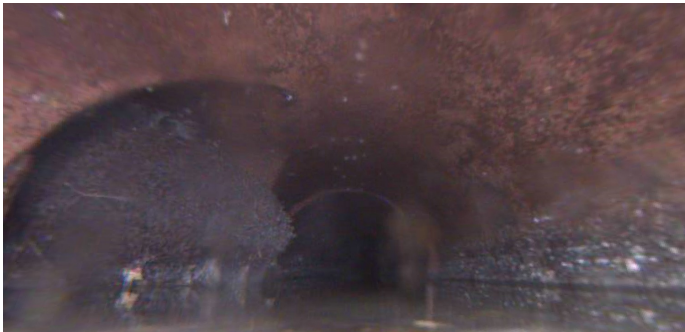
Code: **TFD**  
Description: **Tap Factory Defective**

Distance (ft): **166.2**  
Structural Grade: **0**  
O&M Grade: **2**  
Clock Start/From: **10**  
Clock To:  
1st Value: **4.000**  
2nd Value:  
Value Percent:  
Continuous Index:  
Within 8" of Joint:  
Remarks: **ROOTS**

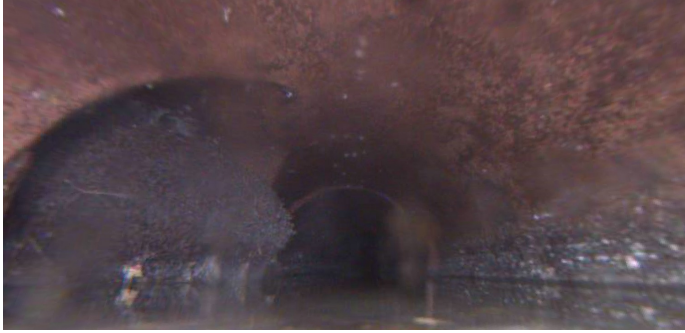
Code: **RML**  
Description: **Roots Medium Lateral**

Distance (ft): **166.2**  
Structural Grade: **0**  
O&M Grade: **3**  
Clock Start/From: **10**  
Clock To:  
1st Value:  
2nd Value:  
Value Percent: **10.000**  
Continuous Index:  
Within 8" of Joint: **NO**  
Remarks:

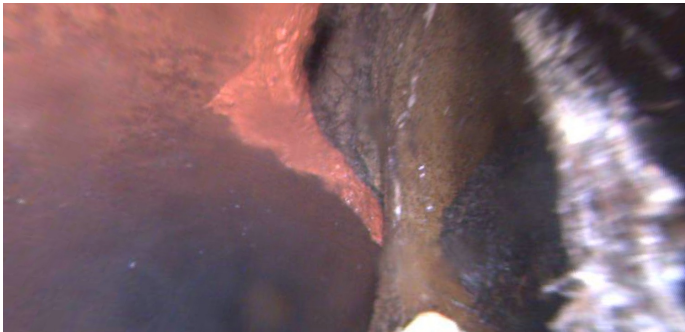
Code: **TBD**  
Description: **Tap Break-in Defective**

Distance (ft): **169.5**  
Structural Grade: **0**  
O&M Grade: **3**  
Clock Start/From: **2**  
Clock To:  
1st Value: **4.000**  
2nd Value:  
Value Percent:  
Continuous Index:  
Within 8" of Joint:  
Remarks: **ROOTS**

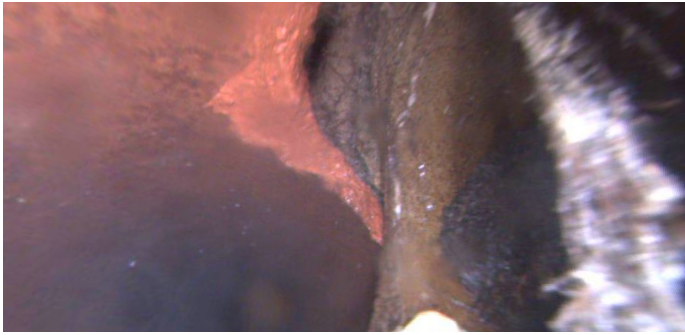
Code: **RML**  
Description: **Roots Medium Lateral**

Distance (ft): **169.5**  
Structural Grade: **0**  
O&M Grade: **3**  
Clock Start/From: **1**  
Clock To:  
1st Value:  
2nd Value:  
Value Percent: **10.000**  
Continuous Index:  
Within 8" of Joint: **NO**  
Remarks:

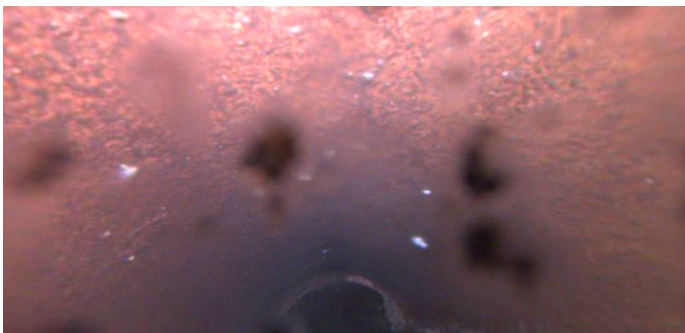
Code: **MSA**  
Description: **Abandoned Survey**

Distance (ft): **178.0**  
Structural Grade: **0**  
O&M Grade: **0**  
Clock Start/From:  
Clock To:  
1st Value:  
2nd Value:  
Value Percent:  
Continuous Index:  
Within 8" of Joint: **NO**  
Remarks: **DEBRIS UNDER WATER**
