## Profile/Photo Observation Report

Date:	<b>04/12/2018</b>	Weather:		Coding:	<b>PACP 6.0</b>
Pipe Length (ft):	<b>24.4</b>	Owner:	<b>NA</b>	Pre Clean:	<b>No Pre-Cleaning</b>
P.O.#:		Surveyor:	<b>Jen Costello</b>	PSR:	<b>P-507-039.5-083</b>
Customer:		Clean Date:	<b>01/01/1900</b>	Shape:	<b>C</b>

Street:	<b>W 10TH PL</b>	Flow Control:	<b>Not Controlled</b>
City:	<b>Hobart, IN</b>	Year Renewed:	
Location:	<b>Yard</b>	Tape/Media #:	
Purpose:	<b>Routine Assessment</b>	Dia/Height:	<b>12"</b>
Use:	<b>Sanitary</b>	Material:	<b>VCP</b>
Drain Area:	<b>NA</b>	Lining:	
Category:	<b>NA</b>		
Comment:

Location Details:		Direction of Survey:	<b>Upstream</b>
US MH:	<b>M-507-039.5</b>	DS MH:	<b>M-507-083</b>
		Total Length Surveyed (ft):	<b>19.5</b>

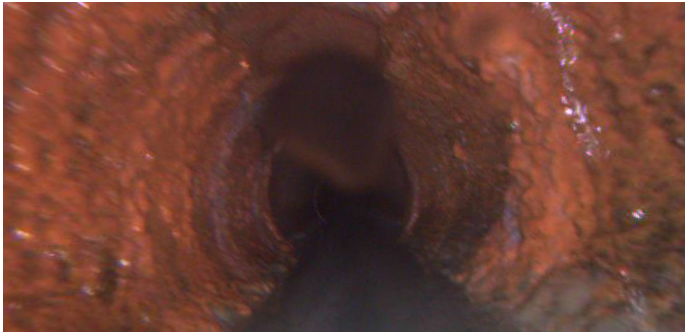
Code:	<b>MWL</b>
Description:	<b>Water Level</b>

Distance (ft):	<b>.0</b>
Structural Grade:	<b>0</b>
O&M Grade:	<b>0</b>
Clock Start/From:	
Clock To:	
1st Value:	
2nd Value:	
Value Percent:	<b>5.000</b>
Continuous Index:	
Within 8" of Joint:	<b>NO</b>
Remarks:

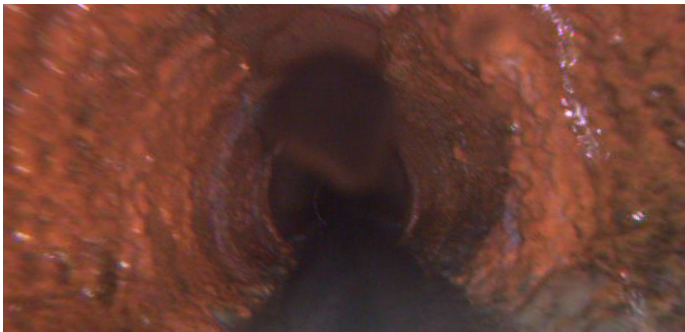
Code:	<b>DAE</b>
Description:	<b>Deposits Attached Encrustation</b>

Distance (ft):	<b>.0</b>
Structural Grade:	<b>0</b>
O&M Grade:	<b>2</b>
Clock Start/From:	<b>7</b>
Clock To:	<b>5</b>
1st Value:	
2nd Value:	
Value Percent:	<b>10.000</b>
Continuous Index:	
Within 8" of Joint:	<b>NO</b>
Remarks:

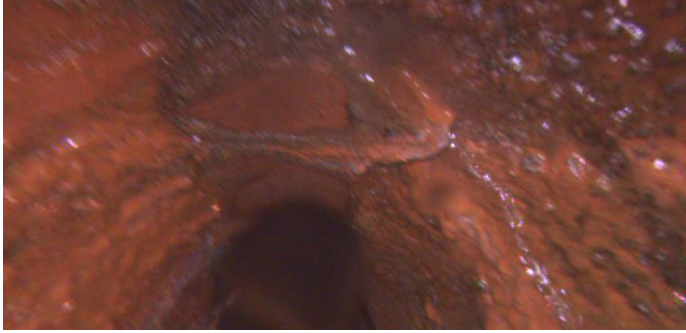
Code: **FM**  
Description: **Fracture Multiple**

Distance (ft): **.0**  
Structural Grade: **4**  
O&M Grade: **0**  
Clock Start/From: **10**  
Clock To: **2**  
1st Value:  
2nd Value:  
Value Percent:  
Continuous Index:  
Within 8" of Joint:  
Remarks:

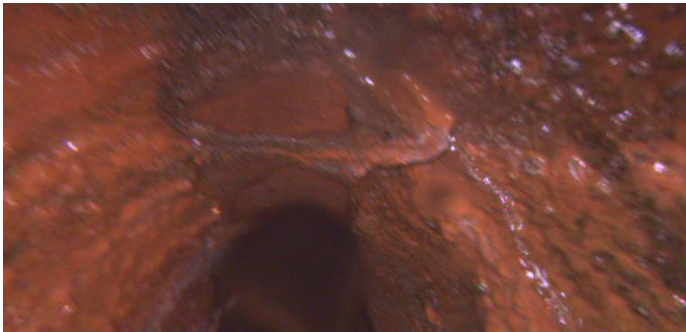
Code: **IR**  
Description: **Infil Runner**

Distance (ft): **.0**  
Structural Grade: **0**  
O&M Grade: **4**  
Clock Start/From: **1**  
Clock To:  
1st Value:  
2nd Value:  
Value Percent:  
Continuous Index:  
Within 8" of Joint:  
Remarks:

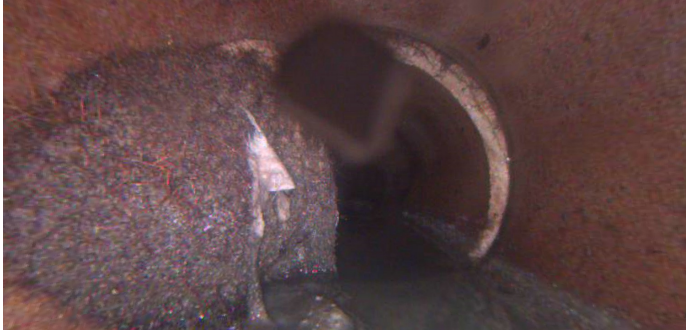
Code: **RMJ**  
Description: **Roots Medium Joint**

Distance (ft): **16.1**  
Structural Grade: **0**  
O&M Grade: **3**  
Clock Start/From: **6**  
Clock To: **12**  
1st Value:  
2nd Value:  
Value Percent: **40.000**  
Continuous Index:  
Within 8" of Joint: **YES**  
Remarks:

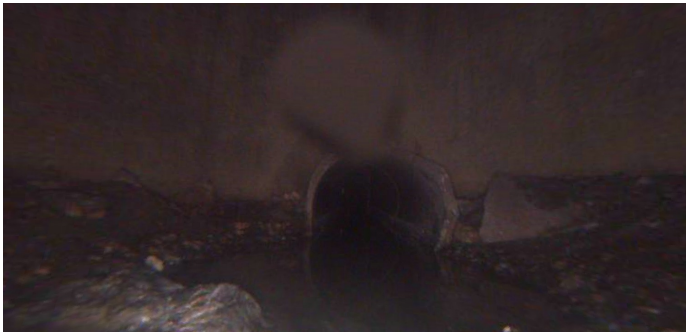
Code: **AMH**  
Description: **Manhole**

Distance (ft): **19.5**  
Structural Grade: **0**  
O&M Grade: **0**  
Clock Start/From:  
Clock To:  
1st Value:  
2nd Value:  
Value Percent:  
Continuous Index:  
Within 8" of Joint: **NO**  
Remarks: **M-507-039.5**
