Profile/Photo Observation Report

Date:	04/12/2018	Weather:		Coding:	PACP 6.0
Pipe Length (ft):	130.8	Owner:	NA	Pre Clean:	No Pre-Cleaning
P.O.#:		Surveyor:	Jen Costello	PSR:	P-507-039.6-039.5
Customer:		Clean Date:	01/01/1900	Shape:	C

Street:	W 10TH PL	Flow Control:	Not Controlled
City:	Hobart, IN	Year Renewed:	
Location:	Yard	Tape/Media #:	
Purpose:	Routine Assessment	Dia/Height:	12"
Use:	Sanitary	Material:	VCP
Drain Area:	NA	Lining:	
Category:	NA		
Comment:

Location Details:		Direction of Survey:	Upstream
US MH:	M-507-039.6	DS MH:	M-507-039.5
		Total Length Surveyed (ft):	9.2

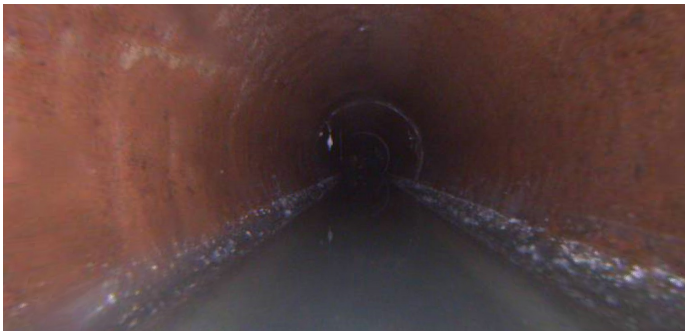
Code: **AMH**
Description: **Manhole**

Manhole

Distance (ft): .0

Within 8" of Joint: **NO**

Remarks: M-507-039.5

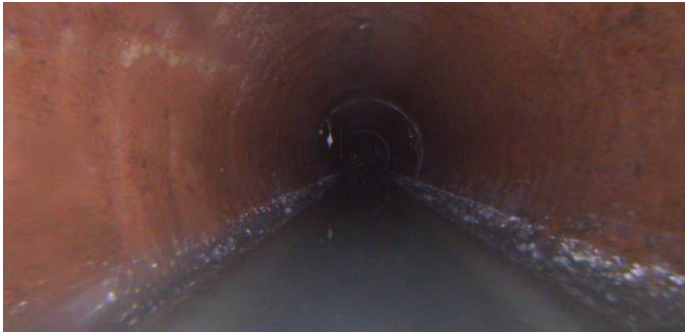
Code:	MWL
Description:	Water Level

Distance (ft):	.0
Structural Grade:	0
O&M Grade:	0
Clock Start/From:	
Clock To:	
1st Value:	
2nd Value:	
Value Percent:	5.000
Continuous Index:	
Within 8" of Joint:	NO
Remarks:

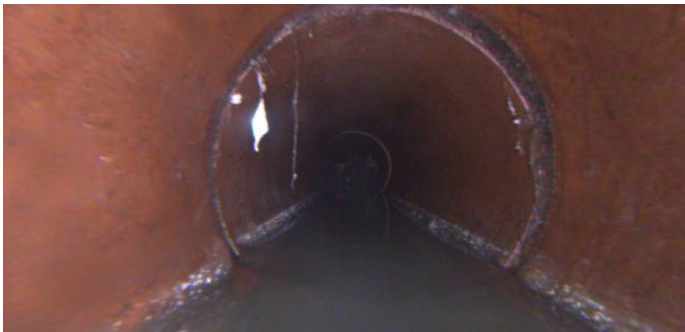
Code:	RFJ
Description:	Roots Fine Joint

Distance (ft):	2.9
Structural Grade:	0
O&M Grade:	1
Clock Start/From:	8
Clock To:	4
1st Value:	
2nd Value:	
Value Percent:	
Continuous Index:	
Within 8" of Joint:	YES
Remarks:

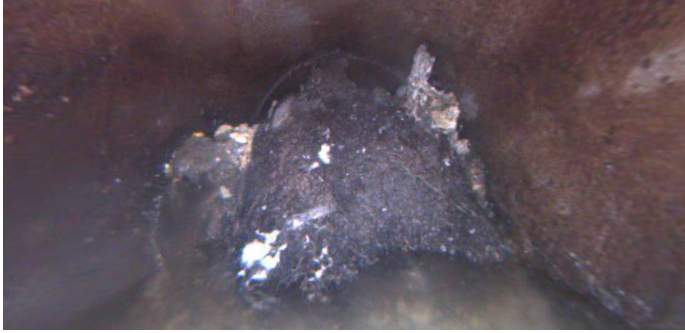
Code: **RBJ**
Description: **Roots Ball Joint**

Distance (ft): **8.2**
Structural Grade: **0**
O&M Grade: **4**
Clock Start/From: **12**
Clock To: **12**
1st Value:
2nd Value:
Value Percent: **90.000**
Continuous Index:
Within 8" of Joint: **YES**
Remarks:
