Profile/Photo Observation Report

Date:	04/12/2018	Weather:		Coding:	PACP 6.0
Pipe Length (ft):	130.8	Owner:	NA	Pre Clean:	No Pre-Cleaning
P.O.#:		Surveyor:	Jen Costello	PSR:	P-507-039.6-039.5
Customer:		Clean Date:	01/01/1900	Shape:	C

Street:	FOXCROFT STREET	Flow Control:	Not Controlled
City:	Hobart, IN	Year Renewed:	
Location:	Yard	Tape/Media #:	
Purpose:	Routine Assessment	Dia/Height:	12"
Use:	Sanitary	Material:	VCP
Drain Area:	NA	Lining:	
Category:	NA		
Comment:

Location Details:		Direction of Survey:	Upstream
US MH:	M-507-039.6	DS MH:	M-507-039.5
		Total Length Surveyed (ft):	9.2

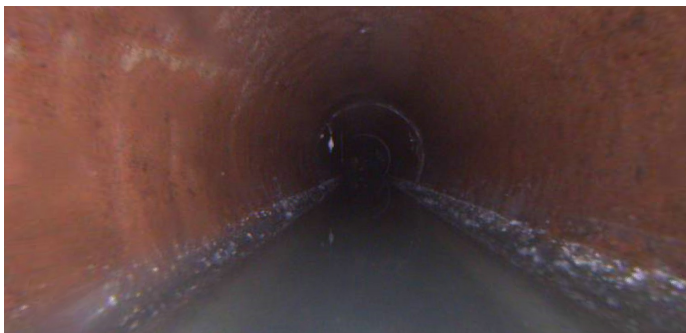
Code: **AMH**
Description: **Manhole**

Distance (ft): **.0**
Structural Grade: **0**
O&M Grade: **0**
Clock Start/From:
Clock To:
1st Value:
2nd Value:
Value Percent:
Continuous Index:
Within 8" of Joint: **NO**
Remarks: **M-507-039.5**

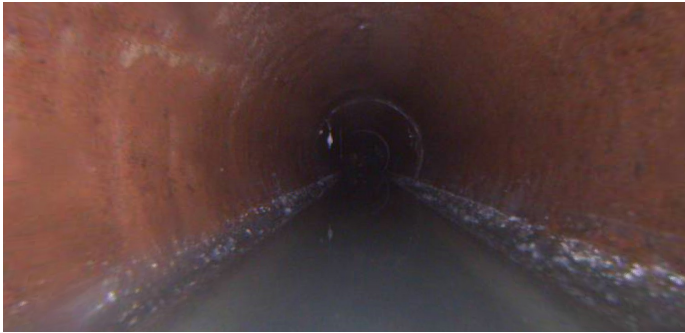
Code:	MWL
Description:	Water Level

Distance (ft):	.0
Structural Grade:	0
O&M Grade:	0
Clock Start/From:	
Clock To:	
1st Value:	
2nd Value:	
Value Percent:	5.000
Continuous Index:	
Within 8" of Joint:	NO
Remarks:

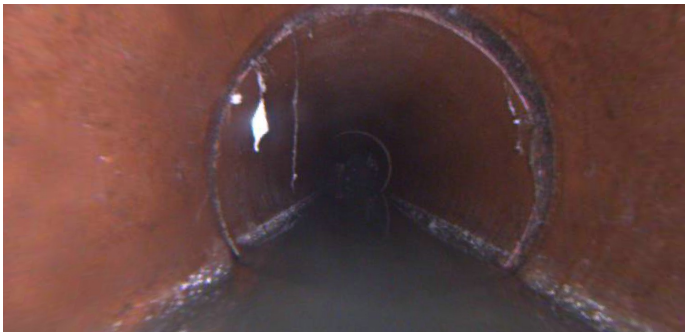
Code:	RFJ
Description:	Roots Fine Joint

Distance (ft):	2.9
Structural Grade:	0
O&M Grade:	1
Clock Start/From:	8
Clock To:	4
1st Value:	
2nd Value:	
Value Percent:	
Continuous Index:	
Within 8" of Joint:	YES
Remarks:

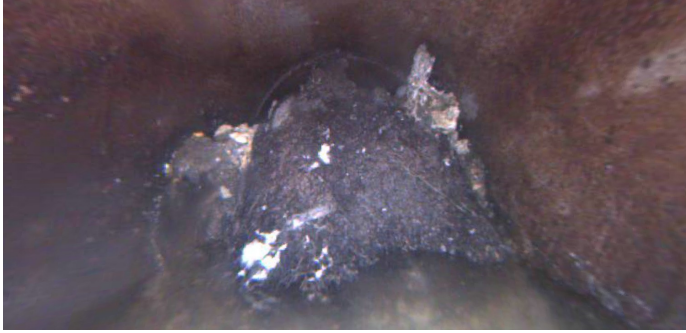
Code: **RBJ**
Description: **Roots Ball Joint**

Distance (ft): **8.2**
Structural Grade: **0**
O&M Grade: **4**
Clock Start/From: **12**
Clock To: **12**
1st Value:
2nd Value:
Value Percent: **90.000**
Continuous Index:
Within 8" of Joint: **YES**
Remarks:
