Profile/Photo Observation Report

Date:	04/12/2018	Weather:		Coding:	PACP 6.0
Pipe Length (ft):	268.5	Owner:	NA	Pre Clean:	No Pre-Cleaning
P.O.#:		Surveyor:	Jen Costello	PSR:	P-507-039.7-039.6
Customer:		Clean Date:	01/01/1900	Shape:	C

Street:	ALLEY BETWEEN W 10TH ST & W 10	Flow Control:	Not Controlled
City:	Hobart, IN	Year Renewed:	
Location:	Yard	Tape/Media #:	
Purpose:	Routine Assessment	Dia/Height:	10"
Use:	Sanitary	Material:	VCP
Drain Area:	NA	Lining:	
Category:	NA		
Comment:	Flow direction is marked wrong.		
Location Details:		Direction of Survey:	Downstream
US MH:	M-507-039.6	DS MH:	M-507-039.7
		Total Length Surveyed (ft):	2.9

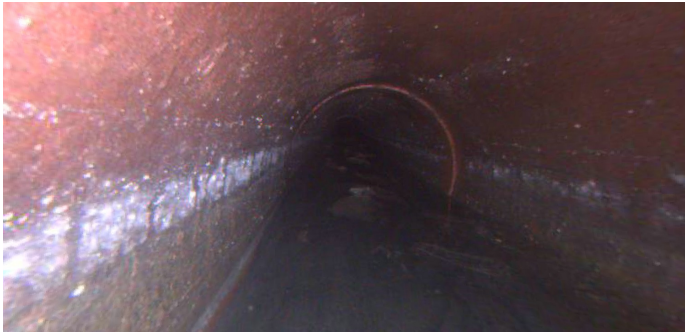
Code:	MWL
Description:	Water Level

Distance (ft):	.0
Structural Grade:	0
O&M Grade:	0
Clock Start/From:	
Clock To:	
1st Value:	
2nd Value:	
Value Percent:	20.000
Continuous Index:	
Within 8" of Joint:	NO
Remarks:

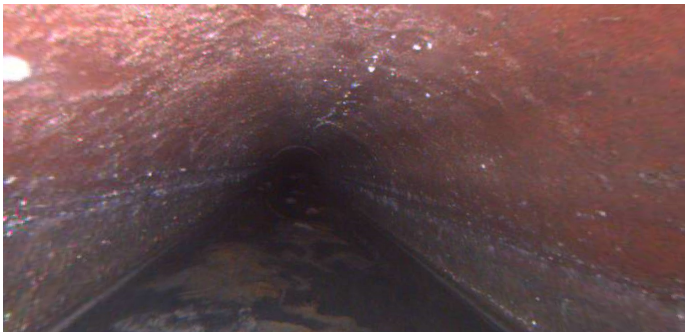
Code:	MSA
Description:	Abandoned Survey

Distance (ft):	2.9
Structural Grade:	0
O&M Grade:	0
Clock Start/From:	
Clock To:	
1st Value:	
2nd Value:	
Value Percent:	
Continuous Index:	
Within 8" of Joint:	NO
Remarks:	DEBRIS UNDER WATER
