Profile/Photo Observation Report

Date:	04/12/2018	Weather:		Coding:	PACP 6.0
Pipe Length (ft):	268.5	Owner:	NA	Pre Clean:	No Pre-Cleaning
P.O.#:		Surveyor:	Jen Costello	PSR:	P-507-039.7-039.6
Customer:		Clean Date:	01/01/1900	Shape:	C

Street:	FOXCROFT STREET	Flow Control:	Not Controlled
City:	Hobart, IN	Year Renewed:	
Location:	Yard	Tape/Media #:	
Purpose:	Routine Assessment	Dia/Height:	10"
Use:	Sanitary	Material:	VCP
Drain Area:	NA	Lining:	
Category:	NA		
Comment:	Flow direction is marked wrong.		
Location Details:		Direction of Survey:	Downstream
US MH:	M-507-039.6	DS MH:	M-507-039.7
		Total Length Surveyed (ft):	2.9

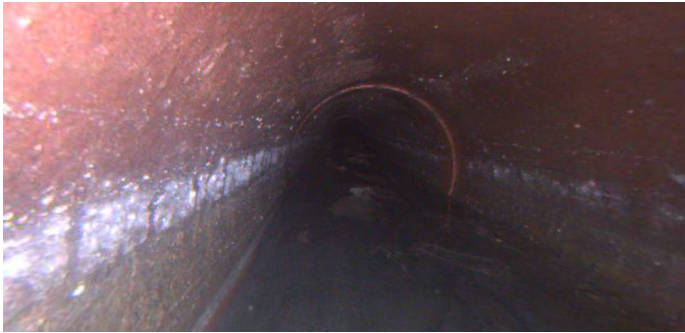
Code:	MWL
Description:	Water Level

Distance (ft):	.0
Structural Grade:	0
O&M Grade:	0
Clock Start/From:	
Clock To:	
1st Value:	
2nd Value:	
Value Percent:	20.000
Continuous Index:	
Within 8" of Joint:	NO
Remarks:

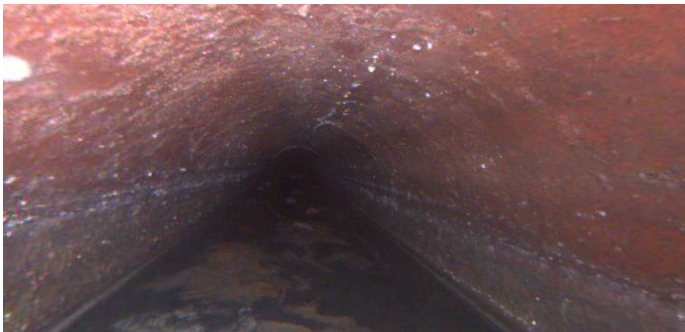
Code:	MSA
Description:	Abandoned Survey

Distance (ft):	2.9
Structural Grade:	0
O&M Grade:	0
Clock Start/From:	
Clock To:	
1st Value:	
2nd Value:	
Value Percent:	
Continuous Index:	
Within 8" of Joint:	NO
Remarks:	DEBRIS UNDER WATER
