Profile/Photo Observation Report

Street:	South Virginia Street	Flow Control:	Not Controlled
City:	Hobart, IN	Year Renewed:	
Location:	Light Highway	Tape/Media #:	DEP290
Purpose:	Routine Assessment	Dia/Height:	12"
Use:	Sanitary	Material:	PVC
Drain Area:		Lining:	
Category:	NA		
Comment:	5-21-2018

Location Details:		Direction of Survey:	Downstream
US MH:	M-507-040	DS MH:	M-507-039
		Total Length Surveyed (ft):	187.1

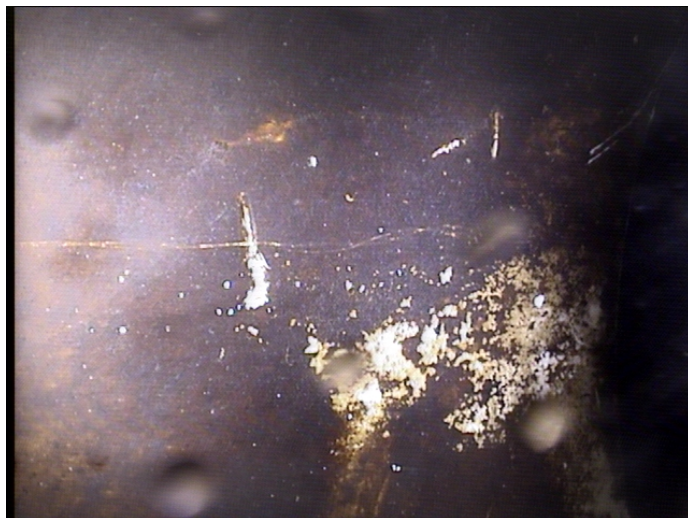
Code: **AMH**
 Description: **Manhole**

Distance (ft): **.0**
 Structural Grade: **0**
 O&M Grade: **0**
 Clock Start/From:
 Clock To:
 1st Value:
 2nd Value:
 Value Percent:
 Continuous Index:
 Within 8" of Joint: **NO**
 Remarks: **M-507-040**

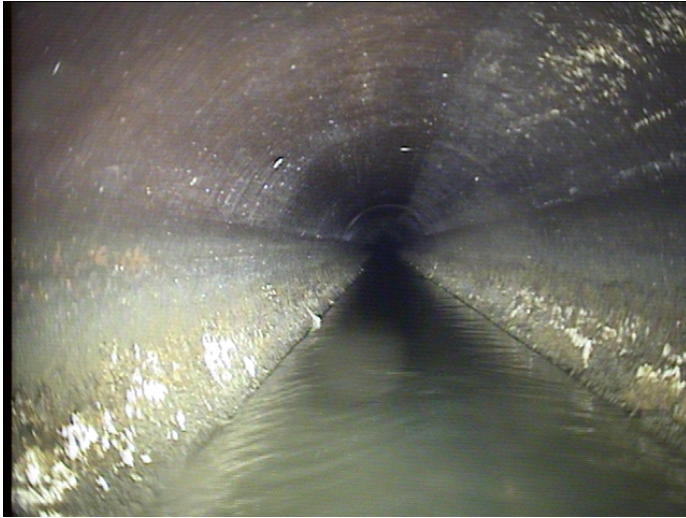
Code: **MWL**
Description: **Water Level**

Distance (ft): **.0**
Structural Grade: **0**
O&M Grade: **0**
Clock Start/From:
Clock To:
1st Value:
2nd Value:
Value Percent: **15.000**
Continuous Index:
Within 8" of Joint: **NO**
Remarks:

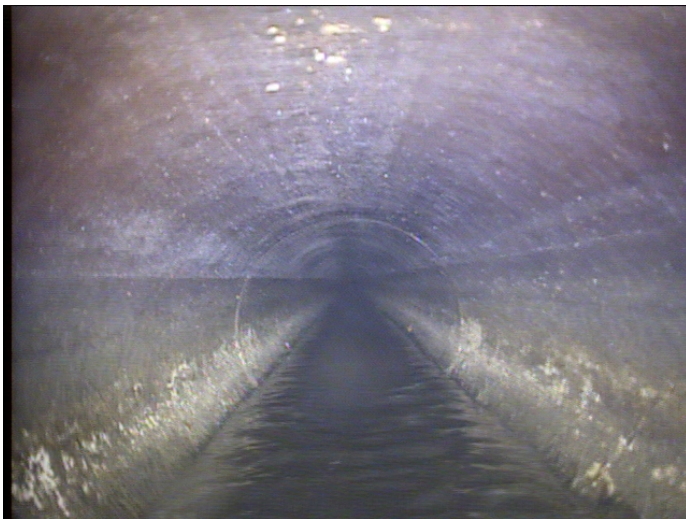
Code: **DSF**
Description: **Deposits Settled Fine**

Distance (ft): **43.1**
Structural Grade: **0**
O&M Grade: **2**
Clock Start/From: **5**
Clock To: **7**
1st Value:
2nd Value:
Value Percent: **5.000**
Continuous Index: **S01**
Within 8" of Joint: **NO**
Remarks:

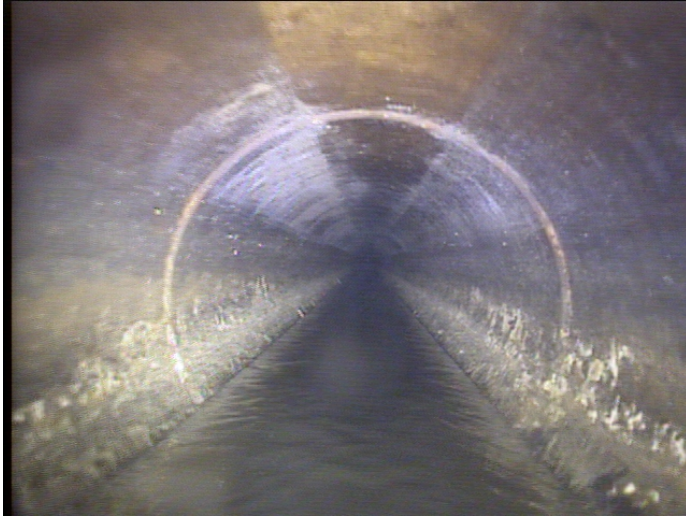
Code: **DSF**
Description: **Deposits Settled Fine**

Distance (ft): **57.3**
Structural Grade: **0**
O&M Grade: **2**
Clock Start/From: **5**
Clock To: **7**
1st Value:
2nd Value:
Value Percent: **5.000**
Continuous Index: **F01**
Within 8" of Joint: **NO**
Remarks:

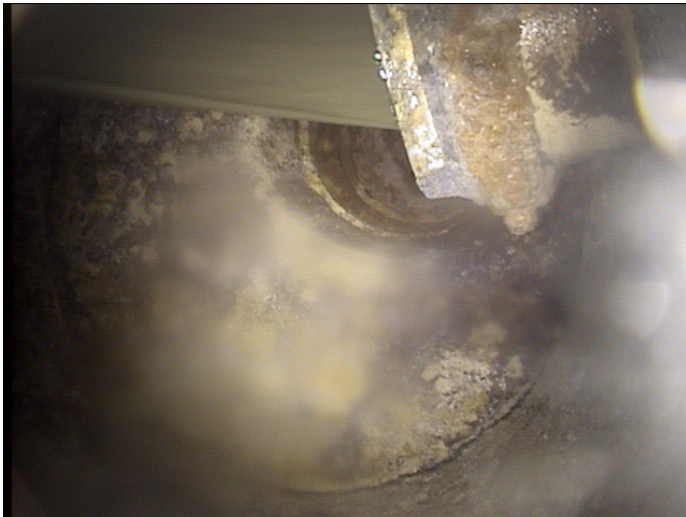
Code: **AMH**
Description: **Manhole**

Distance (ft): **187.1**
Structural Grade: **0**
O&M Grade: **0**
Clock Start/From:
Clock To:
1st Value:
2nd Value:
Value Percent:
Continuous Index:
Within 8" of Joint: **NO**
Remarks: **M-507-039**
