## Profile/Photo Observation Report

Date:	<b>04/07/2018</b>	Weather:		Coding:	<b>PACP 6.0</b>
Pipe Length (ft):		Owner:	<b>City of Hobart</b>	Pre Clean:	<b>Not Known</b>
P.O.#:	<b>200</b>	Surveyor:	<b>B. Helbling</b>	PSR:	<b>P-507-043-042</b>
Customer:	<b>City of Hobart</b>	Clean Date:		Shape:	<b>C</b>

Street:	<b>South Delaware Street</b>	Flow Control:	<b>Not Controlled</b>
City:	<b>Hobart, IN</b>	Year Renewed:	
Location:	<b>Light Highway</b>	Tape/Media #:	<b>DEP200</b>
Purpose:	<b>Routine Assessment</b>	Dia/Height:	<b>15"</b>
Use:	<b>Sanitary</b>	Material:	<b>PVC</b>
Drain Area:		Lining:	
Category:	<b>NA</b>		
Comment:	<b>YES501824 Submittal 2</b>		
Location Details:		Direction of Survey:	<b>Upstream</b>
US MH:	<b>M-507-043</b>	DS MH:	<b>M-507-042</b>
		Total Length Surveyed (ft):	<b>340.1</b>

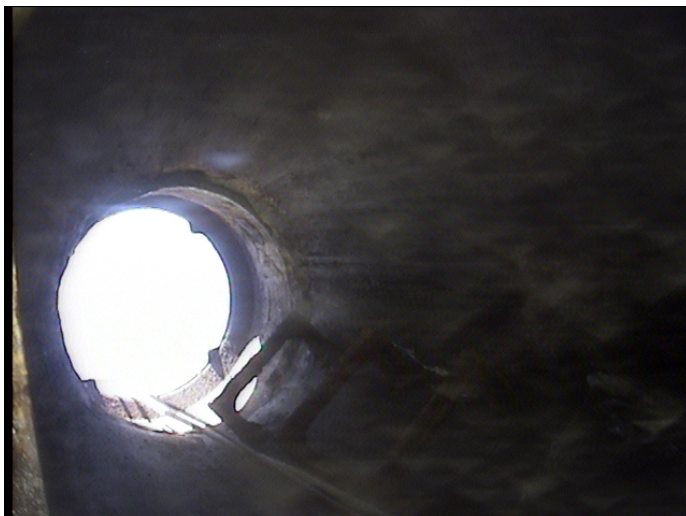
Code: **AMH**  
 Description: **Manhole**

Distance (ft): **.0**  
 Structural Grade: **0**  
 O&M Grade: **0**  
 Clock Start/From:  
 Clock To:  
 1st Value:  
 2nd Value:  
 Value Percent:  
 Continuous Index:  
 Within 8" of Joint: **NO**  
 Remarks: **M-507-042**

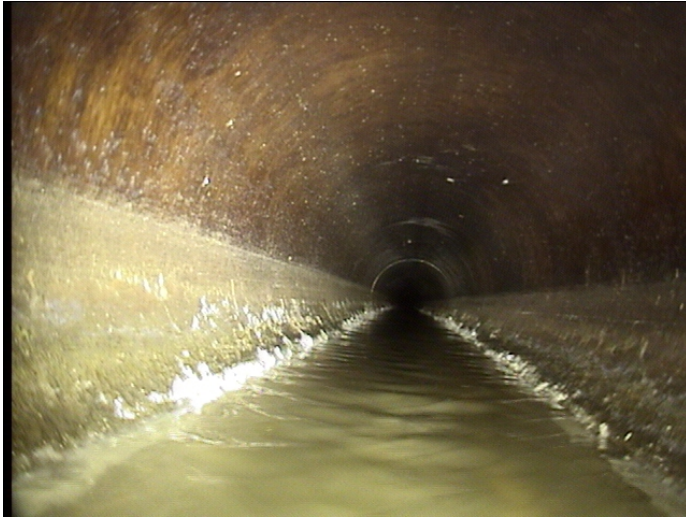
Code: **MWL**  
Description: **Water Level**

Distance (ft): **.0**  
Structural Grade: **0**  
O&M Grade: **0**  
Clock Start/From:  
Clock To:  
1st Value:  
2nd Value:  
Value Percent: **5.000**  
Continuous Index:  
Within 8" of Joint: **NO**  
Remarks:

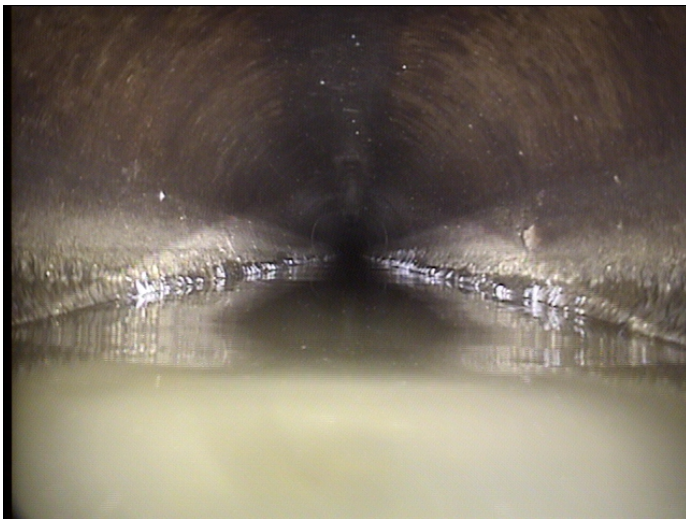
Code: **DAE**  
Description: **Deposits Attached Encrustation**

Distance (ft): **227.6**  
Structural Grade: **0**  
O&M Grade: **2**  
Clock Start/From: **5**  
Clock To: **7**  
1st Value:  
2nd Value:  
Value Percent: **5.000**  
Continuous Index: **S01**  
Within 8" of Joint: **NO**  
Remarks:

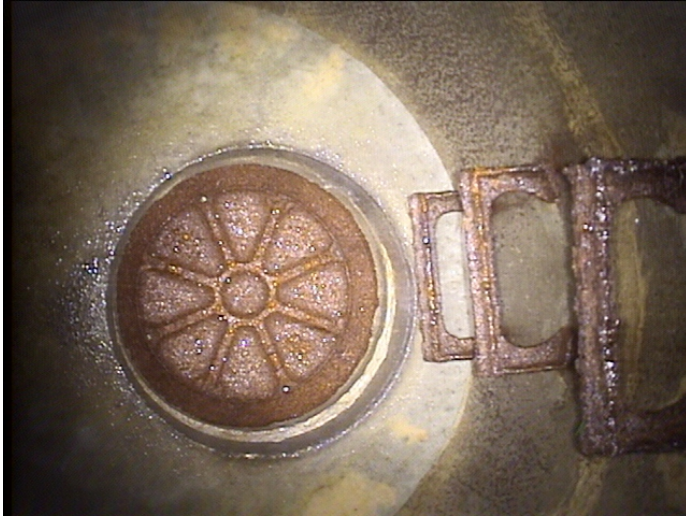
Code: **DAE**  
Description: **Deposits Attached Encrustation**

Distance (ft): **340.1**  
Structural Grade: **0**  
O&M Grade: **2**  
Clock Start/From: **5**  
Clock To: **7**  
1st Value:  
2nd Value:  
Value Percent: **5.000**  
Continuous Index: **F01**  
Within 8" of Joint: **NO**  
Remarks:

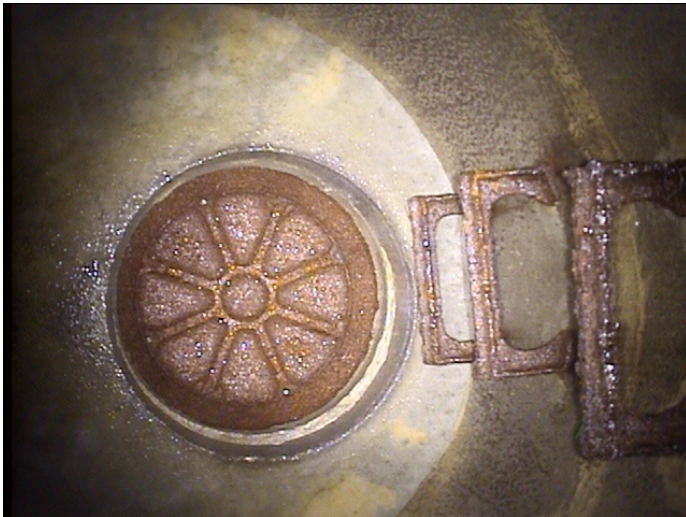
Code: **AMH**  
Description: **Manhole**

Distance (ft): **340.1**  
Structural Grade: **0**  
O&M Grade: **0**  
Clock Start/From:  
Clock To:  
1st Value:  
2nd Value:  
Value Percent:  
Continuous Index:  
Within 8" of Joint: **NO**  
Remarks: **M-507-043**
