Profile/Photo Observation Report

Date:	03/26/2018	Weather:		Coding:	PACP 6.0
Pipe Length (ft):	294.1	Owner:	NA	Pre Clean:	No Pre-Cleaning
P.O.#:		Surveyor:	Justin Gonzales	PSR:	P-507-045-046
Customer:		Clean Date:	01/01/1900	Shape:	C

Street:	S VIRGINIA ST & W 13TH PL	Flow Control:	Not Controlled
City:	Hobart, IN	Year Renewed:	
Location:	Light Highway	Tape/Media #:	
Purpose:	Routine Assessment	Dia/Height:	8"
Use:	Sanitary	Material:	PVC
Drain Area:	NA	Lining:	
Category:	NA		
Comment:			
Location Details:		Direction of Survey:	Upstream
US MH:	M-507-045	DS MH:	M-507-046
		Total Length Surveyed (ft):	291.3

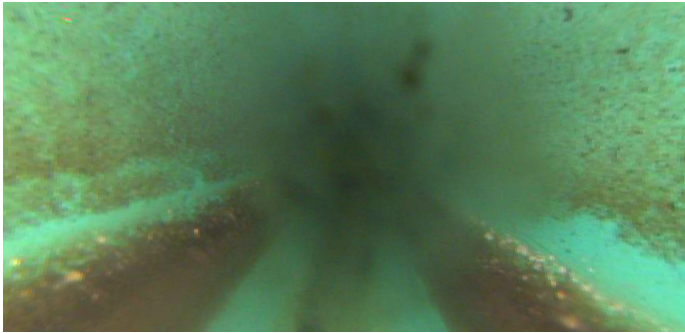
Code:	MWL
Description:	Water Level

Distance (ft):	.0
Structural Grade:	0
O&M Grade:	0
Clock Start/From:	
Clock To:	
1st Value:	
2nd Value:	
Value Percent:	5.000
Continuous Index:	
Within 8" of Joint:	NO
Remarks:

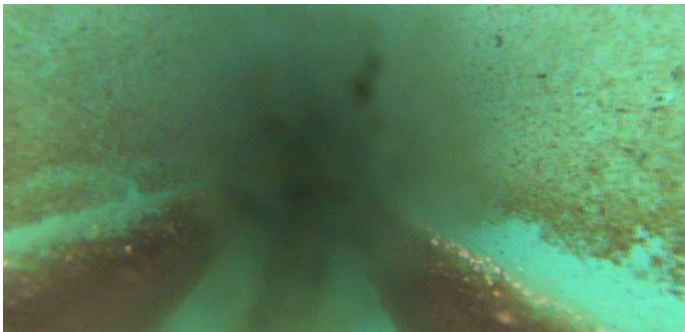
Code:	MGO
Description:	General Observation

Distance (ft):	.0
Structural Grade:	0
O&M Grade:	0
Clock Start/From:	
Clock To:	
1st Value:	
2nd Value:	
Value Percent:	
Continuous Index:	
Within 8" of Joint:	NO
Remarks:	SMUDGE ON LENS

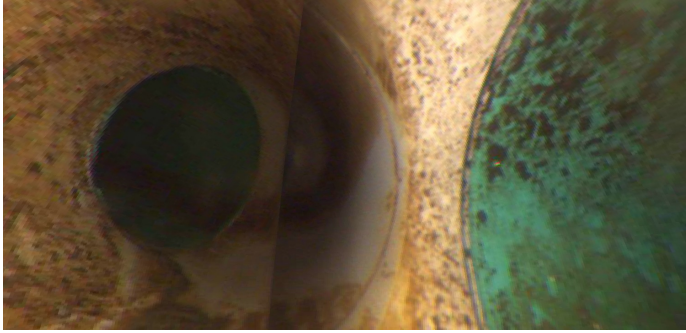
Code: **TF**
Description: **Tap Factory**

Distance (ft): **83.5**
Structural Grade: **0**
O&M Grade: **0**
Clock Start/From: **9**
Clock To:
1st Value: **4.000**
2nd Value:
Value Percent:
Continuous Index:
Within 8" of Joint:
Remarks:

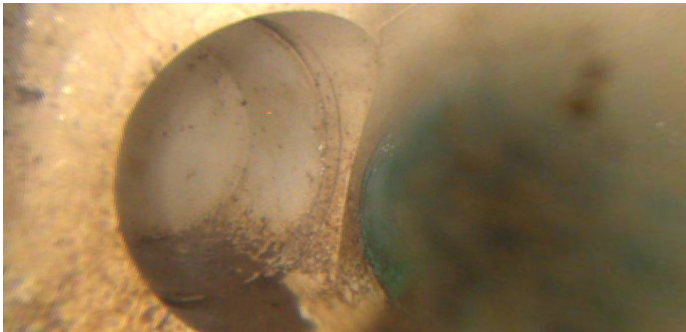
Code: **TFC**
Description: **Tap Factory Capped**

Distance (ft): **176.5**
Structural Grade: **0**
O&M Grade: **0**
Clock Start/From: **9**
Clock To:
1st Value: **4.000**
2nd Value:
Value Percent:
Continuous Index:
Within 8" of Joint:
Remarks:

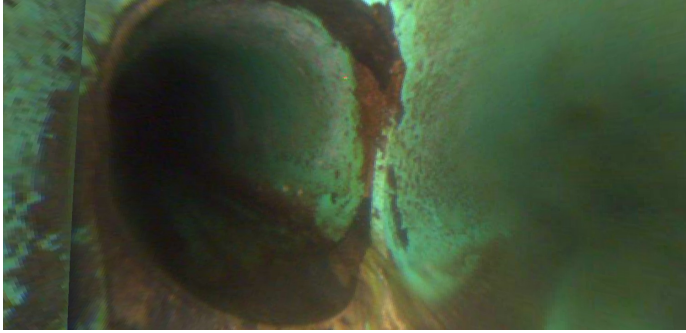
Code: **TF**
Description: **Tap Factory**

Distance (ft): **186.5**
Structural Grade: **0**
O&M Grade: **0**
Clock Start/From: **9**
Clock To:
1st Value: **4.000**
2nd Value:
Value Percent:
Continuous Index:
Within 8" of Joint:
Remarks:

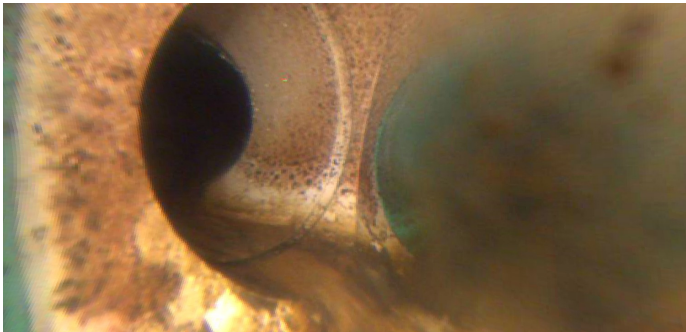
Code: **TF**
Description: **Tap Factory**

Distance (ft): **249.8**
Structural Grade: **0**
O&M Grade: **0**
Clock Start/From: **9**
Clock To:
1st Value: **4.000**
2nd Value:
Value Percent:
Continuous Index:
Within 8" of Joint:
Remarks:

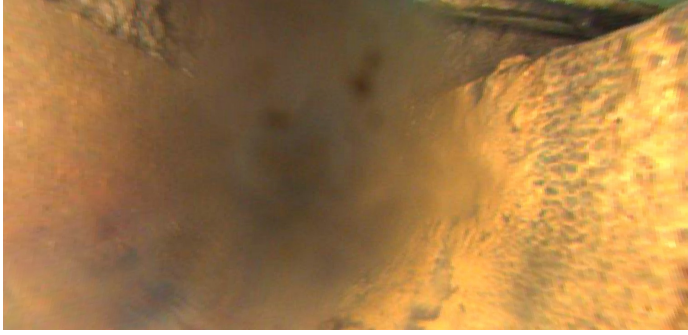
Code:	AMH
Description:	Manhole
Distance (ft):	291.3
Structural Grade:	0
O&M Grade:	0
Clock Start/From:	
Clock To:	
1st Value:	
2nd Value:	
Value Percent:	
Continuous Index:	
Within 8" of Joint:	NO
Remarks:	M-507-045
