Profile/Photo Observation Report

Street:	FOXCROFT STREET	Flow Control:	Not Controlled
City:	Hobart, IN	Year Renewed:	
Location:	Light Highway	Tape/Media #:	
Purpose:	Routine Assessment	Dia/Height:	8"
Use:	Sanitary	Material:	PVC
Drain Area:	NA	Lining:	
Category:	NA		
Comment:

Location Details:		Direction of Survey:	Upstream
US MH:	M-507-045	DS MH:	M-507-046
		Total Length Surveyed (ft):	291.3

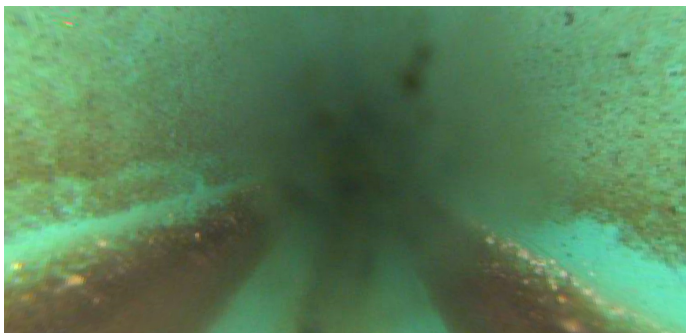
Code: **AMH**
Description: **Manhole**

Distance (ft): **.0**
Structural Grade: **0**
O&M Grade: **0**
Clock Start/From:
Clock To:
1st Value:
2nd Value:
Value Percent:
Continuous Index:
Within 8" of Joint: **NO**
Remarks: **M-507-046**

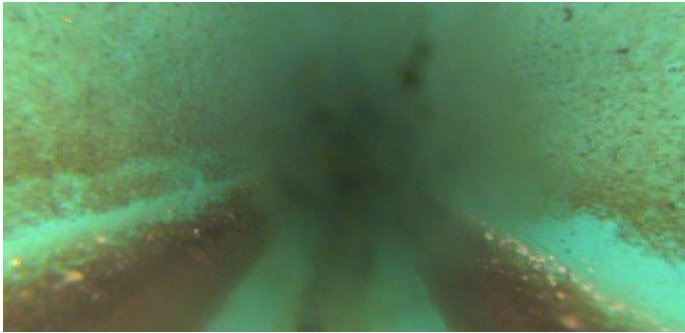
Code:	MWL
Description:	Water Level

Distance (ft):	.0
Structural Grade:	0
O&M Grade:	0
Clock Start/From:	
Clock To:	
1st Value:	
2nd Value:	
Value Percent:	5.000
Continuous Index:	
Within 8" of Joint:	NO
Remarks:

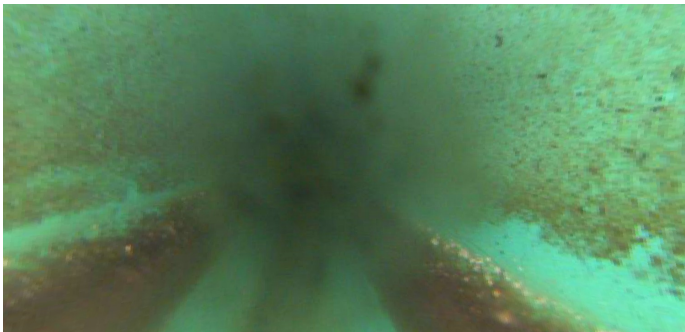
Code:	MGO
Description:	General Observation

Distance (ft):	.0
Structural Grade:	0
O&M Grade:	0
Clock Start/From:	
Clock To:	
1st Value:	
2nd Value:	
Value Percent:	
Continuous Index:	
Within 8" of Joint:	NO
Remarks:	SMUDGE ON LENS

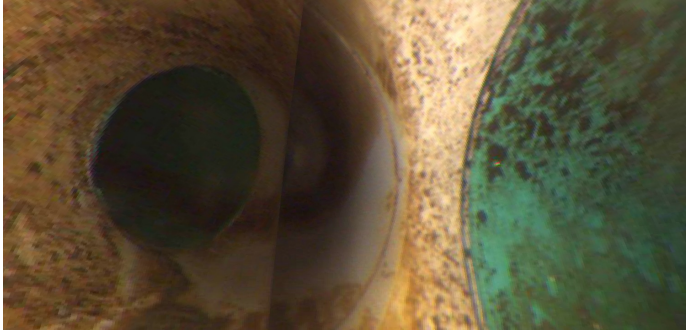
Code: **TF**
Description: **Tap Factory**

Distance (ft): **83.5**
Structural Grade: **0**
O&M Grade: **0**
Clock Start/From: **9**
Clock To:
1st Value: **4.000**
2nd Value:
Value Percent:
Continuous Index:
Within 8" of Joint:
Remarks:

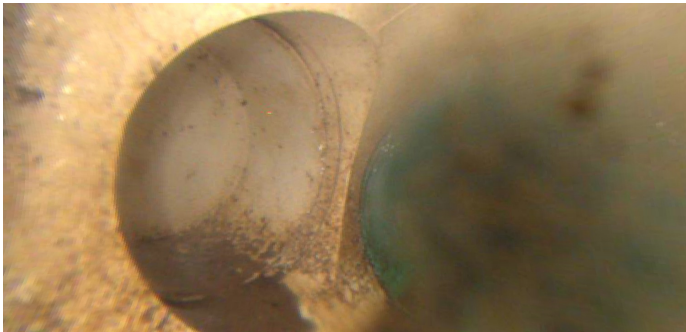
Code: **TFC**
Description: **Tap Factory Capped**

Distance (ft): **176.5**
Structural Grade: **0**
O&M Grade: **0**
Clock Start/From: **9**
Clock To:
1st Value: **4.000**
2nd Value:
Value Percent:
Continuous Index:
Within 8" of Joint:
Remarks:

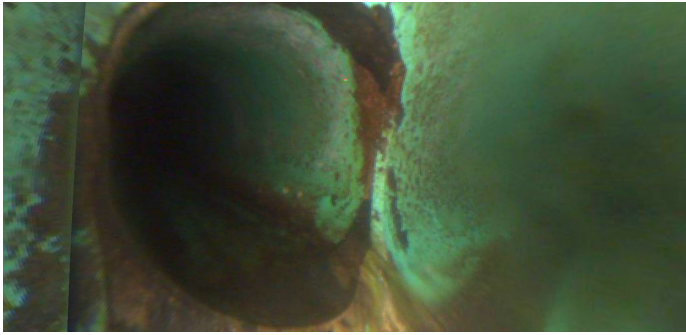
Code: **TF**
Description: **Tap Factory**

Distance (ft): **186.5**
Structural Grade: **0**
O&M Grade: **0**
Clock Start/From: **9**
Clock To:
1st Value: **4.000**
2nd Value:
Value Percent:
Continuous Index:
Within 8" of Joint:
Remarks:

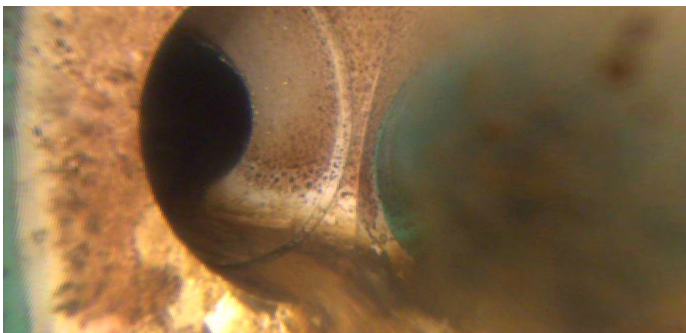
Code: **TF**
Description: **Tap Factory**

Distance (ft): **249.8**
Structural Grade: **0**
O&M Grade: **0**
Clock Start/From: **9**
Clock To:
1st Value: **4.000**
2nd Value:
Value Percent:
Continuous Index:
Within 8" of Joint:
Remarks:

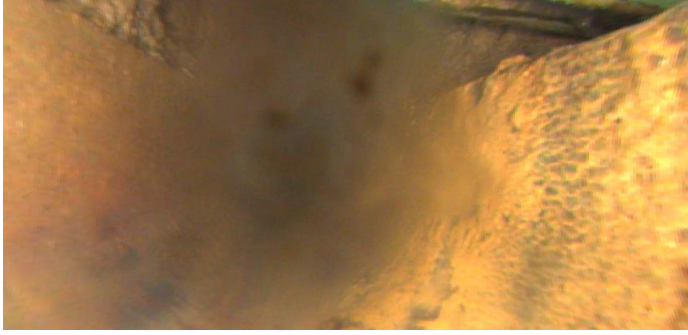
Code:	AMH
Description:	Manhole
Distance (ft):	291.3
Structural Grade:	0
O&M Grade:	0
Clock Start/From:	
Clock To:	
1st Value:	
2nd Value:	
Value Percent:	
Continuous Index:	
Within 8" of Joint:	NO
Remarks:	M-507-045
