## Profile/Photo Observation Report

Date:	<b>03/26/2018</b>	Weather:		Coding:	<b>PACP 6.0</b>
Pipe Length (ft):	<b>187.2</b>	Owner:	<b>NA</b>	Pre Clean:	<b>No Pre-Cleaning</b>
P.O.#:		Surveyor:	<b>Justin Gonzales</b>	PSR:	<b>P-507-046-047</b>
Customer:		Clean Date:	<b>01/01/1900</b>	Shape:	<b>C</b>

Street:	<b>S VIRGINIA ST</b>	Flow Control:	<b>Not Controlled</b>
City:	<b>Hobart, IN</b>	Year Renewed:	
Location:	<b>Light Highway</b>	Tape/Media #:	
Purpose:	<b>Routine Assessment</b>	Dia/Height:	<b>8"</b>
Use:	<b>Sanitary</b>	Material:	<b>PVC</b>
Drain Area:	<b>NA</b>	Lining:	
Category:	<b>NA</b>		
Comment:			
Location Details:		Direction of Survey:	<b>Downstream</b>
US MH:	<b>M-507-046</b>	DS MH:	<b>M-507-047</b>
		Total Length Surveyed (ft):	<b>185.5</b>

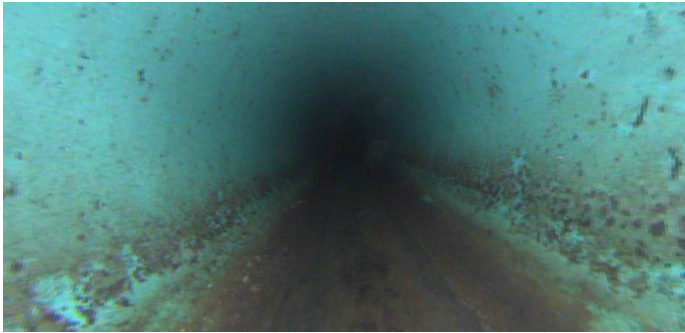
Code:	<b>MWL</b>
Description:	<b>Water Level</b>

Distance (ft):	<b>.0</b>
Structural Grade:	<b>0</b>
O&M Grade:	<b>0</b>
Clock Start/From:	
Clock To:	
1st Value:	
2nd Value:	
Value Percent:	<b>5.000</b>
Continuous Index:	
Within 8" of Joint:	<b>NO</b>
Remarks:

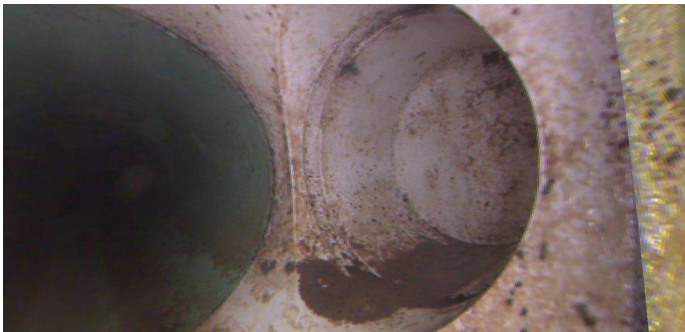
Code:	<b>TFC</b>
Description:	<b>Tap Factory Capped</b>

Distance (ft):	<b>56.9</b>
Structural Grade:	<b>0</b>
O&M Grade:	<b>0</b>
Clock Start/From:	<b>3</b>
Clock To:	
1st Value:	<b>4.000</b>
2nd Value:	
Value Percent:	
Continuous Index:	
Within 8" of Joint:	
Remarks:

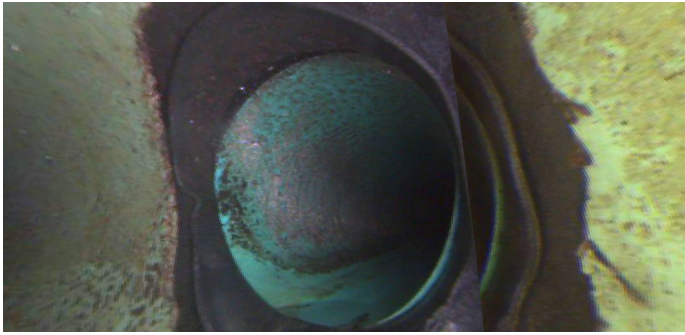
Code: **TB**  
Description: **Tap Break-in**

Distance (ft): **124.9**  
Structural Grade: **0**  
O&M Grade: **0**  
Clock Start/From: **3**  
Clock To:  
1st Value: **4.000**  
2nd Value:  
Value Percent:  
Continuous Index:  
Within 8" of Joint:  
Remarks:

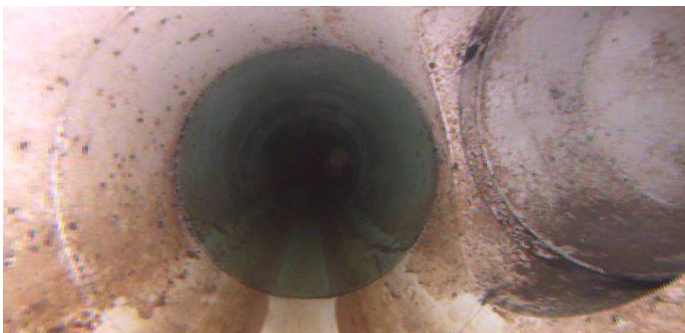
Code: **TFC**  
Description: **Tap Factory Capped**

Distance (ft): **167.8**  
Structural Grade: **0**  
O&M Grade: **0**  
Clock Start/From: **3**  
Clock To:  
1st Value: **4.000**  
2nd Value:  
Value Percent:  
Continuous Index:  
Within 8" of Joint:  
Remarks:

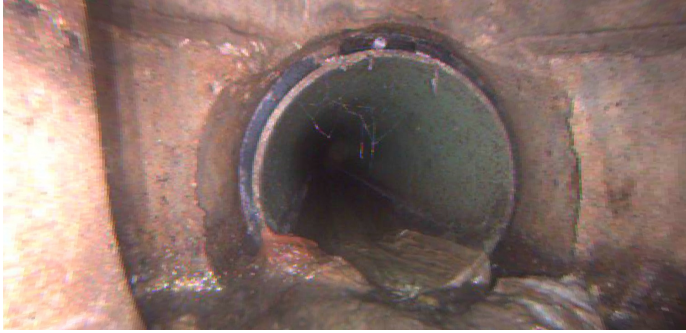
Code:	AMH
Description:	Manhole
Distance (ft):	185.5
Structural Grade:	0
O&M Grade:	0
Clock Start/From:	
Clock To:	
1st Value:	
2nd Value:	
Value Percent:	
Continuous Index:	
Within 8" of Joint:	NO
Remarks:	M-507-047
