Profile/Photo Observation Report

| Street: | FOXCROFT STREET | Flow Control: | Not Controlled |
| City: | Hobart, IN | Year Renewed: | |

| US MH: | M-507-046 | DS MH: | M-507-047 |

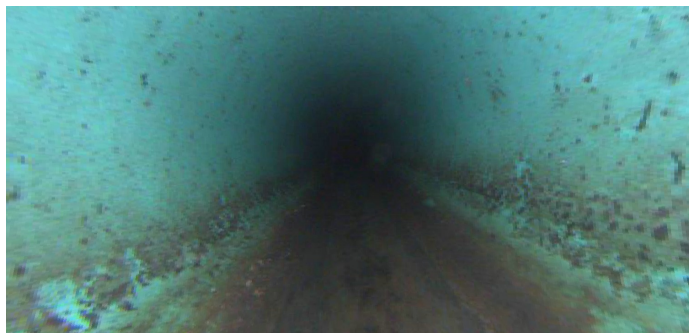
Code: **AMH**
 Description: **Manhole**

Distance (ft): **.0**
 Structural Grade: **0**
 O&M Grade: **0**
 Clock Start/From:
 Clock To:
 1st Value:
 2nd Value:
 Value Percent:
 Continuous Index:
 Within 8" of Joint: **NO**
 Remarks: **M-507-046**

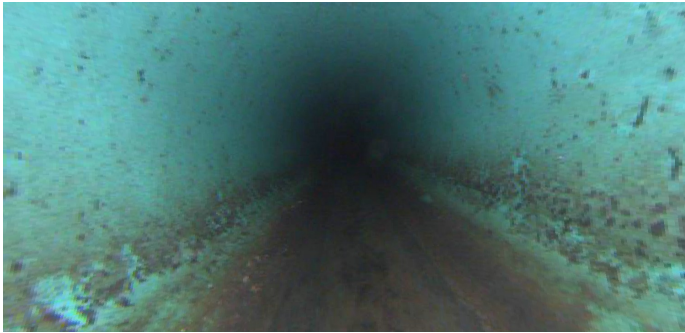
| Code: | MWL |
| Description: | Water Level |

| Distance (ft): | .0 |
| Value Percent: | 5.000 |

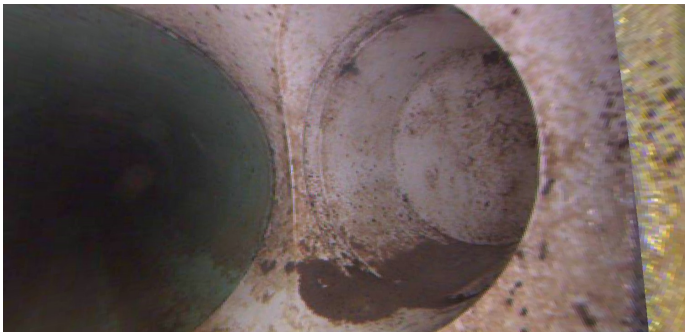
| Code: | TFC |
| Description: | Tap Factory Capped |

| Distance (ft): | 56.9 |
| Clock Start/From: | 3 |
| 1st Value: | 4.000 |

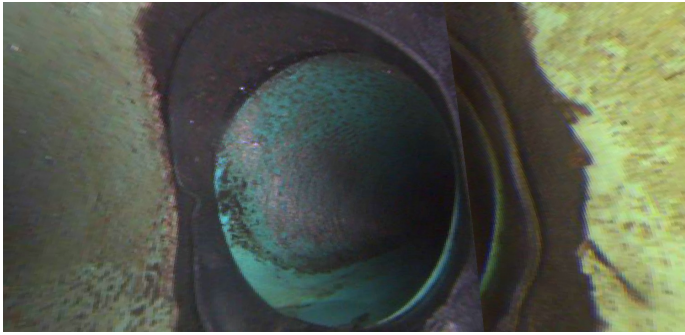
Code: **TB**
Description: **Tap Break-in**

Distance (ft): **124.9**
Structural Grade: **0**
O&M Grade: **0**
Clock Start/From: **3**
Clock To:
1st Value: **4.000**
2nd Value:
Value Percent:
Continuous Index:
Within 8" of Joint:
Remarks:

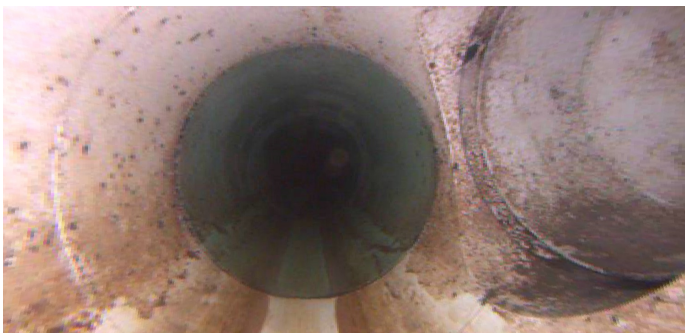
Code: **TFC**
Description: **Tap Factory Capped**

Distance (ft): **167.8**
Structural Grade: **0**
O&M Grade: **0**
Clock Start/From: **3**
Clock To:
1st Value: **4.000**
2nd Value:
Value Percent:
Continuous Index:
Within 8" of Joint:
Remarks:

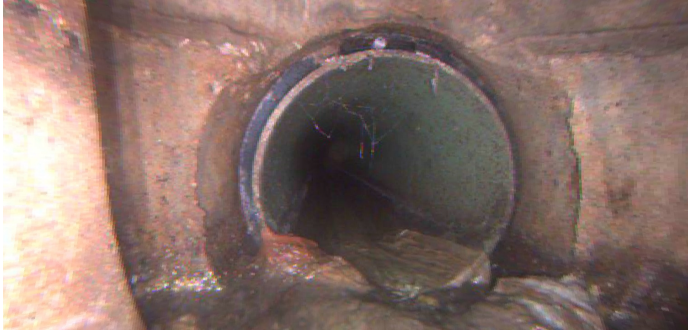
| Code: | AMH |
| Description: | Manhole |
| Distance (ft): | 185.5 |
| Remarks: | M-507-047 |
