Profile/Photo Observation Report

Date:	03/26/2018	Weather:		Coding:	PACP 6.0
Pipe Length (ft):	290.5	Owner:	NA	Pre Clean:	No Pre-Cleaning
P.O.#:		Surveyor:	Justin Gonzales	PSR:	P-507-047-048
Customer:		Clean Date:	01/01/1900	Shape:	C

Location Details:		Direction of Survey:	Upstream
US MH:	M-507-047	DS MH:	M-507-048
		Total Length Surveyed (ft):	289.2

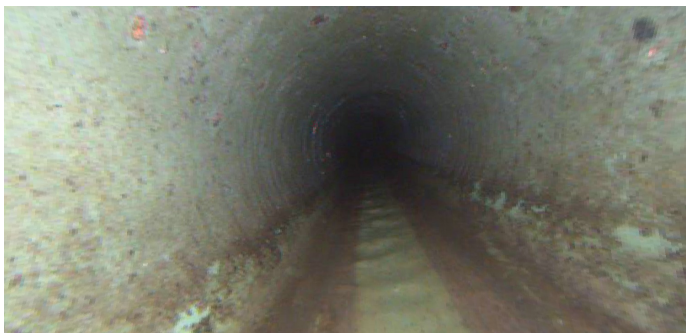
Code: **AMH**
Description: **Manhole**

Distance (ft): **.0**
Structural Grade: **0**
O&M Grade: **0**
Clock Start/From:
Clock To:
1st Value:
2nd Value:
Value Percent:
Continuous Index:
Within 8" of Joint: **NO**
Remarks: **M-507-048**

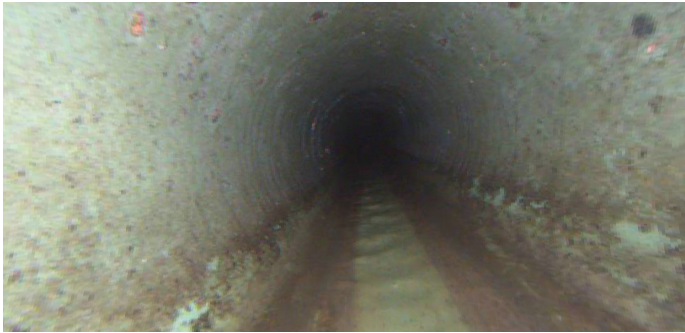
Code:	MWL
Description:	Water Level

Distance (ft):	.0
Structural Grade:	0
O&M Grade:	0
Clock Start/From:	
Clock To:	
1st Value:	
2nd Value:	
Value Percent:	5.000
Continuous Index:	
Within 8" of Joint:	NO
Remarks:

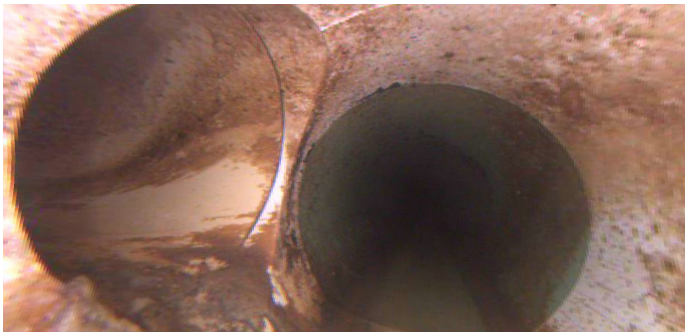
Code:	TF
Description:	Tap Factory

Distance (ft):	32.3
Structural Grade:	0
O&M Grade:	0
Clock Start/From:	9
Clock To:	
1st Value:	4.000
2nd Value:	
Value Percent:	
Continuous Index:	
Within 8" of Joint:	
Remarks:

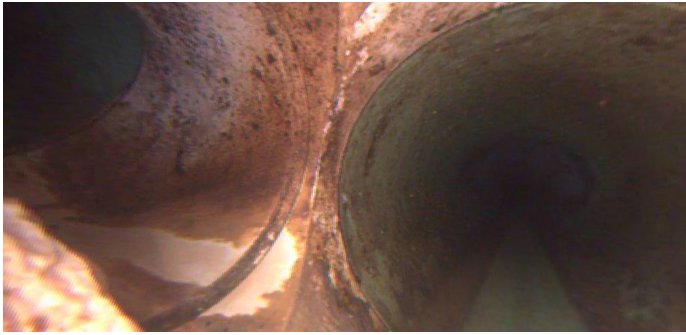
Code: **TF**
Description: **Tap Factory**

Distance (ft): **118.5**
Structural Grade: **0**
O&M Grade: **0**
Clock Start/From: **9**
Clock To:
1st Value: **4.000**
2nd Value:
Value Percent:
Continuous Index:
Within 8" of Joint:
Remarks:

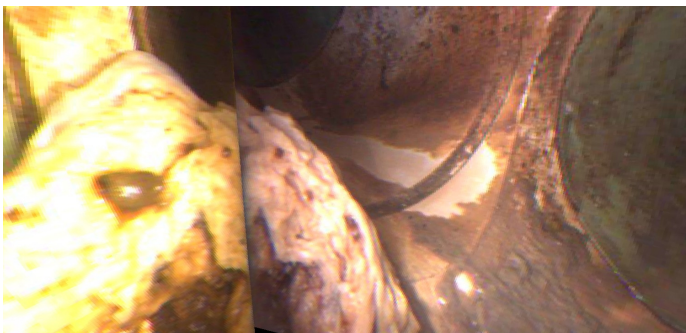
Code: **DAZ**
Description: **Deposits Attached Other**

Distance (ft): **118.5**
Structural Grade: **0**
O&M Grade: **2**
Clock Start/From: **7**
Clock To: **9**
1st Value:
2nd Value:
Value Percent: **5.000**
Continuous Index:
Within 8" of Joint:
Remarks:

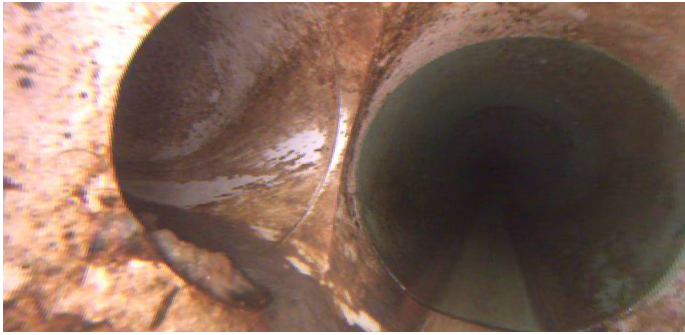
Code: **TF**
Description: **Tap Factory**

Distance (ft): **197.2**
Structural Grade: **0**
O&M Grade: **0**
Clock Start/From: **9**
Clock To:
1st Value: **4.000**
2nd Value:
Value Percent:
Continuous Index:
Within 8" of Joint:
Remarks:

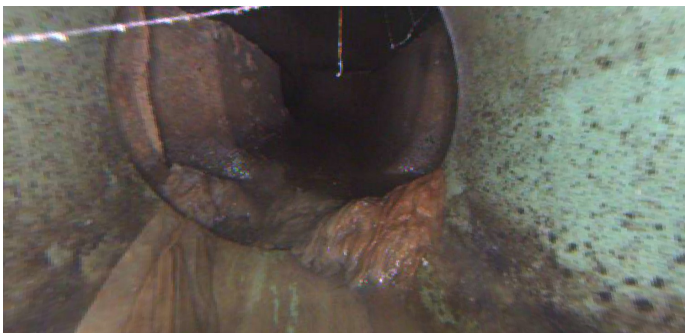
Code: **MGO**
Description: **General Observation**

Distance (ft): **286.0**
Structural Grade: **0**
O&M Grade: **0**
Clock Start/From:
Clock To:
1st Value:
2nd Value:
Value Percent:
Continuous Index:
Within 8" of Joint: **NO**
Remarks: **TOILET TISSUE**

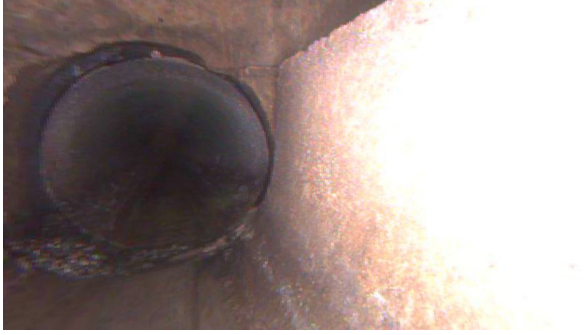
Code:	AMH
Description:	Manhole
Distance (ft):	289.2
Structural Grade:	0
O&M Grade:	0
Clock Start/From:	
Clock To:	
1st Value:	
2nd Value:	
Value Percent:	
Continuous Index:	
Within 8" of Joint:	NO
Remarks:	M-507-047
