Profile/Photo Observation Report

Street:	FOXCROFT STREET	Flow Control:	Not Controlled
City:	Hobart, IN	Year Renewed:	
Location:	Light Highway	Tape/Media #:	
Purpose:	Routine Assessment	Dia/Height:	8"
Use:	Sanitary	Material:	PVC
Drain Area:	NA	Lining:	
Category:	NA		
Comment:

Location Details:		Direction of Survey:	Upstream
US MH:	M-507-047	DS MH:	M-507-048
		Total Length Surveyed (ft):	289.2

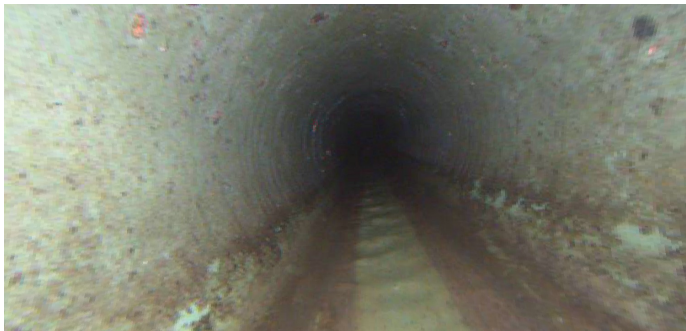
Code: **AMH**
Description: **Manhole**

Distance (ft): **.0**
Structural Grade: **0**
O&M Grade: **0**
Clock Start/From:
Clock To:
1st Value:
2nd Value:
Value Percent:
Continuous Index:
Within 8" of Joint: **NO**
Remarks: **M-507-048**

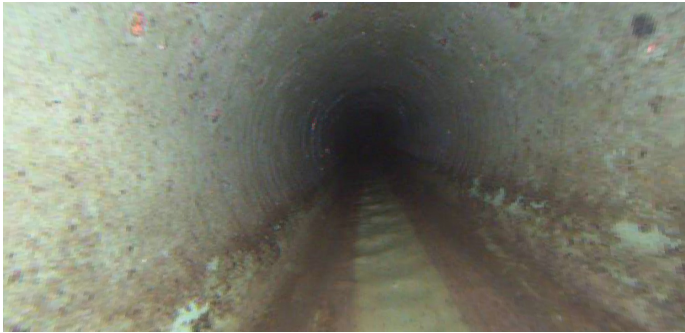
Code:	MWL
Description:	Water Level

Distance (ft):	.0
Structural Grade:	0
O&M Grade:	0
Clock Start/From:	
Clock To:	
1st Value:	
2nd Value:	
Value Percent:	5.000
Continuous Index:	
Within 8" of Joint:	NO
Remarks:

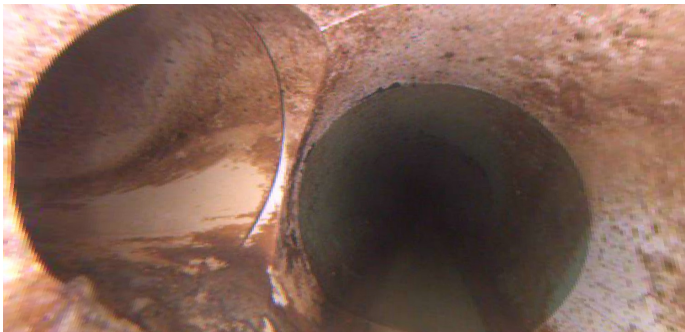
Code:	TF
Description:	Tap Factory

Distance (ft):	32.3
Structural Grade:	0
O&M Grade:	0
Clock Start/From:	9
Clock To:	
1st Value:	4.000
2nd Value:	
Value Percent:	
Continuous Index:	
Within 8" of Joint:	
Remarks:

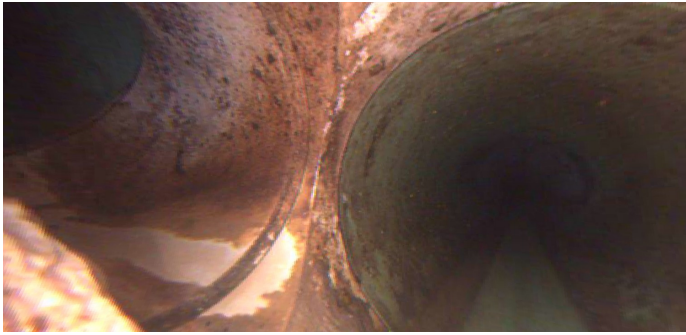
Code: **TF**
Description: **Tap Factory**

Distance (ft): **118.5**
Structural Grade: **0**
O&M Grade: **0**
Clock Start/From: **9**
Clock To:
1st Value: **4.000**
2nd Value:
Value Percent:
Continuous Index:
Within 8" of Joint:
Remarks:

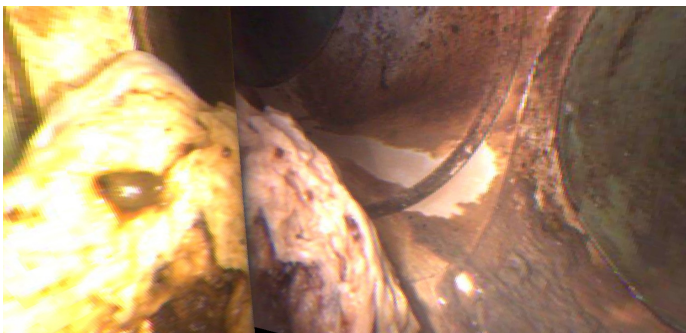
Code: **DAZ**
Description: **Deposits Attached Other**

Distance (ft): **118.5**
Structural Grade: **0**
O&M Grade: **2**
Clock Start/From: **7**
Clock To: **9**
1st Value:
2nd Value:
Value Percent: **5.000**
Continuous Index:
Within 8" of Joint:
Remarks:

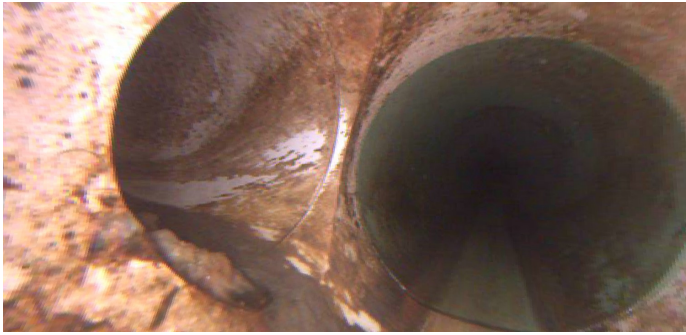
Code: **TF**
Description: **Tap Factory**

Distance (ft): **197.2**
Structural Grade: **0**
O&M Grade: **0**
Clock Start/From: **9**
Clock To:
1st Value: **4.000**
2nd Value:
Value Percent:
Continuous Index:
Within 8" of Joint:
Remarks:

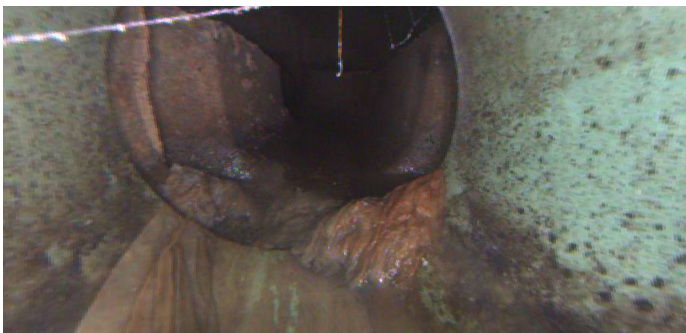
Code: **MGO**
Description: **General Observation**

Distance (ft): **286.0**
Structural Grade: **0**
O&M Grade: **0**
Clock Start/From:
Clock To:
1st Value:
2nd Value:
Value Percent:
Continuous Index:
Within 8" of Joint: **NO**
Remarks: **TOILET TISSUE**

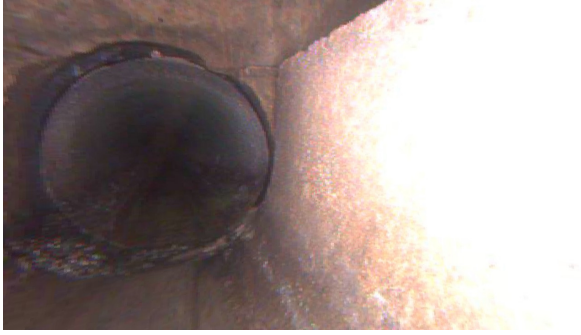
Code:	AMH
Description:	Manhole
Distance (ft):	289.2
Structural Grade:	0
O&M Grade:	0
Clock Start/From:	
Clock To:	
1st Value:	
2nd Value:	
Value Percent:	
Continuous Index:	
Within 8" of Joint:	NO
Remarks:	M-507-047
