Profile/Photo Observation Report

Date:	03/26/2018	Weather:		Coding:	PACP 6.0
Pipe Length (ft):	318.8	Owner:	NA	Pre Clean:	No Pre-Cleaning
P.O.#:		Surveyor:	Justin Gonzales	PSR:	P-507-048-049
Customer:		Clean Date:	01/01/1900	Shape:	C

Street:	FOXCROFT STREET	Flow Control:	Not Controlled
City:	Hobart, IN	Year Renewed:	
Location:	Light Highway	Tape/Media #:	
Purpose:	Routine Assessment	Dia/Height:	8"
Use:	Sanitary	Material:	PVC
Drain Area:	NA	Lining:	
Category:	NA		
Comment:

Location Details:		Direction of Survey:	Downstream
US MH:	M-507-048	DS MH:	M-507-049
		Total Length Surveyed (ft):	319.1

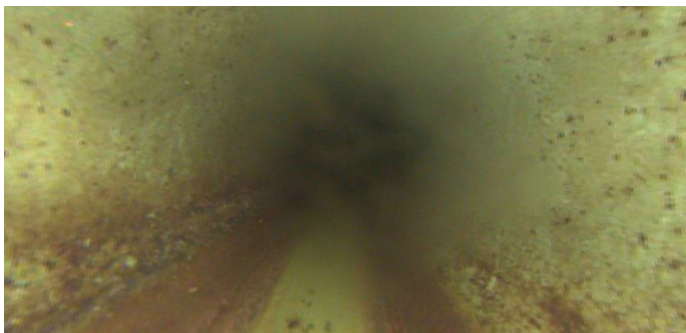
Code: **AMH**
Description: **Manhole**

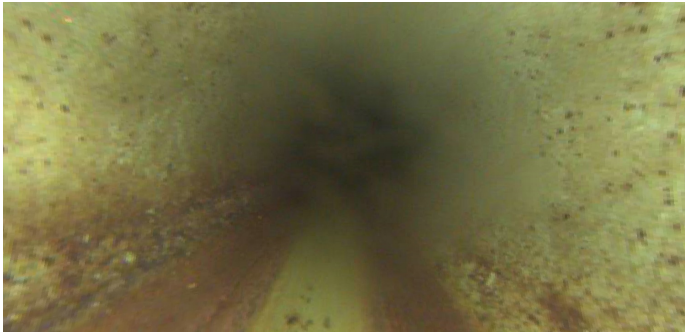
Code:	MWL
Description:	Water Level

Distance (ft):	.0
Structural Grade:	0
O&M Grade:	0
Clock Start/From:	
Clock To:	
1st Value:	
2nd Value:	
Value Percent:	5.000
Continuous Index:	
Within 8" of Joint:	NO
Remarks:

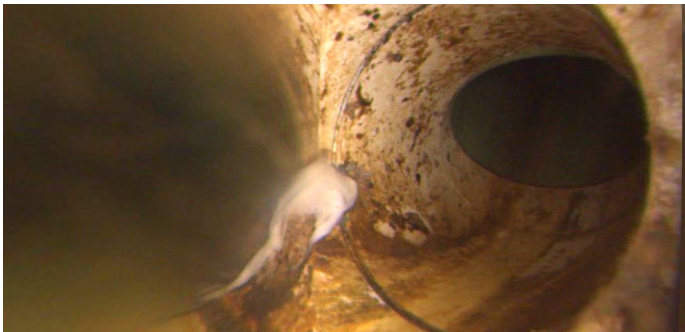
Code:	TFD
Description:	Tap Factory Defective

Distance (ft):	127.3
Structural Grade:	0
O&M Grade:	2
Clock Start/From:	3
Clock To:	
1st Value:	4.000
2nd Value:	
Value Percent:	
Continuous Index:	
Within 8" of Joint:	
Remarks:	dags

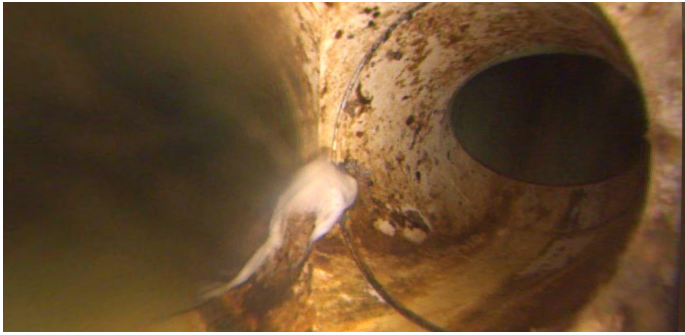
Code: **DAGS**
Description: **Deposits Attached Grease**

Distance (ft): **127.3**
Structural Grade: **0**
O&M Grade: **2**
Clock Start/From: **3**
Clock To: **4**
1st Value:
2nd Value:
Value Percent: **5.000**
Continuous Index:
Within 8" of Joint: **NO**
Remarks:

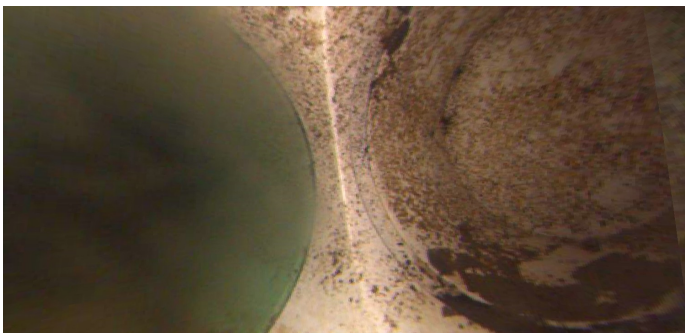
Code: **TFC**
Description: **Tap Factory Capped**

Distance (ft): **205.8**
Structural Grade: **0**
O&M Grade: **0**
Clock Start/From: **3**
Clock To:
1st Value: **4.000**
2nd Value:
Value Percent:
Continuous Index:
Within 8" of Joint:
Remarks:

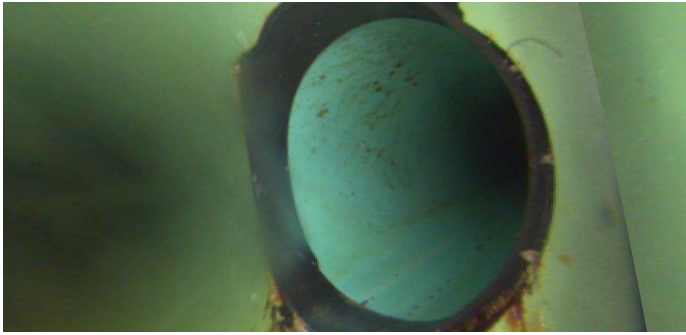
Code: **TF**
Description: **Tap Factory**

Distance (ft): **218.6**
Structural Grade: **0**
O&M Grade: **0**
Clock Start/From: **3**
Clock To:
1st Value: **4.000**
2nd Value:
Value Percent:
Continuous Index:
Within 8" of Joint:
Remarks:

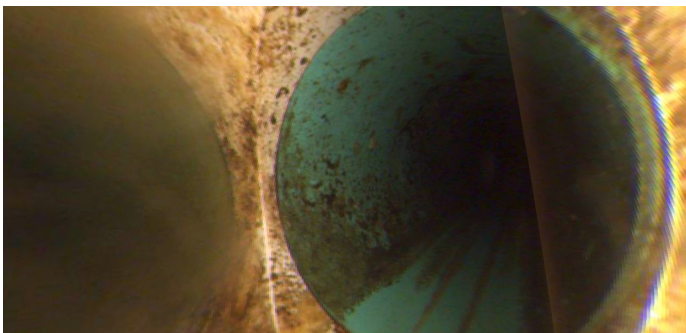
Code: **TF**
Description: **Tap Factory**

Distance (ft): **281.9**
Structural Grade: **0**
O&M Grade: **0**
Clock Start/From: **3**
Clock To:
1st Value: **4.000**
2nd Value:
Value Percent:
Continuous Index:
Within 8" of Joint:
Remarks:

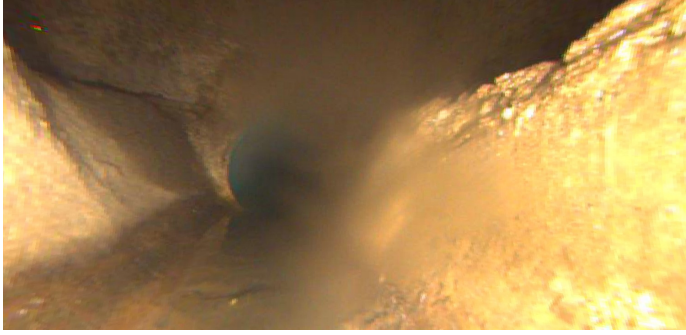
Code:	AMH
Description:	Manhole
Distance (ft):	319.1
Structural Grade:	0
O&M Grade:	0
Clock Start/From:	
Clock To:	
1st Value:	
2nd Value:	
Value Percent:	
Continuous Index:	
Within 8" of Joint:	NO
Remarks:	M-507-049
