Profile/Photo Observation Report

Street:	S VIRGINIA ST	Flow Control:	Not Controlled
City:	Hobart, IN	Year Renewed:	
Location:	Light Highway	Tape/Media #:	
Purpose:	Routine Assessment	Dia/Height:	10"
Use:	Sanitary	Material:	VCP
Drain Area:	NA	Lining:	
Category:	NA		
Comment:

Location Details:		Direction of Survey:	Downstream
US MH:	M-507-049	DS MH:	M-507-050
		Total Length Surveyed (ft):	309.5

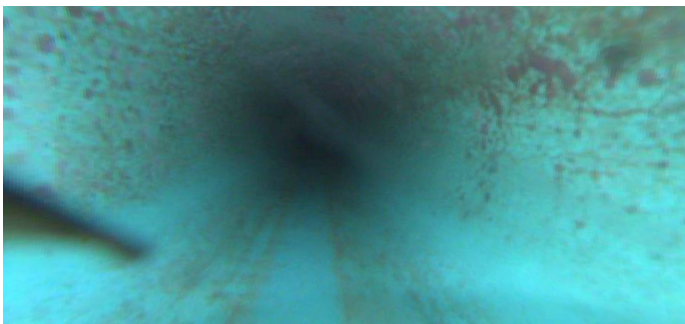
Code: **AMH**
Description: **Manhole**

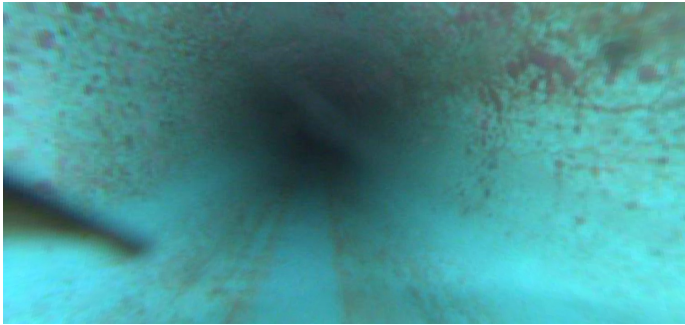
Code:	MWL
Description:	Water Level

Distance (ft):	.0
Structural Grade:	0
O&M Grade:	0
Clock Start/From:	
Clock To:	
1st Value:	
2nd Value:	
Value Percent:	5.000
Continuous Index:	
Within 8" of Joint:	NO
Remarks:

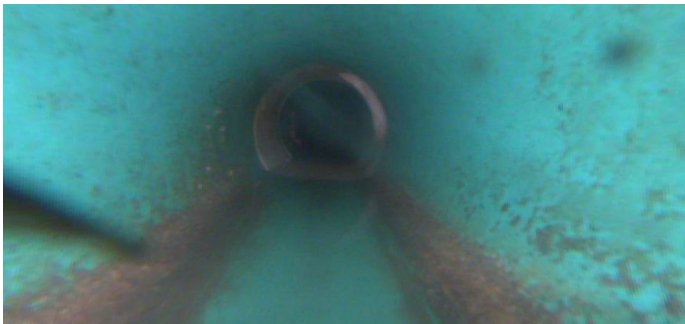
Code:	TF
Description:	Tap Factory

Distance (ft):	33.6
Structural Grade:	0
O&M Grade:	0
Clock Start/From:	2
Clock To:	
1st Value:	4.000
2nd Value:	
Value Percent:	
Continuous Index:	
Within 8" of Joint:	
Remarks:

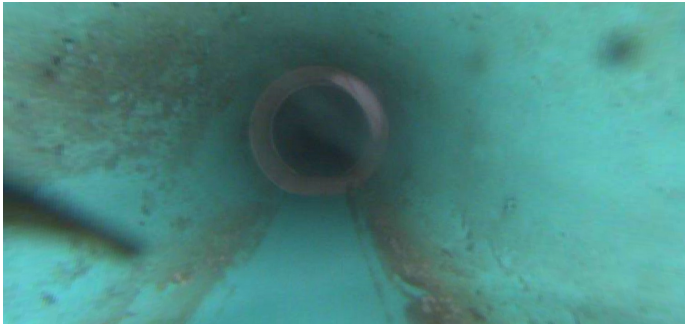
Code: **TF**
Description: **Tap Factory**

Distance (ft): **102.0**
Structural Grade: **0**
O&M Grade: **0**
Clock Start/From: **2**
Clock To:
1st Value: **4.000**
2nd Value:
Value Percent:
Continuous Index:
Within 8" of Joint:
Remarks:

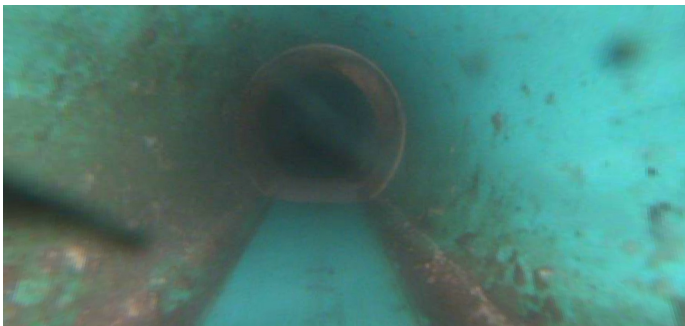
Code: **TF**
Description: **Tap Factory**

Distance (ft): **185.2**
Structural Grade: **0**
O&M Grade: **0**
Clock Start/From: **2**
Clock To:
1st Value: **4.000**
2nd Value:
Value Percent:
Continuous Index:
Within 8" of Joint:
Remarks:

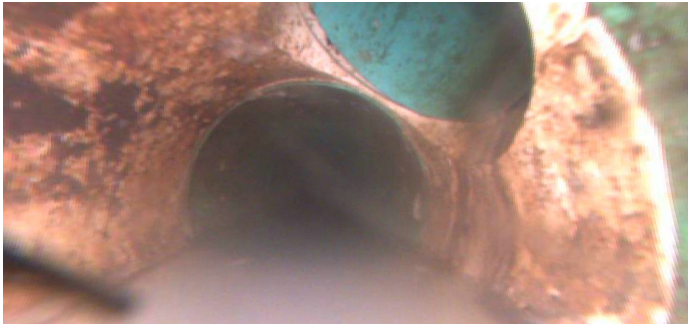
Code: **TF**
Description: **Tap Factory**

Distance (ft): **268.3**
Structural Grade: **0**
O&M Grade: **0**
Clock Start/From: **2**
Clock To:
1st Value: **4.000**
2nd Value:
Value Percent:
Continuous Index:
Within 8" of Joint:
Remarks:

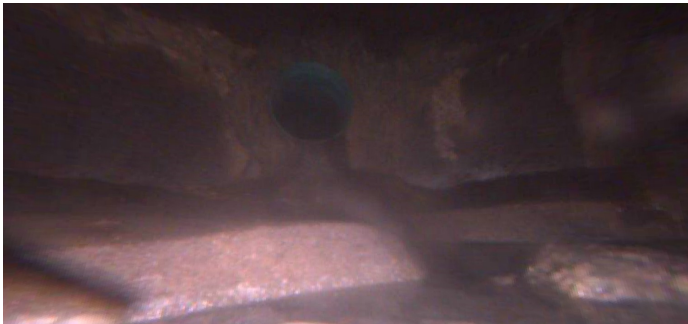
Code: **AMH**
Description: **Manhole**

Distance (ft): **309.5**
Structural Grade: **0**
O&M Grade: **0**
Clock Start/From:
Clock To:
1st Value:
2nd Value:
Value Percent:
Continuous Index:
Within 8" of Joint: **NO**
Remarks: **M-507-050**
