Profile/Photo Observation Report

Street:	Virginia St.	Flow Control:	Not Controlled
City:	Hobart, IN	Year Renewed:	
Location:	Light Highway	Tape/Media #:	
Purpose:	Routine Assessment	Dia/Height:	10"
Use:	Sanitary	Material:	VCP
Drain Area:	NA	Lining:	
Category:	NA		
Comment:

Location Details:		Direction of Survey:	Downstream
US MH:	M-507-049	DS MH:	M-507-050
		Total Length Surveyed (ft):	309.5

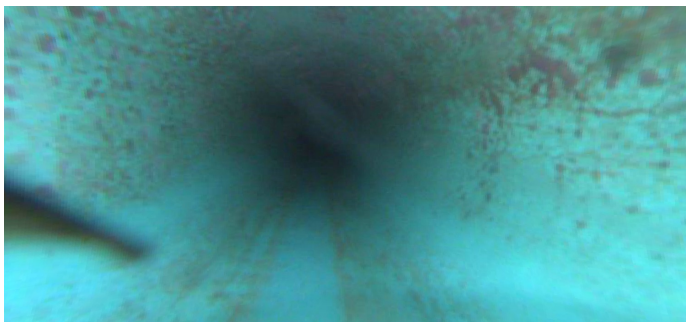
Code: **AMH**
Description: **Manhole**

Distance (ft): **.0**
Structural Grade: **0**
O&M Grade: **0**
Clock Start/From:
Clock To:
1st Value:
2nd Value:
Value Percent:
Continuous Index:
Within 8" of Joint: **NO**
Remarks: **M-507-049**

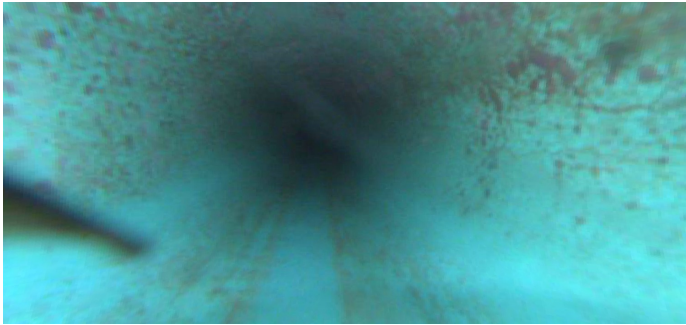
Code:	MWL
Description:	Water Level

Distance (ft):	.0
Structural Grade:	0
O&M Grade:	0
Clock Start/From:	
Clock To:	
1st Value:	
2nd Value:	
Value Percent:	5.000
Continuous Index:	
Within 8" of Joint:	NO
Remarks:

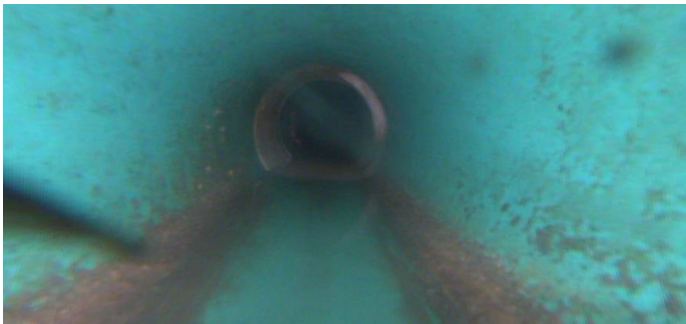
Code:	TF
Description:	Tap Factory

Distance (ft):	33.6
Structural Grade:	0
O&M Grade:	0
Clock Start/From:	2
Clock To:	
1st Value:	4.000
2nd Value:	
Value Percent:	
Continuous Index:	
Within 8" of Joint:	
Remarks:

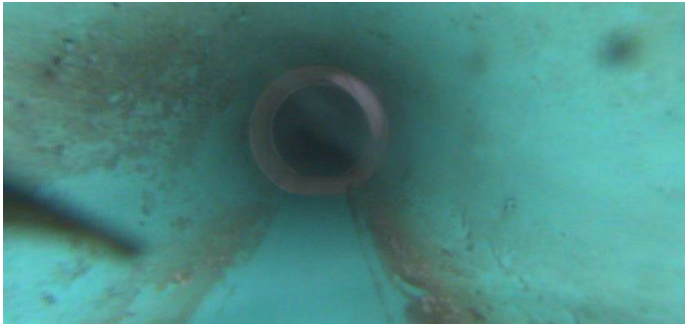
Code: **TF**
Description: **Tap Factory**

Distance (ft): **102.0**
Structural Grade: **0**
O&M Grade: **0**
Clock Start/From: **2**
Clock To:
1st Value: **4.000**
2nd Value:
Value Percent:
Continuous Index:
Within 8" of Joint:
Remarks:

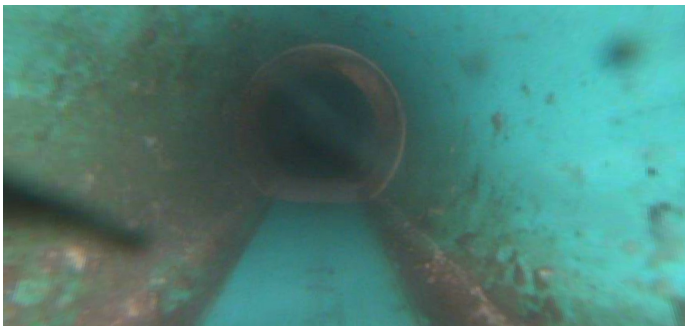
Code: **TF**
Description: **Tap Factory**

Distance (ft): **185.2**
Structural Grade: **0**
O&M Grade: **0**
Clock Start/From: **2**
Clock To:
1st Value: **4.000**
2nd Value:
Value Percent:
Continuous Index:
Within 8" of Joint:
Remarks:

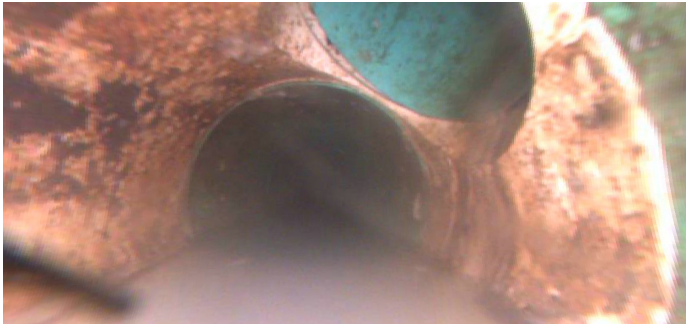
Code: **TF**
Description: **Tap Factory**

Distance (ft): **268.3**
Structural Grade: **0**
O&M Grade: **0**
Clock Start/From: **2**
Clock To:
1st Value: **4.000**
2nd Value:
Value Percent:
Continuous Index:
Within 8" of Joint:
Remarks:

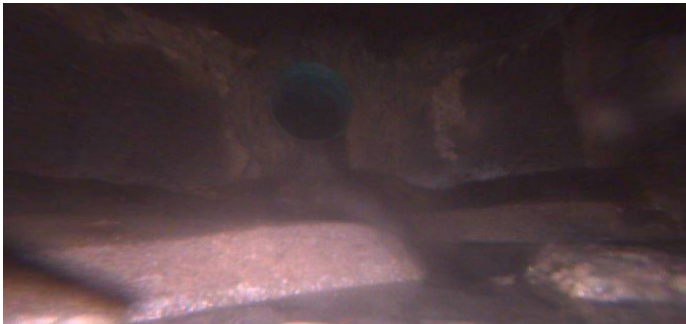
Code: **AMH**
Description: **Manhole**

Distance (ft): **309.5**
Structural Grade: **0**
O&M Grade: **0**
Clock Start/From:
Clock To:
1st Value:
2nd Value:
Value Percent:
Continuous Index:
Within 8" of Joint: **NO**
Remarks: **M-507-050**
