Profile/Photo Observation Report

Date:	12/12/2024	Weather:		Coding:	PACP 7.0
Pipe Length (ft):	166.0	Owner:	City of Hobart	Pre Clean:	Heavy Cleaning
P.O.#:	YES502259	Surveyor:	S. Bucklin	PSR:	P-507-051-050
Customer:	City of Hobart	Clean Date:	12/04/2024	Shape:	C

Street:	South Virginia Street	Flow Control:	Not Controlled
City:	Hobart, IN	Year Renewed:	
Location:	Sidewalk	Tape/Media #:	
Purpose:	Sewer System Evaluation Survey (SS	Dia/Height:	8"
Use:	Sanitary Sewage Pipe	Material:	PVC
Drain Area:		Lining:	None
Category:	NA		
Comment:

Location Details:		Direction of Survey:	Downstream
US MH:	M-507-051	DS MH:	M-507-050
		Total Length Surveyed (ft):	164.9

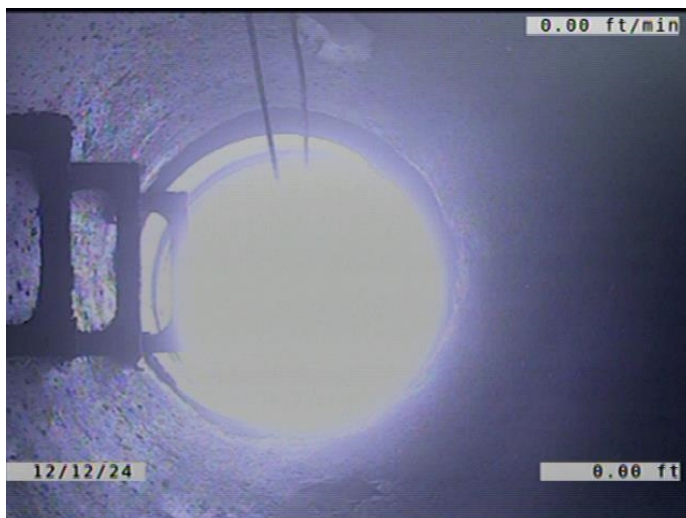
Code: **AMH**
Description: **Manhole**

Distance (ft): **.0**
Structural Grade: **0**
O&M Grade: **0**
Clock Start/From:
Clock To:
1st Value:
2nd Value:
Value Percent:
Continuous Index:
Within 8" of Joint: **NO**
Remarks: **M-507-051**

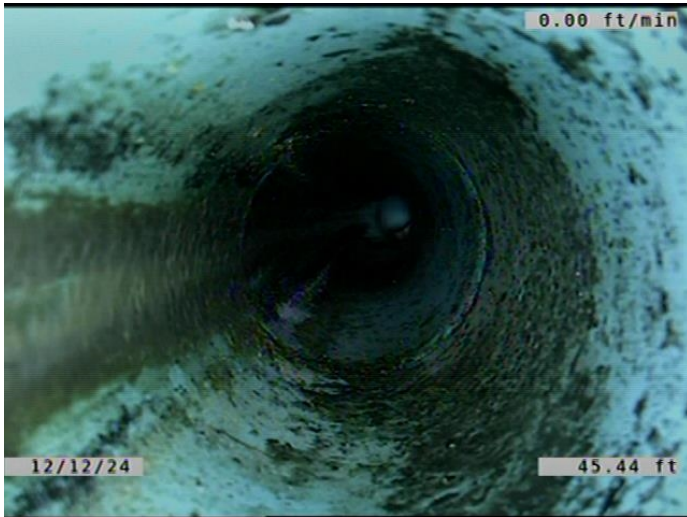
Code:	TFA
Description:	Tap Factory Activity
Distance (ft):	45.4
Structural Grade:	0
O&M Grade:	0
Clock Start/From:	10
Clock To:	
1st Value:	6.000
2nd Value:	
Value Percent:	
Continuous Index:	
Within 8" of Joint:	NO
Remarks:	CONSTANTLY RUNNING WATER.

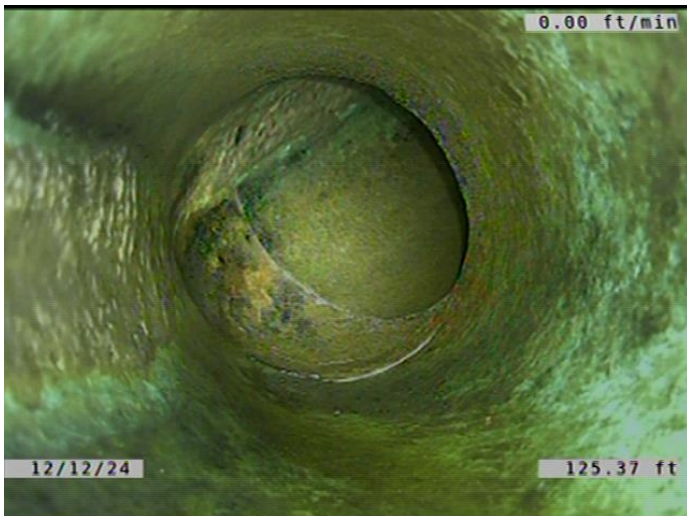
Code:	TF
Description:	Tap Factory
Distance (ft):	125.4
Structural Grade:	0
O&M Grade:	0
Clock Start/From:	10
Clock To:	
1st Value:	6.000
2nd Value:	
Value Percent:	
Continuous Index:	
Within 8" of Joint:	NO
Remarks:
