## Profile/Photo Observation Report

Street:	<b>FOXCROFT STREET</b>	Flow Control:	<b>Not Controlled</b>
City:	<b>Hobart, IN</b>	Year Renewed:	
Location:	<b>Light Highway</b>	Tape/Media #:	
Purpose:	<b>Routine Assessment</b>	Dia/Height:	<b>8"</b>
Use:	<b>Sanitary</b>	Material:	<b>PVC</b>
Drain Area:	<b>NA</b>	Lining:	
Category:	<b>NA</b>		
Comment:	<b>M-507-069 is a lift station</b>

Location Details:		Direction of Survey:	<b>Downstream</b>
US MH:	<b>M-507-050</b>	DS MH:	<b>M-507-069</b>
		Total Length Surveyed (ft):	<b>165.7</b>

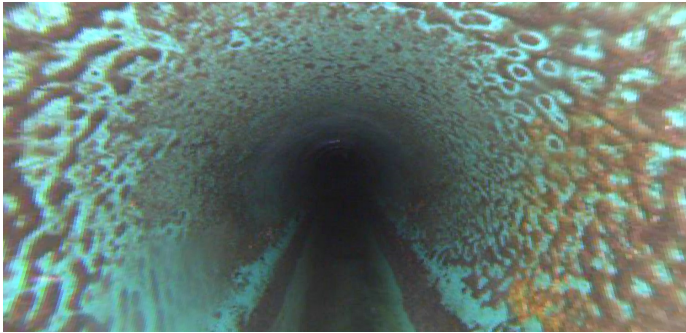
Code:	<b>MWL</b>
Description:	<b>Water Level</b>

Distance (ft):	<b>.0</b>
Structural Grade:	<b>0</b>
O&M Grade:	<b>0</b>
Clock Start/From:	
Clock To:	
1st Value:	
2nd Value:	
Value Percent:	<b>5.000</b>
Continuous Index:	
Within 8" of Joint:	<b>NO</b>
Remarks:

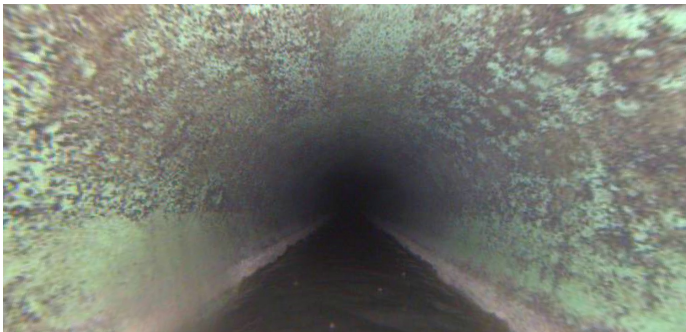
Code:	<b>MWL</b>
Description:	<b>Water Level</b>

Distance (ft):	<b>125.8</b>
Structural Grade:	<b>0</b>
O&M Grade:	<b>0</b>
Clock Start/From:	
Clock To:	
1st Value:	
2nd Value:	
Value Percent:	<b>15.000</b>
Continuous Index:	
Within 8" of Joint:	<b>NO</b>
Remarks:
