Profile/Photo Observation Report

Street:	FOXCROFT STREET	Flow Control:	Not Controlled
City:	Hobart, IN	Year Renewed:	
Location:	Light Highway	Tape/Media #:	
Purpose:	Routine Assessment	Dia/Height:	8"
Use:	Sanitary	Material:	PVC
Drain Area:	NA	Lining:	
Category:	NA		
Comment:

Location Details:		Direction of Survey:	Downstream
US MH:	M-507-052	DS MH:	M-507-053
		Total Length Surveyed (ft):	197.7

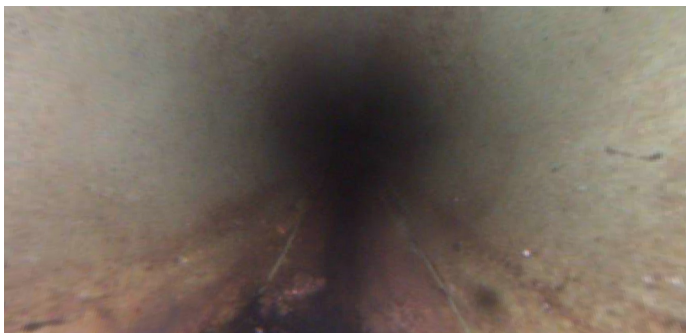
Code: **AMH**
Description: **Manhole**

Distance (ft): **.0**
Structural Grade: **0**
O&M Grade: **0**
Clock Start/From:
Clock To:
1st Value:
2nd Value:
Value Percent:
Continuous Index:
Within 8" of Joint: **NO**
Remarks: **M-507-052**

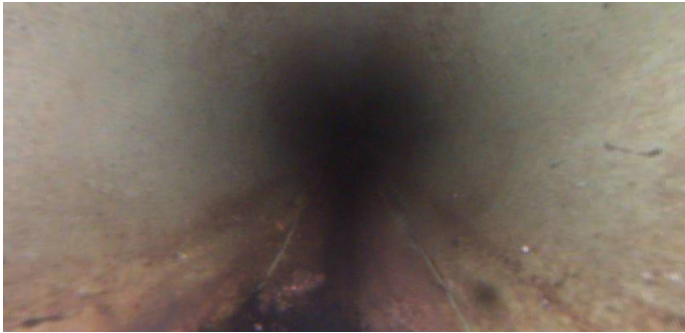
Code:	MWL
Description:	Water Level

Distance (ft):	.0
Structural Grade:	0
O&M Grade:	0
Clock Start/From:	
Clock To:	
1st Value:	
2nd Value:	
Value Percent:	5.000
Continuous Index:	
Within 8" of Joint:	NO
Remarks:

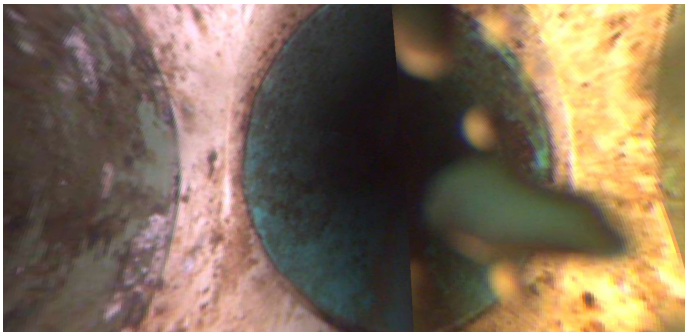
Code:	TF
Description:	Tap Factory

Distance (ft):	47.4
Structural Grade:	0
O&M Grade:	0
Clock Start/From:	2
Clock To:	
1st Value:	4.000
2nd Value:	
Value Percent:	
Continuous Index:	
Within 8" of Joint:	
Remarks:

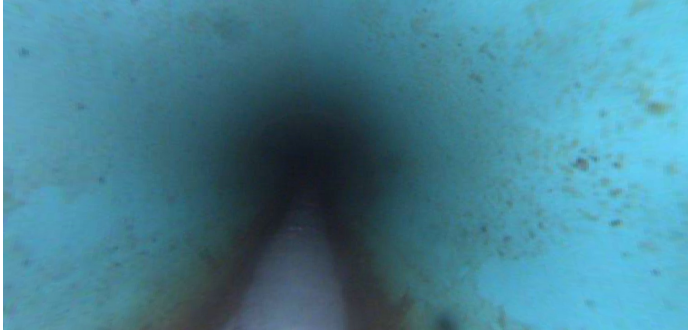
Code:	MGO
Description:	General Observation
Distance (ft):	97.9
Structural Grade:	0
O&M Grade:	0
Clock Start/From:	
Clock To:	
1st Value:	
2nd Value:	
Value Percent:	
Continuous Index:	
Within 8" of Joint:	NO
Remarks:	SOAP SUDS

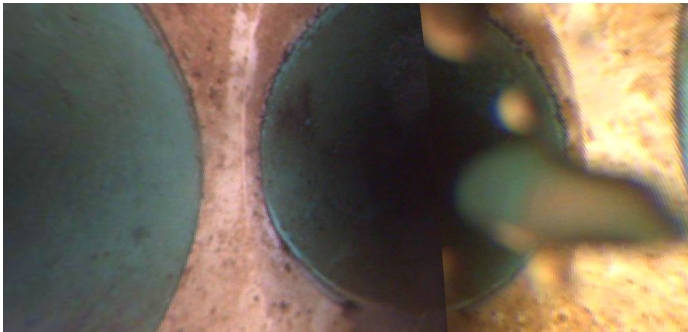
Code:	TF
Description:	Tap Factory
Distance (ft):	112.7
Structural Grade:	0
O&M Grade:	0
Clock Start/From:	3
Clock To:	
1st Value:	4.000
2nd Value:	
Value Percent:	
Continuous Index:	
Within 8" of Joint:	
Remarks:

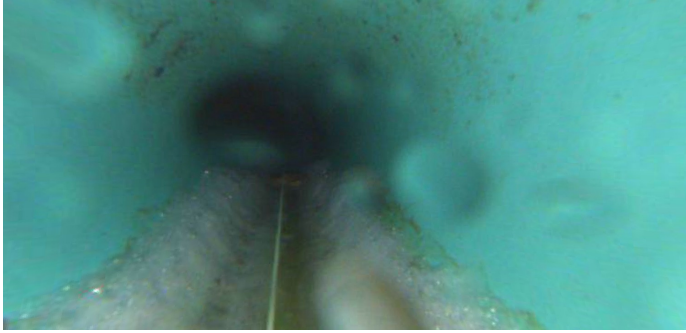
Code: **MGO**
Description: **General Observation**

Distance (ft): **130.0**
Structural Grade: **0**
O&M Grade: **0**
Clock Start/From:
Clock To:
1st Value:
2nd Value:
Value Percent:
Continuous Index:
Within 8" of Joint: **NO**
Remarks: **REAR CAMERA**

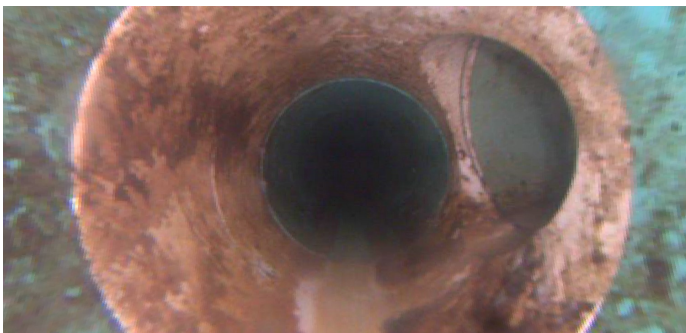
Code: **TF**
Description: **Tap Factory**

Distance (ft): **178.0**
Structural Grade: **0**
O&M Grade: **0**
Clock Start/From: **3**
Clock To:
1st Value: **4.000**
2nd Value:
Value Percent:
Continuous Index:
Within 8" of Joint:
Remarks:

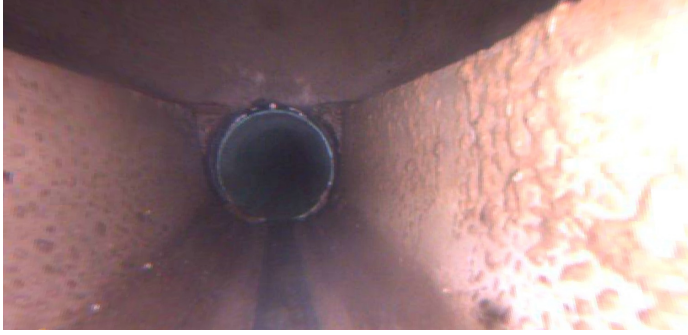
Code:	AMH
Description:	Manhole
Distance (ft):	197.7
Structural Grade:	0
O&M Grade:	0
Clock Start/From:	
Clock To:	
1st Value:	
2nd Value:	
Value Percent:	
Continuous Index:	
Within 8" of Joint:	NO
Remarks:	M-507-053
