Profile/Photo Observation Report

Date:	03/26/2018	Weather:		Coding:	PACP 6.0
Pipe Length (ft):	229.9	Owner:	NA	Pre Clean:	No Pre-Cleaning
P.O.#:		Surveyor:	Justin Gonzales	PSR:	P-507-053-054
Customer:		Clean Date:	01/01/1900	Shape:	C

Street:	FOXCROFT STREET	Flow Control:	Not Controlled
City:	Hobart, IN	Year Renewed:	
Location:	Light Highway	Tape/Media #:	
Purpose:	Routine Assessment	Dia/Height:	8"
Use:	Sanitary	Material:	PVC
Drain Area:	NA	Lining:	
Category:	NA		
Comment:			
Location Details:		Direction of Survey:	Upstream
US MH:	M-507-053	DS MH:	M-507-054
		Total Length Surveyed (ft):	229.2

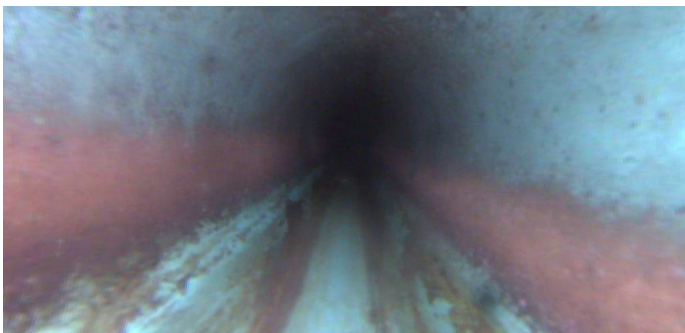
Code: **AMH**
Description: **Manhole**

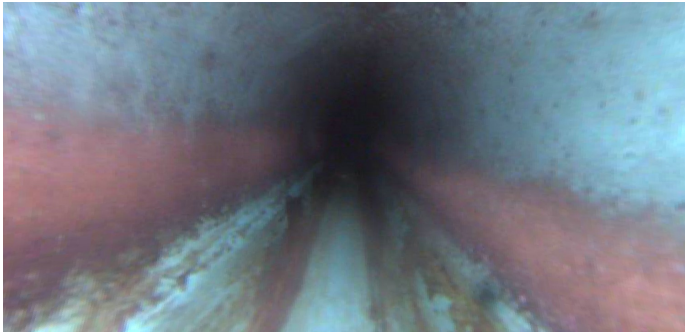
Code:	MWL
Description:	Water Level

Distance (ft):	.0
Structural Grade:	0
O&M Grade:	0
Clock Start/From:	
Clock To:	
1st Value:	
2nd Value:	
Value Percent:	5.000
Continuous Index:	
Within 8" of Joint:	NO
Remarks:

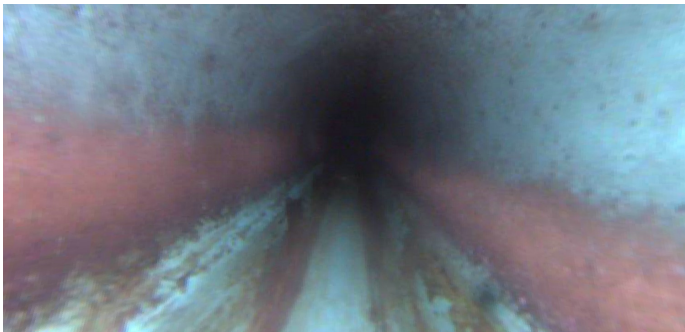
Code:	DAZ
Description:	Deposits Attached Other

Distance (ft):	.0
Structural Grade:	0
O&M Grade:	2
Clock Start/From:	7
Clock To:	5
1st Value:	
2nd Value:	
Value Percent:	5.000
Continuous Index:	S01
Within 8" of Joint:	YES
Remarks:	WANDER

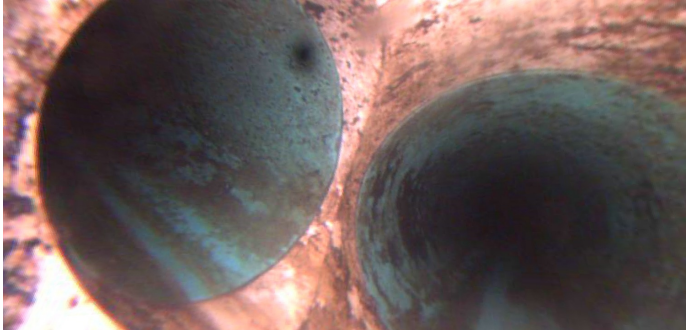
Code: **TF**
Description: **Tap Factory**

Distance (ft): **16.9**
Structural Grade: **0**
O&M Grade: **0**
Clock Start/From: **9**
Clock To:
1st Value: **4.000**
2nd Value:
Value Percent:
Continuous Index:
Within 8" of Joint:
Remarks:

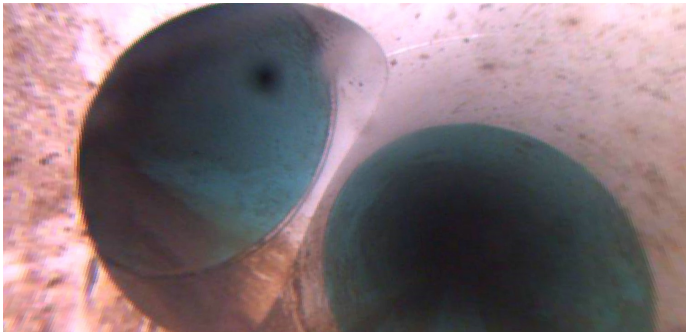
Code: **TF**
Description: **Tap Factory**

Distance (ft): **86.4**
Structural Grade: **0**
O&M Grade: **0**
Clock Start/From: **10**
Clock To:
1st Value: **4.000**
2nd Value:
Value Percent:
Continuous Index:
Within 8" of Joint:
Remarks:

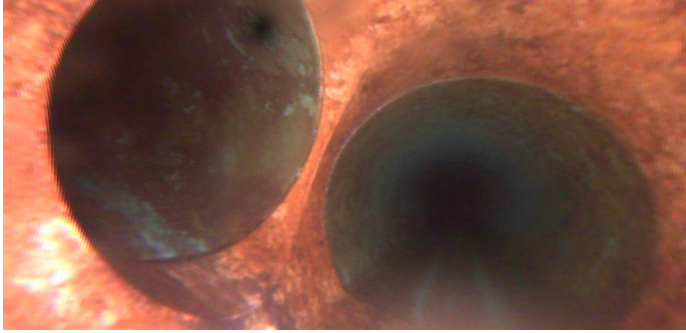
Code: **TF**
Description: **Tap Factory**

Distance (ft): **165.3**
Structural Grade: **0**
O&M Grade: **0**
Clock Start/From: **10**
Clock To:
1st Value: **4.000**
2nd Value:
Value Percent:
Continuous Index:
Within 8" of Joint:
Remarks:

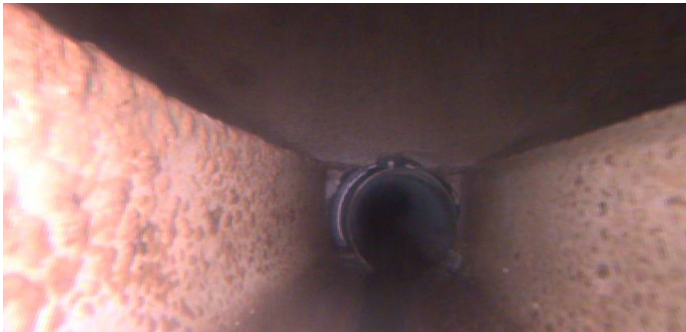
Code: **AMH**
Description: **Manhole**

Distance (ft): **229.2**
Structural Grade: **0**
O&M Grade: **0**
Clock Start/From:
Clock To:
1st Value:
2nd Value:
Value Percent:
Continuous Index:
Within 8" of Joint: **NO**
Remarks: **M-507-053**

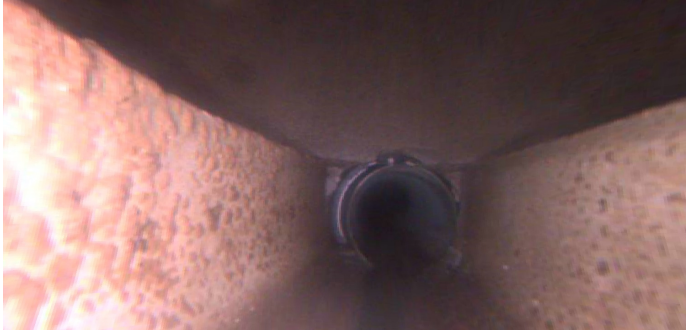
Code:	DAZ
Description:	Deposits Attached Other
Distance (ft):	229.2
Structural Grade:	0
O&M Grade:	2
Clock Start/From:	7
Clock To:	5
1st Value:	
2nd Value:	
Value Percent:	5.000
Continuous Index:	F01
Within 8" of Joint:	YES
Remarks:	WANDER
