Profile/Photo Observation Report

Street:	West 11th Street	Flow Control:	Not Controlled
City:	Hobart, IN	Year Renewed:	
Location:	Light Highway	Tape/Media #:	DEP288
Purpose:	Routine Assessment	Dia/Height:	12"
Use:	Sanitary	Material:	PVC
Drain Area:		Lining:	
Category:	NA		
Comment:	5-21-2018

Location Details:		Direction of Survey:	Downstream
US MH:	M-507-055	DS MH:	M-507-041
		Total Length Surveyed (ft):	131.9

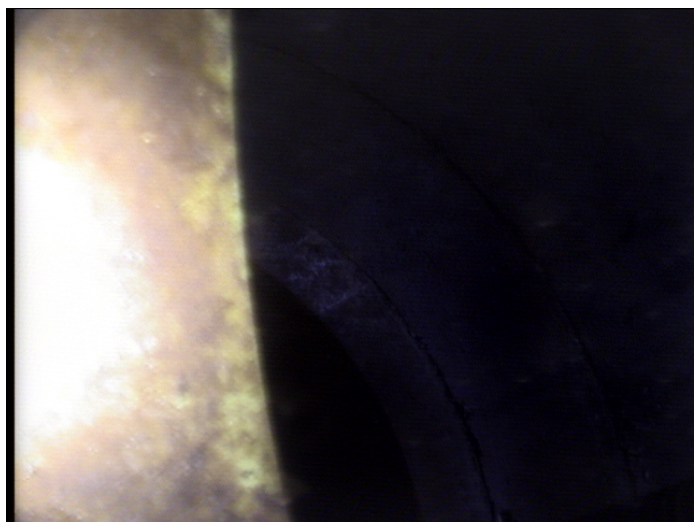
Code: **AMH**
Description: **Manhole**

Distance (ft): **.0**
Structural Grade: **0**
O&M Grade: **0**
Clock Start/From:
Clock To:
1st Value:
2nd Value:
Value Percent:
Continuous Index:
Within 8" of Joint: **NO**
Remarks: **M-507-055**

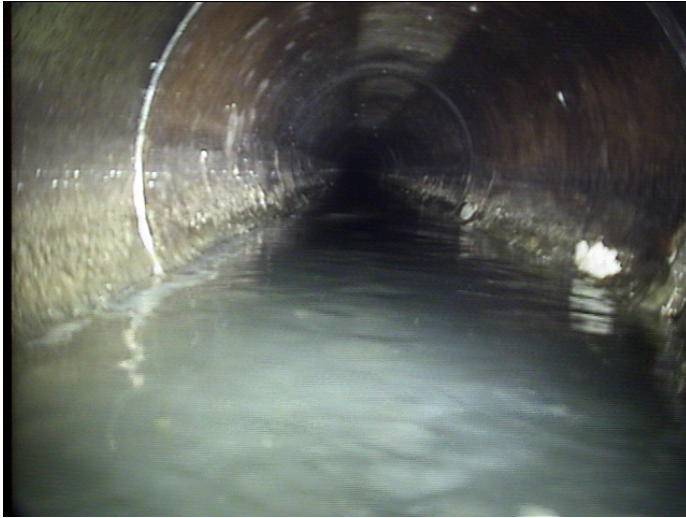
Code: **MWL**
Description: **Water Level**

Distance (ft): **.0**
Structural Grade: **0**
O&M Grade: **0**
Clock Start/From:
Clock To:
1st Value:
2nd Value:
Value Percent: **20.000**
Continuous Index:
Within 8" of Joint: **NO**
Remarks:

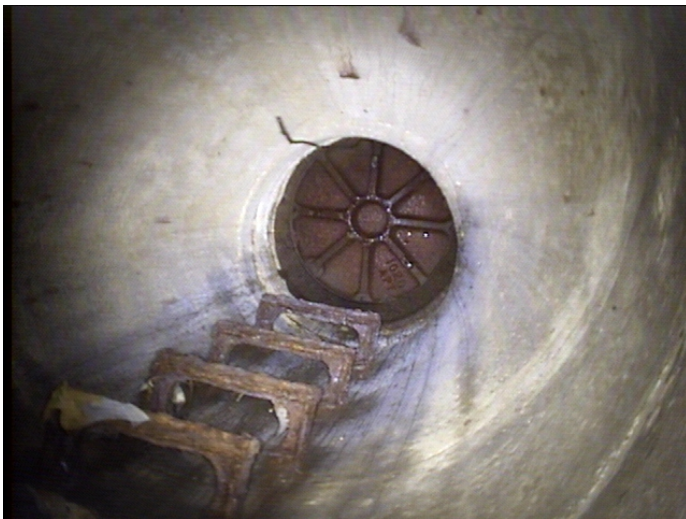
Code: **AMH**
Description: **Manhole**

Distance (ft): **131.9**
Structural Grade: **0**
O&M Grade: **0**
Clock Start/From:
Clock To:
1st Value:
2nd Value:
Value Percent:
Continuous Index:
Within 8" of Joint: **NO**
Remarks: **M-507-041**
