## Profile/Photo Observation Report

Date:	<b>04/13/2018</b>	Weather:		Coding:	<b>PACP 6.0</b>
Pipe Length (ft):	<b>217.8</b>	Owner:	<b>NA</b>	Pre Clean:	<b>No Pre-Cleaning</b>
P.O.#:		Surveyor:	<b>John Kuglmaier</b>	PSR:	<b>P-507-056-055</b>
Customer:		Clean Date:	<b>01/01/1900</b>	Shape:	<b>C</b>

Street:	<b>W 11TH ST</b>	Flow Control:	<b>Not Controlled</b>
City:	<b>Hobart, IN</b>	Year Renewed:	
Location:	<b>Yard</b>	Tape/Media #:	
Purpose:	<b>Routine Assessment</b>	Dia/Height:	<b>8"</b>
Use:	<b>Sanitary</b>	Material:	<b>PVC</b>
Drain Area:	<b>NA</b>	Lining:	
Category:	<b>NA</b>		
Comment:	<b>Flow direction is marked wrong.</b>		
Location Details:		Direction of Survey:	<b>Downstream</b>
US MH:	<b>M-507-055</b>	DS MH:	<b>M-507-056</b>
		Total Length Surveyed (ft):	<b>210.7</b>

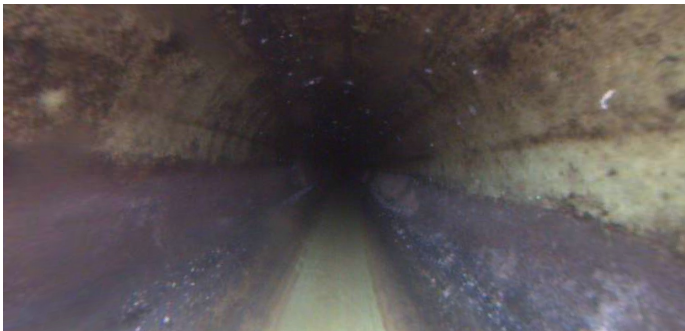
Code: **AMH**  
Description: **Manhole**

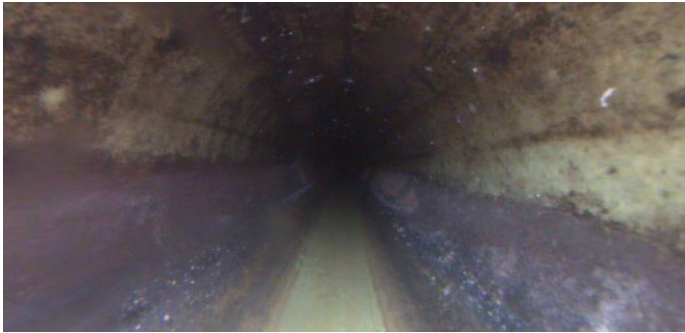
Code:	<b>MWL</b>
Description:	<b>Water Level</b>

Distance (ft):	<b>.0</b>
Structural Grade:	<b>0</b>
O&M Grade:	<b>0</b>
Clock Start/From:	
Clock To:	
1st Value:	
2nd Value:	
Value Percent:	<b>5.000</b>
Continuous Index:	
Within 8" of Joint:	<b>NO</b>
Remarks:

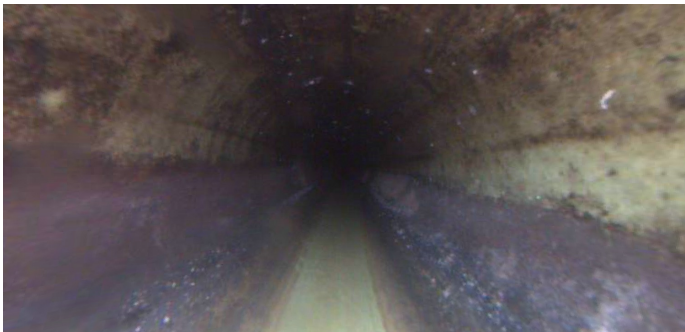
Code:	<b>DAGS</b>
Description:	<b>Deposits Attached Grease</b>

Distance (ft):	<b>.0</b>
Structural Grade:	<b>0</b>
O&M Grade:	<b>2</b>
Clock Start/From:	<b>7</b>
Clock To:	<b>5</b>
1st Value:	
2nd Value:	
Value Percent:	<b>5.000</b>
Continuous Index:	<b>S01</b>
Within 8" of Joint:	<b>NO</b>
Remarks:

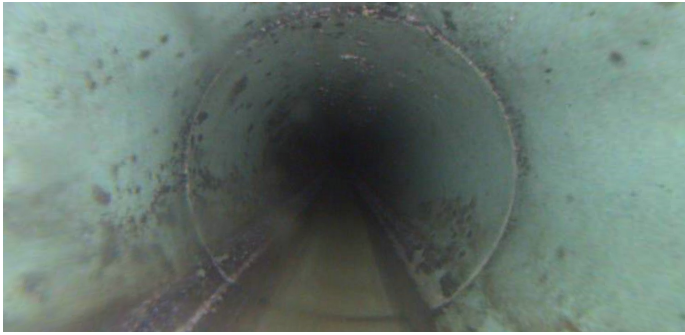
Code: **DAGS**  
Description: **Deposits Attached Grease**

Distance (ft): **49.7**  
Structural Grade: **0**  
O&M Grade: **2**  
Clock Start/From: **7**  
Clock To: **5**  
1st Value:  
2nd Value:  
Value Percent: **5.000**  
Continuous Index: **F01**  
Within 8" of Joint: **NO**  
Remarks:

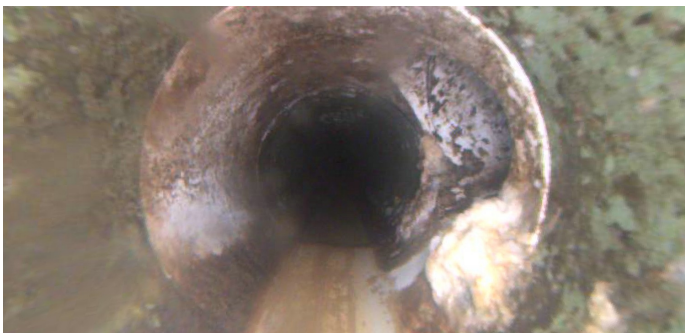
Code: **DAGS**  
Description: **Deposits Attached Grease**

Distance (ft): **69.3**  
Structural Grade: **0**  
O&M Grade: **2**  
Clock Start/From: **3**  
Clock To: **4**  
1st Value:  
2nd Value:  
Value Percent: **5.000**  
Continuous Index:  
Within 8" of Joint: **NO**  
Remarks:

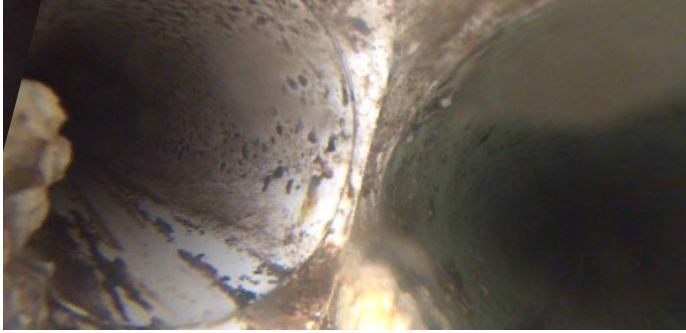
Code: **TF**  
Description: **Tap Factory**

Distance (ft): **70.2**  
Structural Grade: **0**  
O&M Grade: **0**  
Clock Start/From: **3**  
Clock To:  
1st Value: **4.000**  
2nd Value:  
Value Percent:  
Continuous Index:  
Within 8" of Joint:  
Remarks:

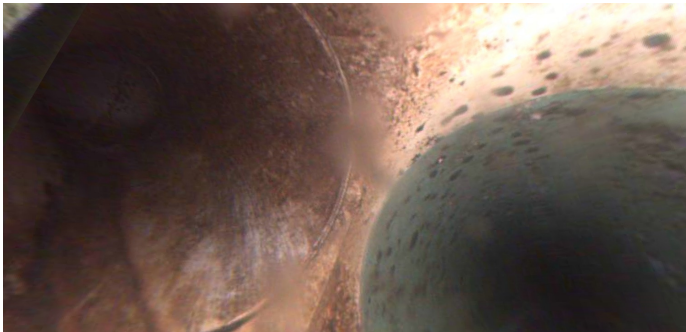
Code: **TF**  
Description: **Tap Factory**

Distance (ft): **78.0**  
Structural Grade: **0**  
O&M Grade: **0**  
Clock Start/From: **10**  
Clock To:  
1st Value: **4.000**  
2nd Value:  
Value Percent:  
Continuous Index:  
Within 8" of Joint:  
Remarks:

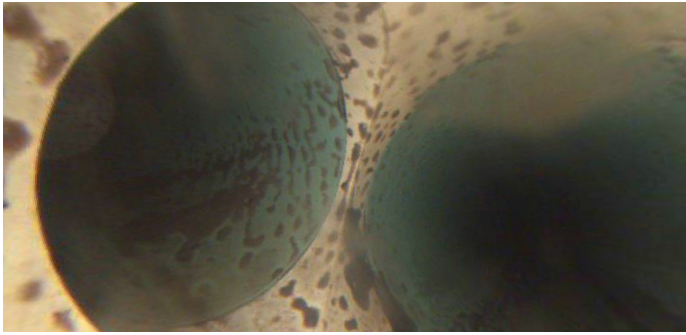
Code: **TFC**  
Description: **Tap Factory Capped**

Distance (ft): **161.3**  
Structural Grade: **0**  
O&M Grade: **0**  
Clock Start/From: **3**  
Clock To:  
1st Value: **4.000**  
2nd Value:  
Value Percent:  
Continuous Index:  
Within 8" of Joint:  
Remarks:

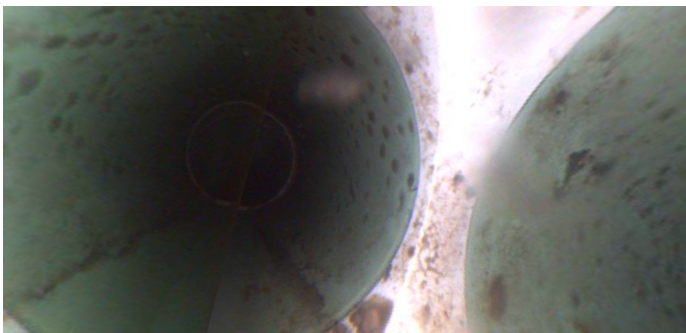
Code: **TF**  
Description: **Tap Factory**

Distance (ft): **168.0**  
Structural Grade: **0**  
O&M Grade: **0**  
Clock Start/From: **10**  
Clock To:  
1st Value: **4.000**  
2nd Value:  
Value Percent:  
Continuous Index:  
Within 8" of Joint:  
Remarks:

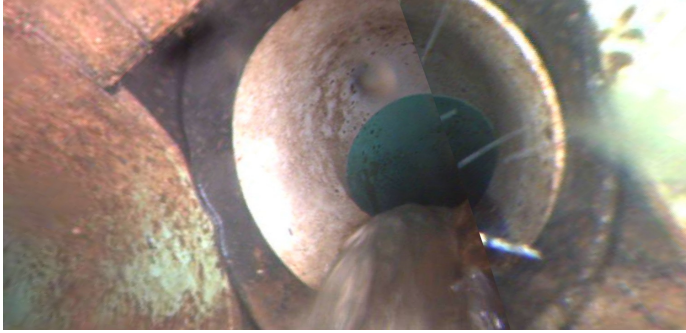
Code: **TBA**  
Description: **Tap Break-in Active**

Distance (ft): **177.9**  
Structural Grade: **0**  
O&M Grade: **0**  
Clock Start/From: **2**  
Clock To:  
1st Value: **4.000**  
2nd Value:  
Value Percent:  
Continuous Index:  
Within 8" of Joint:  
Remarks:

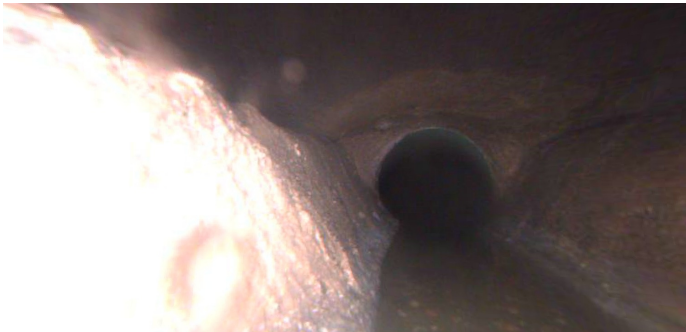
Code: **AMH**  
Description: **Manhole**

Distance (ft): **210.7**  
Structural Grade: **0**  
O&M Grade: **0**  
Clock Start/From:  
Clock To:  
1st Value:  
2nd Value:  
Value Percent:  
Continuous Index:  
Within 8" of Joint: **NO**  
Remarks: **M-507-056**
