## Profile/Photo Observation Report

Date:	<b>03/29/2018</b>	Weather:		Coding:	<b>PACP 6.0</b>
Pipe Length (ft):	<b>312.6</b>	Owner:	<b>NA</b>	Pre Clean:	<b>No Pre-Cleaning</b>
P.O.#:		Surveyor:	<b>Jen Costello</b>	PSR:	<b>P-507-060-059</b>
Customer:		Clean Date:	<b>01/01/1900</b>	Shape:	<b>C</b>

Street:	<b>ALLEY BETWEEN S VIRGINIA ST &amp; S</b>	Flow Control:	<b>Not Controlled</b>
City:	<b>Hobart, IN</b>	Year Renewed:	
Location:	<b>Yard</b>	Tape/Media #:	
Purpose:	<b>Routine Assessment</b>	Dia/Height:	<b>8"</b>
Use:	<b>Sanitary</b>	Material:	<b>PVC</b>
Drain Area:	<b>NA</b>	Lining:	
Category:	<b>NA</b>		
Comment:	<b>R_M at 294 ft debris . Flow direction wrong</b>		
Location Details:		Direction of Survey:	<b>Downstream</b>
US MH:	<b>M-507-059</b>	DS MH:	<b>M-507-060</b>
		Total Length Surveyed (ft):	<b>295.9</b>

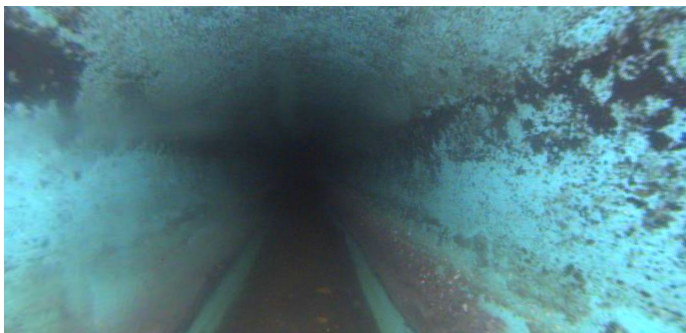
Code: **AMH**  
Description: **Manhole**

Distance (ft): **.0**  
Structural Grade: **0**  
O&M Grade: **0**  
Clock Start/From:  
Clock To:  
1st Value:  
2nd Value:  
Value Percent:  
Continuous Index:  
Within 8" of Joint: **NO**  
Remarks: **M-507-059**

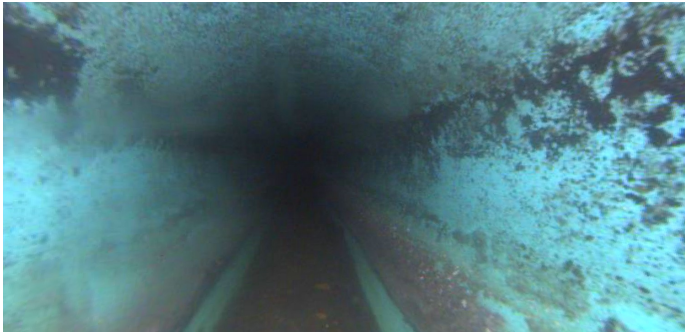
Code:	<b>MWL</b>
Description:	<b>Water Level</b>

Distance (ft):	<b>.0</b>
Structural Grade:	<b>0</b>
O&M Grade:	<b>0</b>
Clock Start/From:	
Clock To:	
1st Value:	
2nd Value:	
Value Percent:	<b>5.000</b>
Continuous Index:	
Within 8" of Joint:	<b>NO</b>
Remarks:

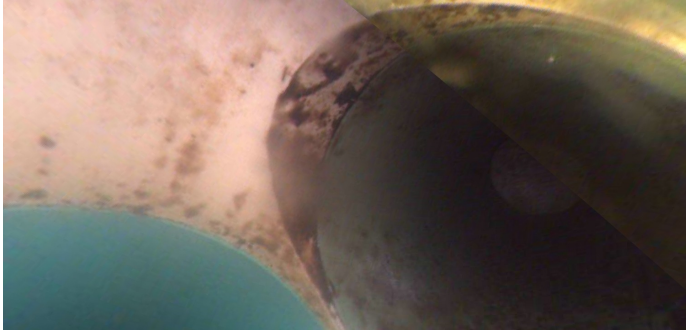
Code: **TF**  
Description: **Tap Factory**

Distance (ft): **28.3**  
Structural Grade: **0**  
O&M Grade: **0**  
Clock Start/From: **2**  
Clock To:  
1st Value: **4.000**  
2nd Value:  
Value Percent:  
Continuous Index:  
Within 8" of Joint:  
Remarks:

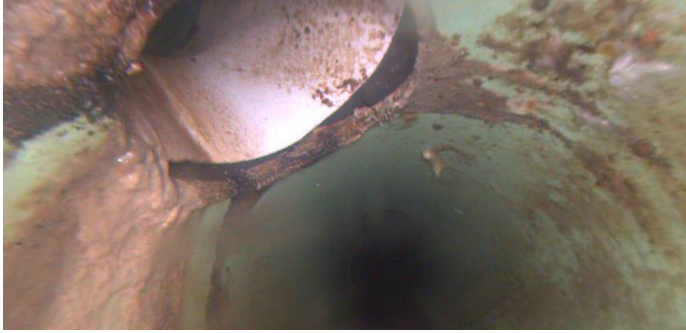
Code: **TS**  
Description: **Tap Saddle**

Distance (ft): **257.2**  
Structural Grade: **0**  
O&M Grade: **0**  
Clock Start/From: **11**  
Clock To:  
1st Value: **4.000**  
2nd Value:  
Value Percent:  
Continuous Index:  
Within 8" of Joint:  
Remarks:

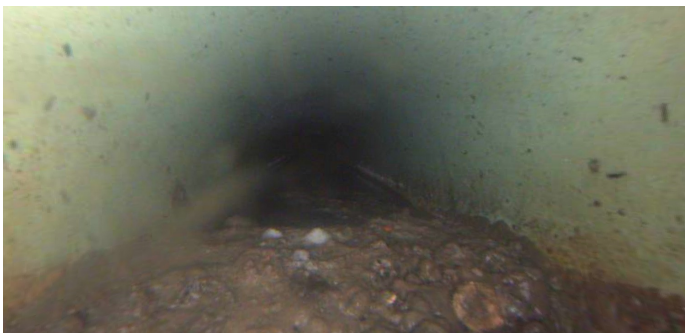
Code: **DSGV**  
Description: **Deposits Settled Gravel**

Distance (ft): **295.2**  
Structural Grade: **0**  
O&M Grade: **5**  
Clock Start/From: **3**  
Clock To: **9**  
1st Value:  
2nd Value:  
Value Percent: **40.000**  
Continuous Index:  
Within 8" of Joint: **NO**  
Remarks:

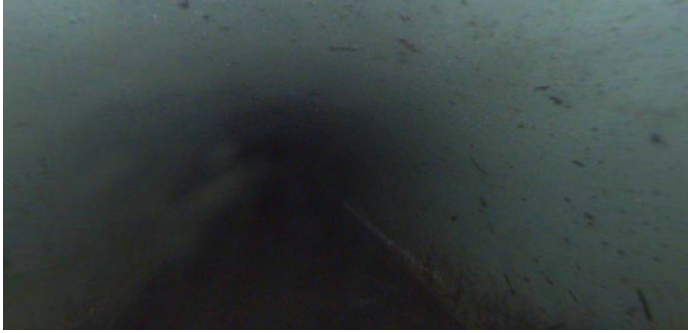
Code:	<b>MSA</b>
Description:	<b>Abandoned Survey</b>
Distance (ft):	<b>295.9</b>
Structural Grade:	<b>0</b>
O&M Grade:	<b>0</b>
Clock Start/From:	
Clock To:	
1st Value:	
2nd Value:	
Value Percent:	
Continuous Index:	
Within 8" of Joint:	<b>NO</b>
Remarks:	<b>ROCKS</b>
