Profile/Photo Observation Report

Street:	FOXCROFT STREET	Flow Control:	Not Controlled
City:	Hobart, IN	Year Renewed:	
Location:	Yard	Tape/Media #:	
Purpose:	Routine Assessment	Dia/Height:	8"
Use:	Sanitary	Material:	PVC
Drain Area:	NA	Lining:	
Category:	NA		
Comment:	R_M at 294 ft debris . Flow direction wrong		
Location Details:		Direction of Survey:	Downstream
US MH:	M-507-059	DS MH:	M-507-060
		Total Length Surveyed (ft):	295.9

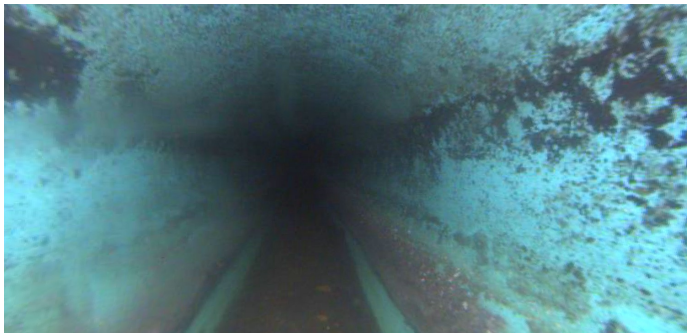
Code:	MWL
Description:	Water Level

Distance (ft):	.0
Structural Grade:	0
O&M Grade:	0
Clock Start/From:	
Clock To:	
1st Value:	
2nd Value:	
Value Percent:	5.000
Continuous Index:	
Within 8" of Joint:	NO
Remarks:

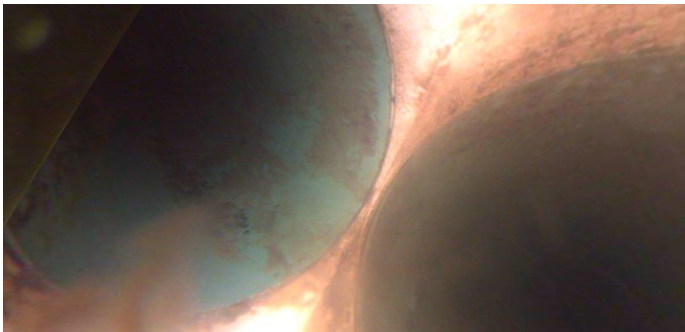
Code:	TF
Description:	Tap Factory

Distance (ft):	24.1
Structural Grade:	0
O&M Grade:	0
Clock Start/From:	10
Clock To:	
1st Value:	4.000
2nd Value:	
Value Percent:	
Continuous Index:	
Within 8" of Joint:	
Remarks:

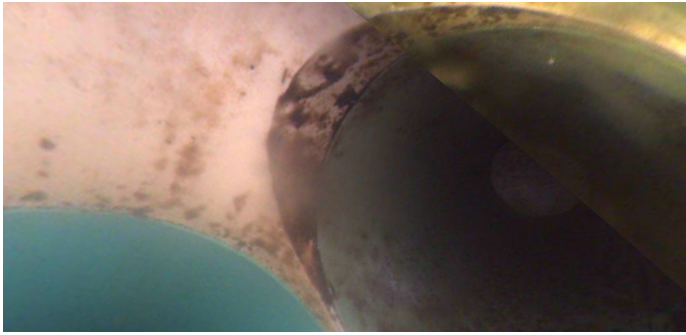
Code: **TF**
Description: **Tap Factory**

Distance (ft): **28.3**
Structural Grade: **0**
O&M Grade: **0**
Clock Start/From: **2**
Clock To:
1st Value: **4.000**
2nd Value:
Value Percent:
Continuous Index:
Within 8" of Joint:
Remarks:

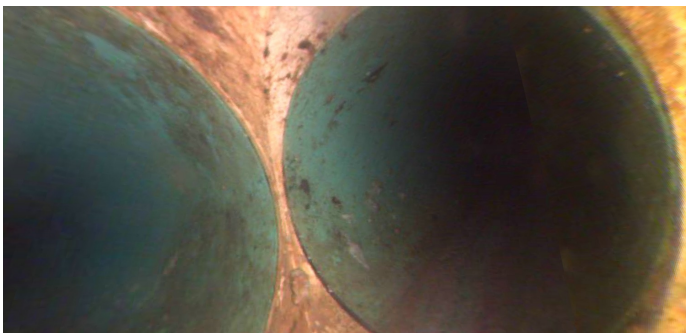
Code: **TF**
Description: **Tap Factory**

Distance (ft): **79.4**
Structural Grade: **0**
O&M Grade: **0**
Clock Start/From: **3**
Clock To:
1st Value: **4.000**
2nd Value:
Value Percent:
Continuous Index:
Within 8" of Joint:
Remarks:

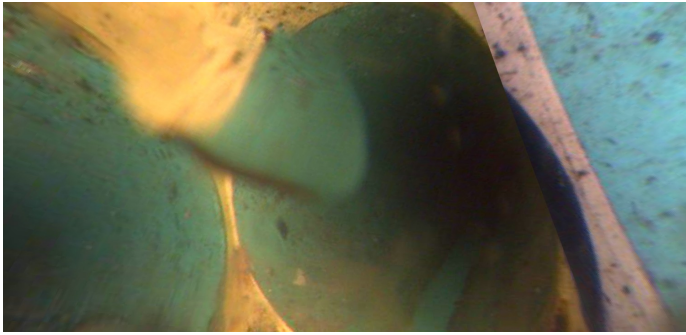
Code: **TF**
Description: **Tap Factory**

Distance (ft): **105.6**
Structural Grade: **0**
O&M Grade: **0**
Clock Start/From: **10**
Clock To:
1st Value: **4.000**
2nd Value:
Value Percent:
Continuous Index:
Within 8" of Joint:
Remarks:

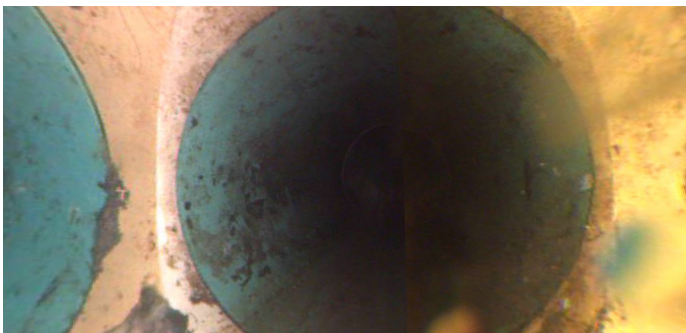
Code: **TFC**
Description: **Tap Factory Capped**

Distance (ft): **156.7**
Structural Grade: **0**
O&M Grade: **0**
Clock Start/From: **3**
Clock To:
1st Value: **4.000**
2nd Value:
Value Percent:
Continuous Index:
Within 8" of Joint:
Remarks:

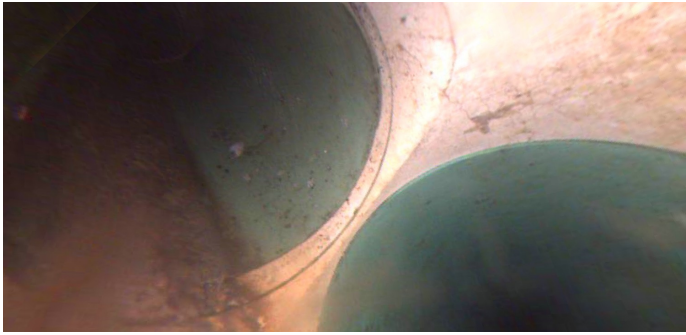
Code: **TFA**
Description: **Tap Factory Active**

Distance (ft): **168.8**
Structural Grade: **0**
O&M Grade: **0**
Clock Start/From: **10**
Clock To:
1st Value: **4.000**
2nd Value:
Value Percent:
Continuous Index:
Within 8" of Joint:
Remarks:

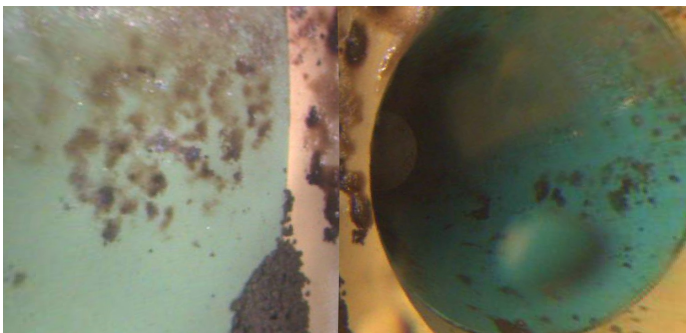
Code: **TFC**
Description: **Tap Factory Capped**

Distance (ft): **233.9**
Structural Grade: **0**
O&M Grade: **0**
Clock Start/From: **3**
Clock To:
1st Value: **4.000**
2nd Value:
Value Percent:
Continuous Index:
Within 8" of Joint:
Remarks:

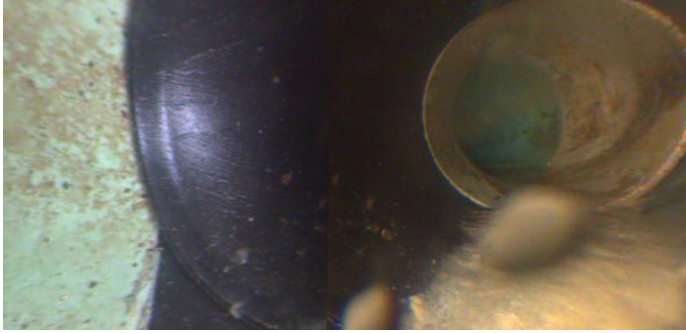
Code: **TS**
Description: **Tap Saddle**

Distance (ft): **244.6**
Structural Grade: **0**
O&M Grade: **0**
Clock Start/From: **3**
Clock To:
1st Value: **4.000**
2nd Value:
Value Percent:
Continuous Index:
Within 8" of Joint:
Remarks:

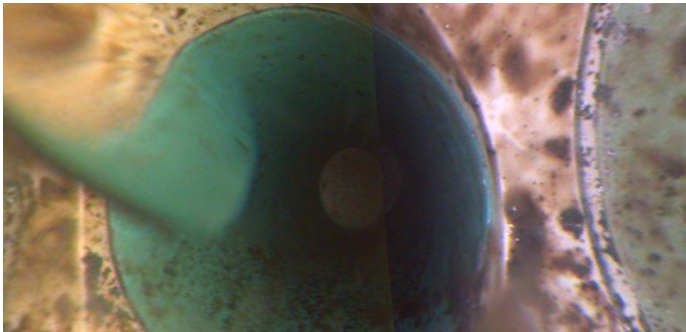
Code: **TFC**
Description: **Tap Factory Capped**

Distance (ft): **253.5**
Structural Grade: **0**
O&M Grade: **0**
Clock Start/From: **10**
Clock To:
1st Value: **4.000**
2nd Value:
Value Percent:
Continuous Index:
Within 8" of Joint:
Remarks:

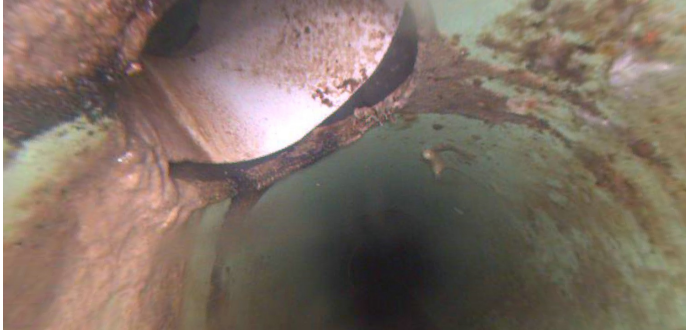
Code: **TS**
Description: **Tap Saddle**

Distance (ft): **257.2**
Structural Grade: **0**
O&M Grade: **0**
Clock Start/From: **11**
Clock To:
1st Value: **4.000**
2nd Value:
Value Percent:
Continuous Index:
Within 8" of Joint:
Remarks:

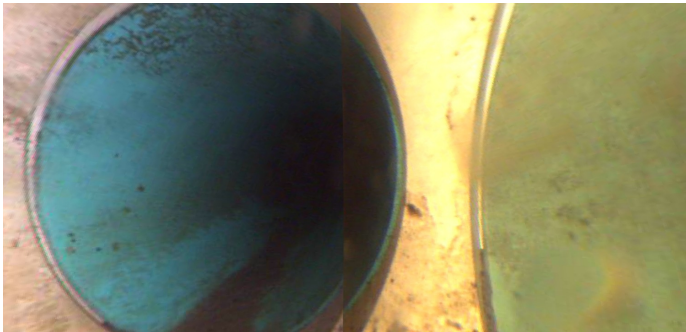
Code: **TF**
Description: **Tap Factory**

Distance (ft): **291.8**
Structural Grade: **0**
O&M Grade: **0**
Clock Start/From: **3**
Clock To:
1st Value: **4.000**
2nd Value:
Value Percent:
Continuous Index:
Within 8" of Joint:
Remarks:

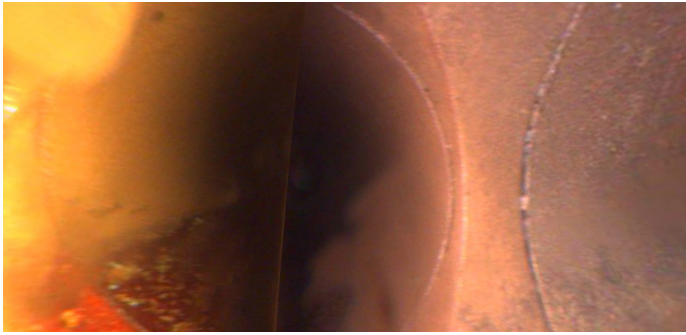
Code: **TF**
Description: **Tap Factory**

Distance (ft): **294.0**
Structural Grade: **0**
O&M Grade: **0**
Clock Start/From: **9**
Clock To:
1st Value: **4.000**
2nd Value:
Value Percent:
Continuous Index:
Within 8" of Joint:
Remarks:

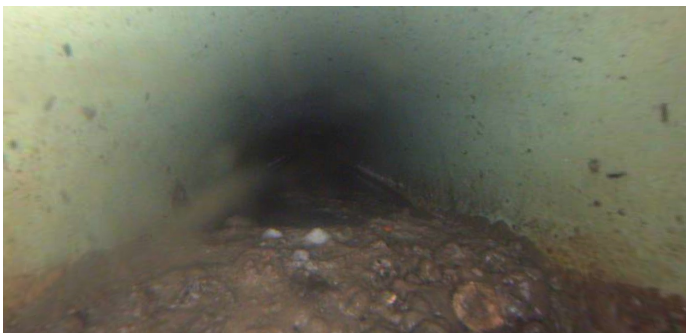
Code: **DSGV**
Description: **Deposits Settled Gravel**

Distance (ft): **295.2**
Structural Grade: **0**
O&M Grade: **5**
Clock Start/From: **3**
Clock To: **9**
1st Value:
2nd Value:
Value Percent: **40.000**
Continuous Index:
Within 8" of Joint: **NO**
Remarks:

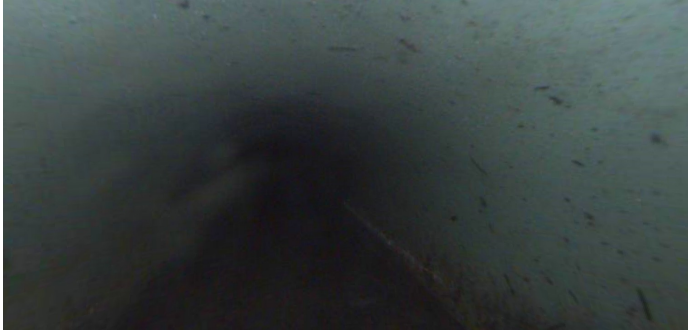
Code:	MSA
Description:	Abandoned Survey
Distance (ft):	295.9
Structural Grade:	0
O&M Grade:	0
Clock Start/From:	
Clock To:	
1st Value:	
2nd Value:	
Value Percent:	
Continuous Index:	
Within 8" of Joint:	NO
Remarks:	ROCKS
