Profile/Photo Observation Report

Date:	03/26/2018	Weather:		Coding:	PACP 6.0
Pipe Length (ft):	211.8	Owner:	NA	Pre Clean:	No Pre-Cleaning
P.O.#:		Surveyor:	Jen Costello	PSR:	P-507-064-067
Customer:		Clean Date:	01/01/1900	Shape:	C

Street:	FOXCROFT STREET	Flow Control:	Not Controlled
City:	Hobart, IN	Year Renewed:	
Location:	Light Highway	Tape/Media #:	
Purpose:	Routine Assessment	Dia/Height:	8"
Use:	Sanitary	Material:	PVC
Drain Area:	NA	Lining:	
Category:	NA		
Comment:	Flow direction wrong

Location Details:		Direction of Survey:	Upstream
US MH:	M-507-064	DS MH:	M-507-067
		Total Length Surveyed (ft):	198.8

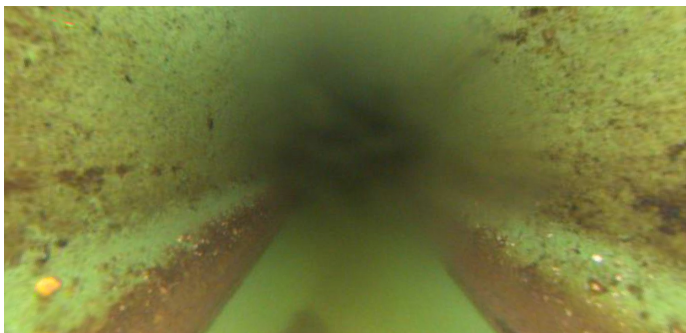
Code: **AMH**
Description: **Manhole**

Distance (ft): **.0**
Structural Grade: **0**
O&M Grade: **0**
Clock Start/From:
Clock To:
1st Value:
2nd Value:
Value Percent:
Continuous Index:
Within 8" of Joint: **NO**
Remarks: **M-507-067**

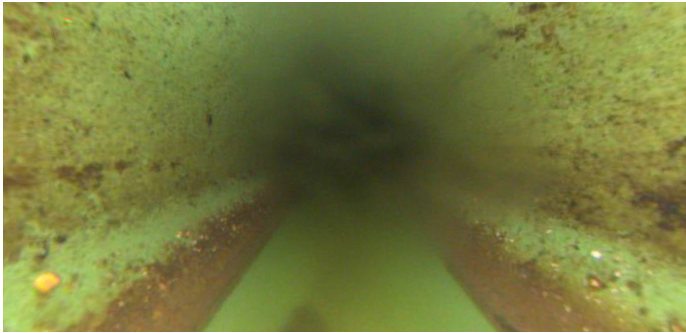
Code:	MWL
Description:	Water Level

Distance (ft):	.0
Structural Grade:	0
O&M Grade:	0
Clock Start/From:	
Clock To:	
1st Value:	
2nd Value:	
Value Percent:	10.000
Continuous Index:	
Within 8" of Joint:	NO
Remarks:

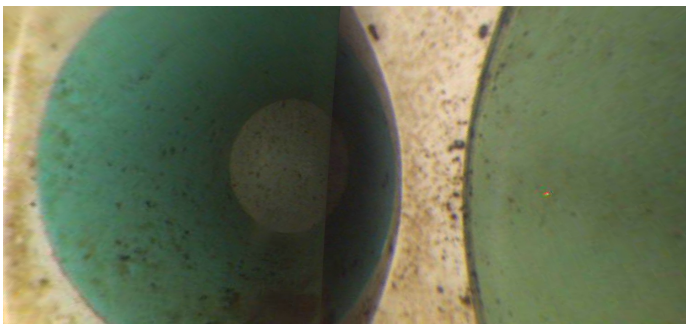
Code:	TFC
Description:	Tap Factory Capped

Distance (ft):	63.2
Structural Grade:	0
O&M Grade:	0
Clock Start/From:	9
Clock To:	
1st Value:	4.000
2nd Value:	
Value Percent:	
Continuous Index:	
Within 8" of Joint:	
Remarks:

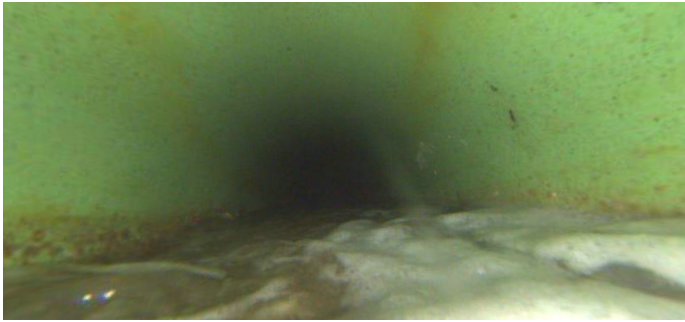
Code: **MGO**
Description: **General Observation**

Distance (ft): **86.4**
Structural Grade: **0**
O&M Grade: **0**
Clock Start/From:
Clock To:
1st Value:
2nd Value:
Value Percent:
Continuous Index:
Within 8" of Joint: **NO**
Remarks: **rear camera**

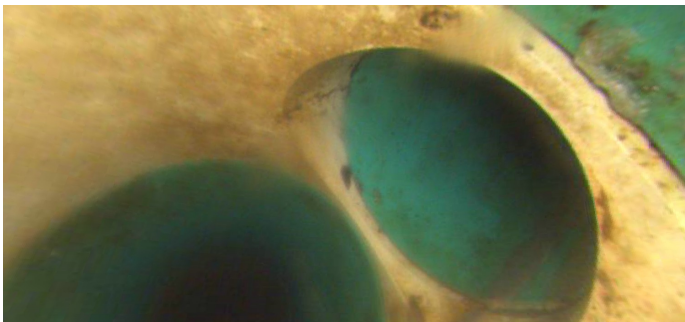
Code: **TF**
Description: **Tap Factory**

Distance (ft): **93.9**
Structural Grade: **0**
O&M Grade: **0**
Clock Start/From: **10**
Clock To:
1st Value: **4.000**
2nd Value:
Value Percent:
Continuous Index:
Within 8" of Joint:
Remarks:

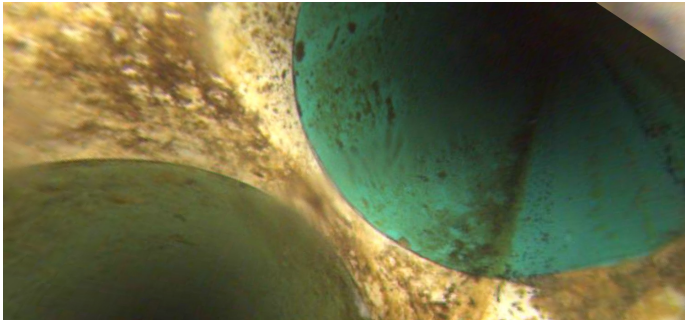
Code: **TF**
Description: **Tap Factory**

Distance (ft): **152.3**
Structural Grade: **0**
O&M Grade: **0**
Clock Start/From: **10**
Clock To:
1st Value: **4.000**
2nd Value:
Value Percent:
Continuous Index:
Within 8" of Joint:
Remarks:

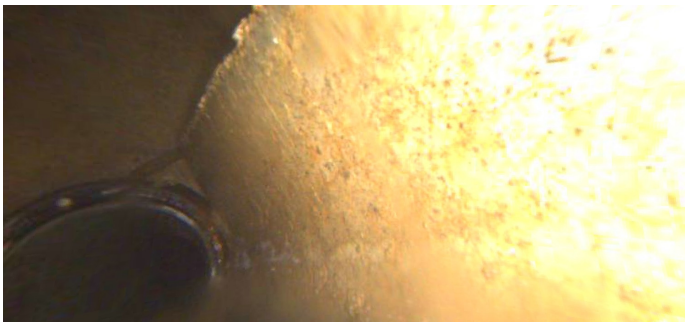
Code: **AMH**
Description: **Manhole**

Distance (ft): **198.8**
Structural Grade: **0**
O&M Grade: **0**
Clock Start/From:
Clock To:
1st Value:
2nd Value:
Value Percent:
Continuous Index:
Within 8" of Joint: **NO**
Remarks: **M-507-064**
