## Profile/Photo Observation Report

| Street: | <b>CSOKASY LN</b> | Flow Control: | <b>Not Controlled</b> |
| City: | <b>Hobart, IN</b> | Year Renewed: | |

| US MH: | <b>M-507-066</b> | DS MH: | <b>M-507-065</b> |

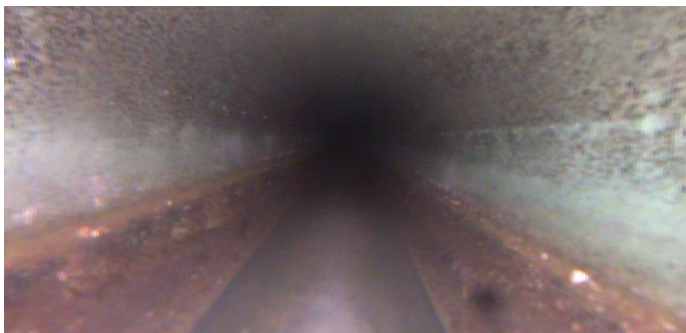
Code: **AMH**  
Description: **Manhole**

Distance (ft): **.0**  
Structural Grade: **0**  
O&M Grade: **0**  
Clock Start/From:  
Clock To:  
1st Value:  
2nd Value:  
Value Percent:  
Continuous Index:  
Within 8" of Joint: **NO**  
Remarks: **M-507-066**

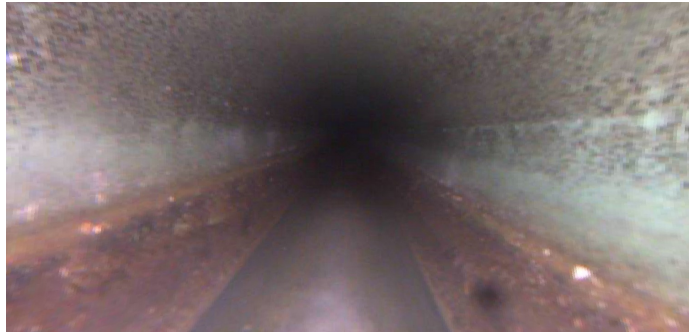
| Code: | <b>MWL</b> |
| Description: | <b>Water Level</b> |
| Distance (ft): | <b>.0</b> |
| Value Percent: | <b>5.000</b> |

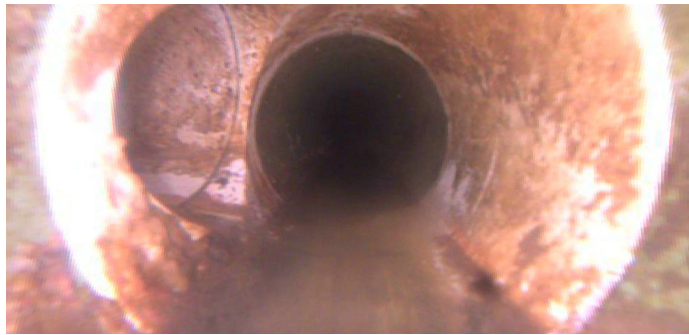
| Code: | <b>TF</b> |
| Description: | <b>Tap Factory</b> |
| Distance (ft): | <b>16.1</b> |
| Clock Start/From: | <b>9</b> |
| 1st Value: | <b>4.000</b> |

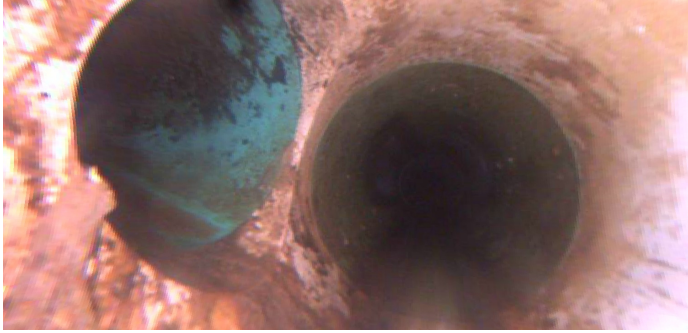
Code: **TF**  
Description: **Tap Factory**

Distance (ft): **66.0**  
Structural Grade: **0**  
O&M Grade: **0**  
Clock Start/From: **9**  
Clock To:  
1st Value: **4.000**  
2nd Value:  
Value Percent:  
Continuous Index:  
Within 8" of Joint:  
Remarks:

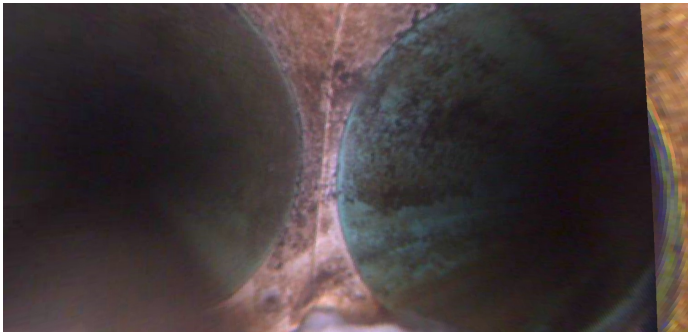
Code: **TF**  
Description: **Tap Factory**

Distance (ft): **83.8**  
Structural Grade: **0**  
O&M Grade: **0**  
Clock Start/From: **3**  
Clock To:  
1st Value: **4.000**  
2nd Value:  
Value Percent:  
Continuous Index:  
Within 8" of Joint:  
Remarks:

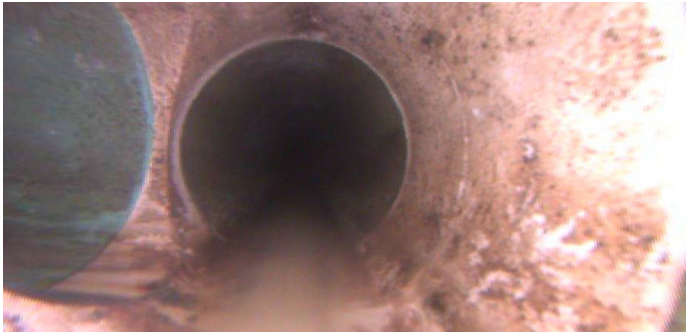
Code: **TF**  
Description: **Tap Factory**

Distance (ft): **121.1**  
Structural Grade: **0**  
O&M Grade: **0**  
Clock Start/From: **9**  
Clock To:  
1st Value: **4.000**  
2nd Value:  
Value Percent:  
Continuous Index:  
Within 8" of Joint:  
Remarks:

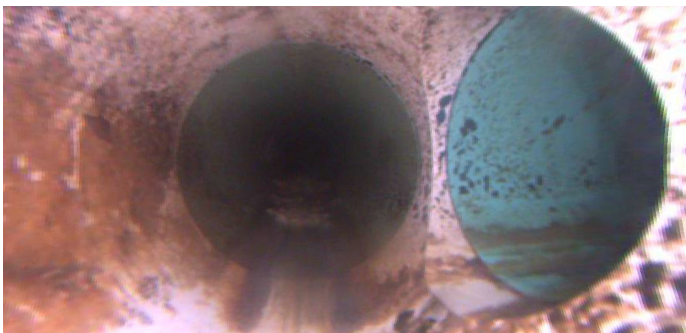
Code: **TF**  
Description: **Tap Factory**

Distance (ft): **152.9**  
Structural Grade: **0**  
O&M Grade: **0**  
Clock Start/From: **3**  
Clock To:  
1st Value: **4.000**  
2nd Value:  
Value Percent:  
Continuous Index:  
Within 8" of Joint:  
Remarks:

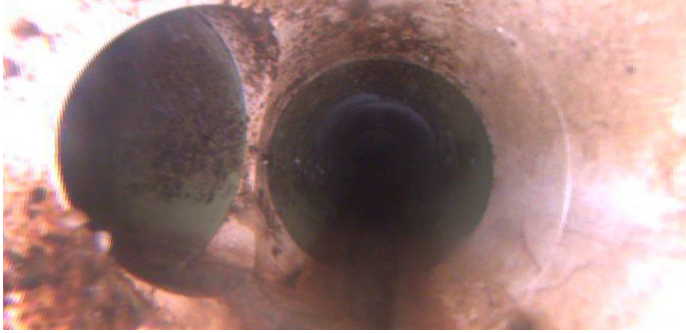
Code: **TF**  
Description: **Tap Factory**

Distance (ft): **171.1**  
Structural Grade: **0**  
O&M Grade: **0**  
Clock Start/From: **9**  
Clock To:  
1st Value: **4.000**  
2nd Value:  
Value Percent:  
Continuous Index:  
Within 8" of Joint:  
Remarks:

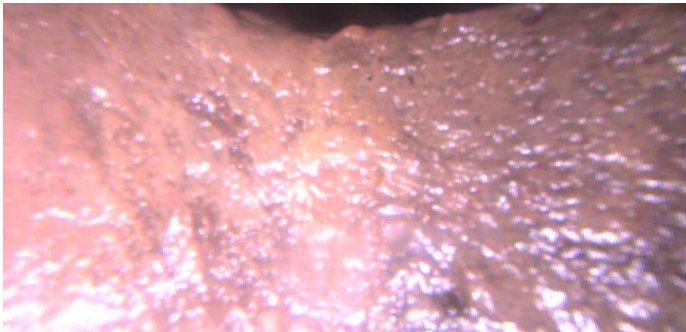
Code: **AMH**  
Description: **Manhole**

Distance (ft): **199.3**  
Structural Grade: **0**  
O&M Grade: **0**  
Clock Start/From:  
Clock To:  
1st Value:  
2nd Value:  
Value Percent:  
Continuous Index:  
Within 8" of Joint: **NO**  
Remarks: **M-507-065**
