Profile/Photo Observation Report

Date:	03/26/2018	Weather:		Coding:	PACP 6.0
Pipe Length (ft):	201.3	Owner:	NA	Pre Clean:	No Pre-Cleaning
P.O.#:		Surveyor:	Justin Gonzales	PSR:	P-507-065-066
Customer:		Clean Date:	01/01/1900	Shape:	C

Street:	FOXCROFT STREET	Flow Control:	Not Controlled
City:	Hobart, IN	Year Renewed:	
Location:	Light Highway	Tape/Media #:	
Purpose:	Routine Assessment	Dia/Height:	8"
Use:	Sanitary	Material:	PVC
Drain Area:	NA	Lining:	
Category:	NA		
Comment:	Flow direction wrong

Location Details:		Direction of Survey:	Downstream
US MH:	M-507-066	DS MH:	M-507-065
		Total Length Surveyed (ft):	199.3

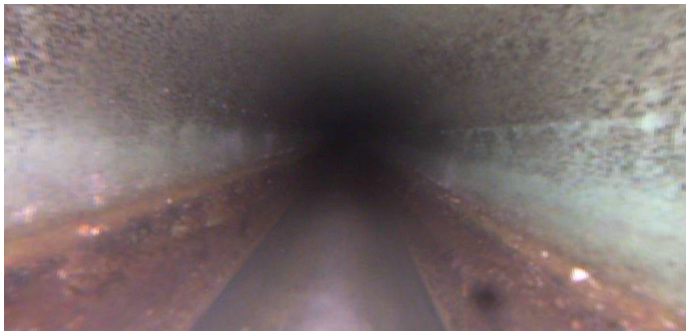
Code: **AMH**
Description: **Manhole**

Distance (ft): **.0**
Structural Grade: **0**
O&M Grade: **0**
Clock Start/From:
Clock To:
1st Value:
2nd Value:
Value Percent:
Continuous Index:
Within 8" of Joint: **NO**
Remarks: **M-507-066**

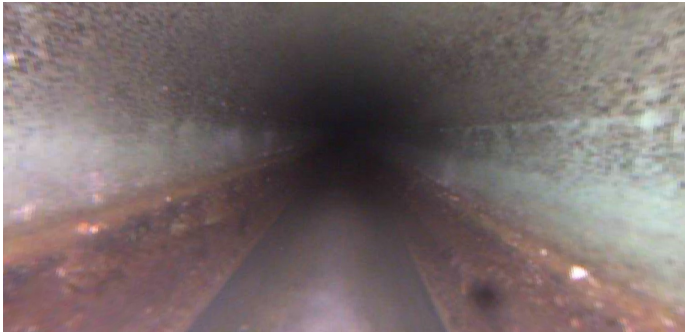
Code:	MWL
Description:	Water Level

Distance (ft):	.0
Structural Grade:	0
O&M Grade:	0
Clock Start/From:	
Clock To:	
1st Value:	
2nd Value:	
Value Percent:	5.000
Continuous Index:	
Within 8" of Joint:	NO
Remarks:

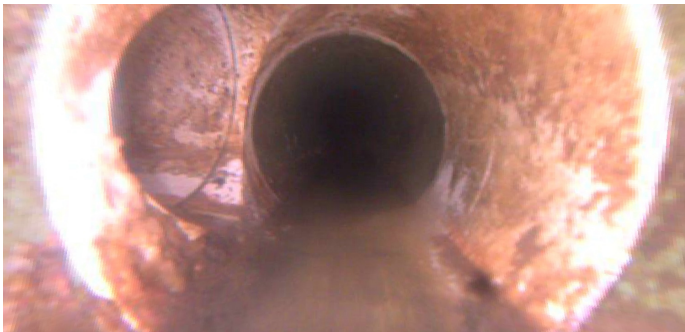
Code:	TF
Description:	Tap Factory

Distance (ft):	16.1
Structural Grade:	0
O&M Grade:	0
Clock Start/From:	9
Clock To:	
1st Value:	4.000
2nd Value:	
Value Percent:	
Continuous Index:	
Within 8" of Joint:	
Remarks:

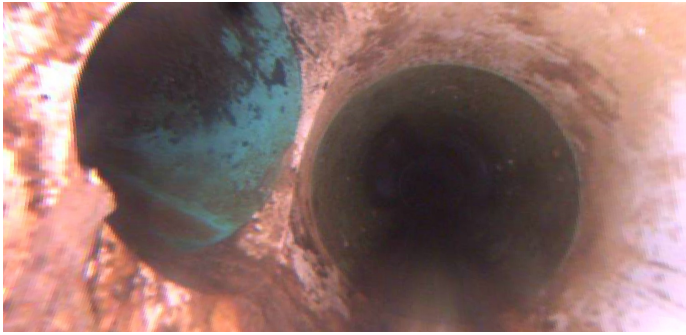
Code: **TF**
Description: **Tap Factory**

Distance (ft): **66.0**
Structural Grade: **0**
O&M Grade: **0**
Clock Start/From: **9**
Clock To:
1st Value: **4.000**
2nd Value:
Value Percent:
Continuous Index:
Within 8" of Joint:
Remarks:

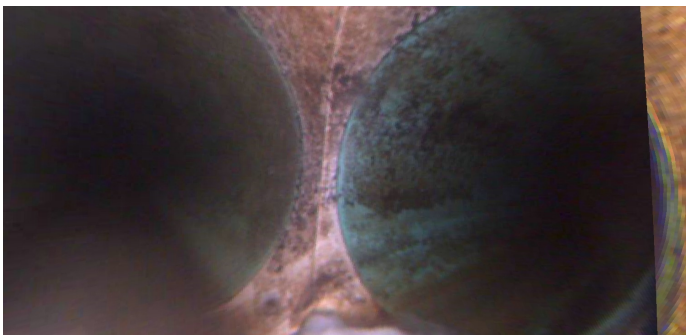
Code: **TF**
Description: **Tap Factory**

Distance (ft): **83.8**
Structural Grade: **0**
O&M Grade: **0**
Clock Start/From: **3**
Clock To:
1st Value: **4.000**
2nd Value:
Value Percent:
Continuous Index:
Within 8" of Joint:
Remarks:

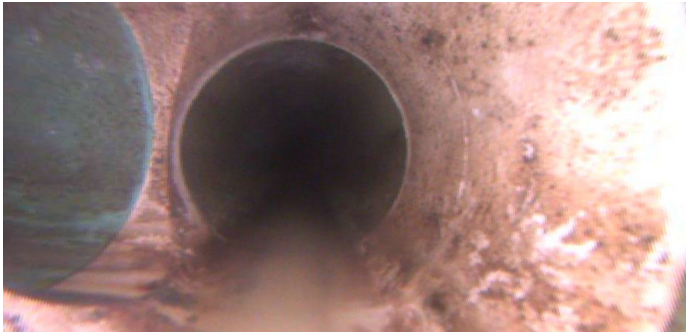
Code: **TF**
Description: **Tap Factory**

Distance (ft): **121.1**
Structural Grade: **0**
O&M Grade: **0**
Clock Start/From: **9**
Clock To:
1st Value: **4.000**
2nd Value:
Value Percent:
Continuous Index:
Within 8" of Joint:
Remarks:

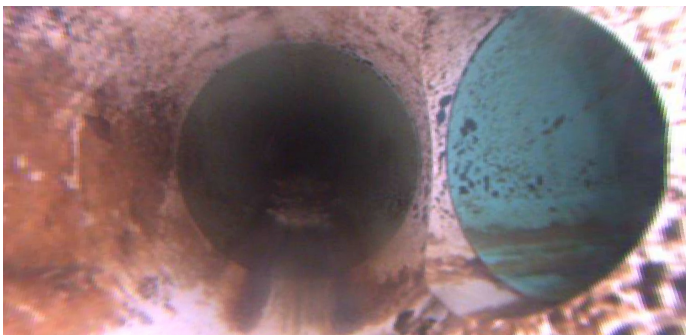
Code: **TF**
Description: **Tap Factory**

Distance (ft): **152.9**
Structural Grade: **0**
O&M Grade: **0**
Clock Start/From: **3**
Clock To:
1st Value: **4.000**
2nd Value:
Value Percent:
Continuous Index:
Within 8" of Joint:
Remarks:

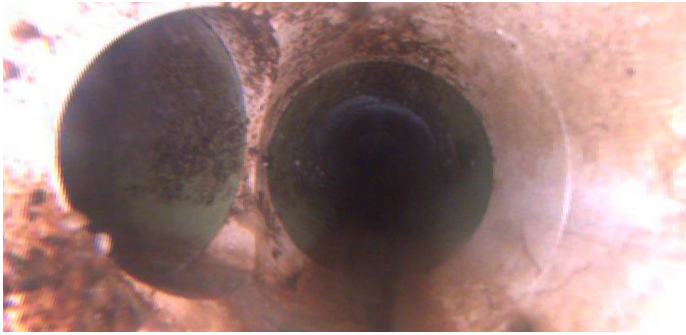
Code: **TF**
Description: **Tap Factory**

Distance (ft): **171.1**
Structural Grade: **0**
O&M Grade: **0**
Clock Start/From: **9**
Clock To:
1st Value: **4.000**
2nd Value:
Value Percent:
Continuous Index:
Within 8" of Joint:
Remarks:

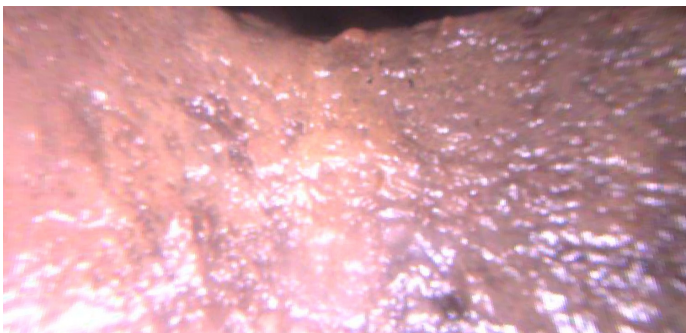
Code: **AMH**
Description: **Manhole**

Distance (ft): **199.3**
Structural Grade: **0**
O&M Grade: **0**
Clock Start/From:
Clock To:
1st Value:
2nd Value:
Value Percent:
Continuous Index:
Within 8" of Joint: **NO**
Remarks: **M-507-065**
