## Profile/Photo Observation Report

Street:	<b>FOXCROFT STREET</b>	Flow Control:	<b>Not Controlled</b>
City:	<b>Hobart, IN</b>	Year Renewed:	
Location:	<b>Light Highway</b>	Tape/Media #:	
Purpose:	<b>Routine Assessment</b>	Dia/Height:	<b>8"</b>
Use:	<b>Sanitary</b>	Material:	<b>PVC</b>
Drain Area:	<b>NA</b>	Lining:	
Category:	<b>NA</b>		
Comment:	<b>Flow direction wrong</b>

Location Details:		Direction of Survey:	<b>Downstream</b>
US MH:	<b>M-507-067</b>	DS MH:	<b>M-507-066</b>
		Total Length Surveyed (ft):	<b>250.2</b>

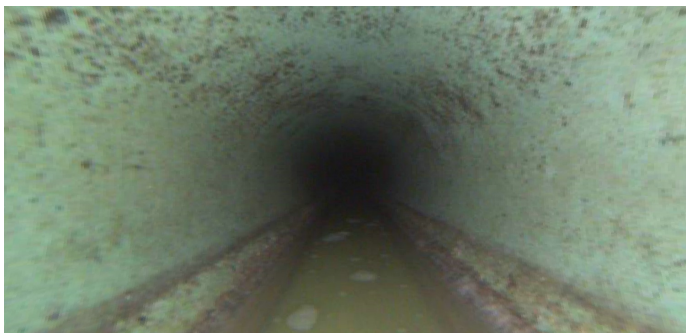
Code: **AMH**  
Description: **Manhole**

Distance (ft): **.0**  
Structural Grade: **0**  
O&M Grade: **0**  
Clock Start/From:  
Clock To:  
1st Value:  
2nd Value:  
Value Percent:  
Continuous Index:  
Within 8" of Joint: **NO**  
Remarks: **M-507-067**

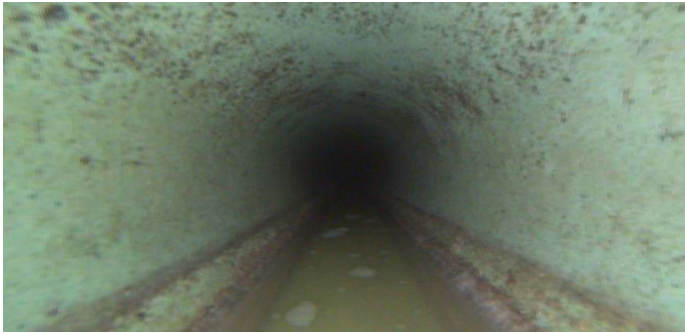
Code:	<b>MWL</b>
Description:	<b>Water Level</b>

Distance (ft):	<b>.0</b>
Structural Grade:	<b>0</b>
O&M Grade:	<b>0</b>
Clock Start/From:	
Clock To:	
1st Value:	
2nd Value:	
Value Percent:	<b>5.000</b>
Continuous Index:	
Within 8" of Joint:	<b>NO</b>
Remarks:

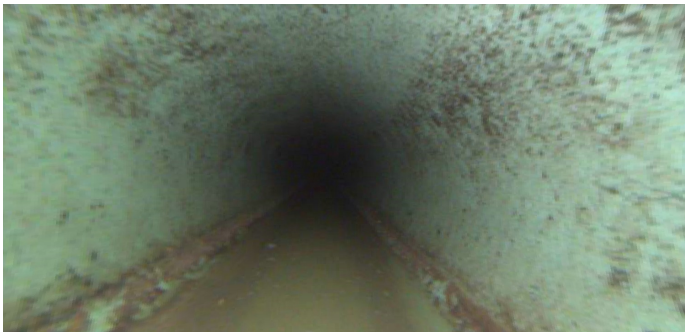
Code:	<b>DAZ</b>
Description:	<b>Deposits Attached Other</b>

Distance (ft):	<b>6.3</b>
Structural Grade:	<b>0</b>
O&M Grade:	<b>2</b>
Clock Start/From:	<b>7</b>
Clock To:	<b>5</b>
1st Value:	
2nd Value:	
Value Percent:	<b>5.000</b>
Continuous Index:	<b>S01</b>
Within 8" of Joint:	
Remarks:	<b>WANDER</b>

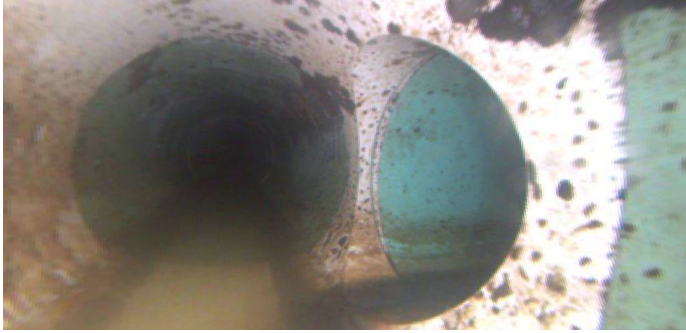
Code: **TF**  
Description: **Tap Factory**

Distance (ft): **29.9**  
Structural Grade: **0**  
O&M Grade: **0**  
Clock Start/From: **3**  
Clock To:  
1st Value: **4.000**  
2nd Value:  
Value Percent:  
Continuous Index:  
Within 8" of Joint:  
Remarks:

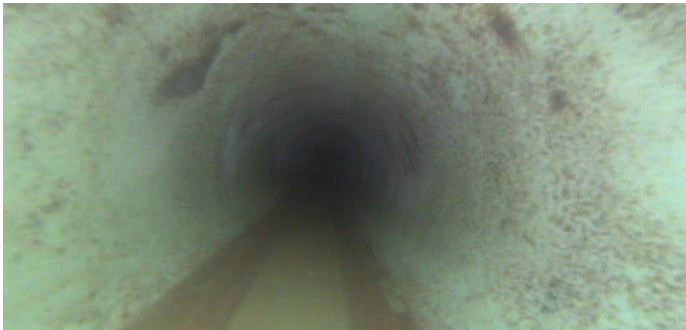
Code: **DAGS**  
Description: **Deposits Attached Grease**

Distance (ft): **36.2**  
Structural Grade: **0**  
O&M Grade: **2**  
Clock Start/From: **7**  
Clock To: **5**  
1st Value:  
2nd Value:  
Value Percent: **0.000**  
Continuous Index: **S02**  
Within 8" of Joint: **YES**  
Remarks: **LESS THAN 5%; WANDER**

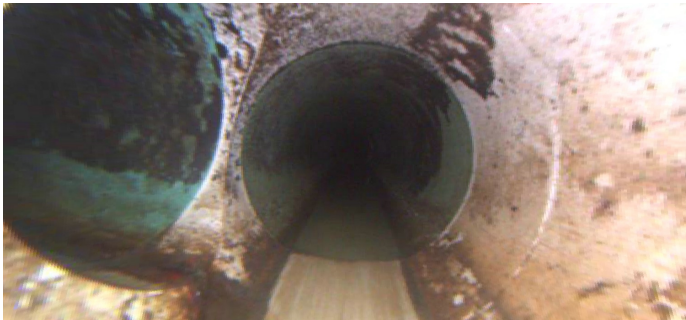
Code: **TF**  
Description: **Tap Factory**

Distance (ft): **116.3**  
Structural Grade: **0**  
O&M Grade: **0**  
Clock Start/From: **9**  
Clock To:  
1st Value: **4.000**  
2nd Value:  
Value Percent:  
Continuous Index:  
Within 8" of Joint:  
Remarks:

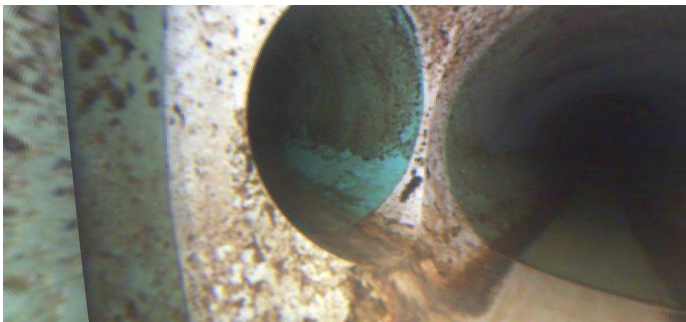
Code: **TF**  
Description: **Tap Factory**

Distance (ft): **168.4**  
Structural Grade: **0**  
O&M Grade: **0**  
Clock Start/From: **9**  
Clock To:  
1st Value: **4.000**  
2nd Value:  
Value Percent:  
Continuous Index:  
Within 8" of Joint:  
Remarks:

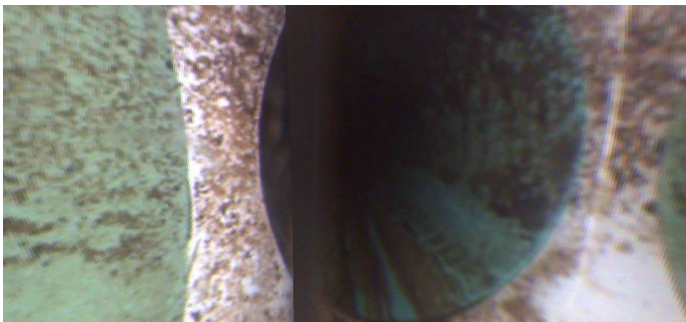
Code: **TF**  
Description: **Tap Factory**

Distance (ft): **226.8**  
Structural Grade: **0**  
O&M Grade: **0**  
Clock Start/From: **3**  
Clock To:  
1st Value: **4.000**  
2nd Value:  
Value Percent:  
Continuous Index:  
Within 8" of Joint:  
Remarks:

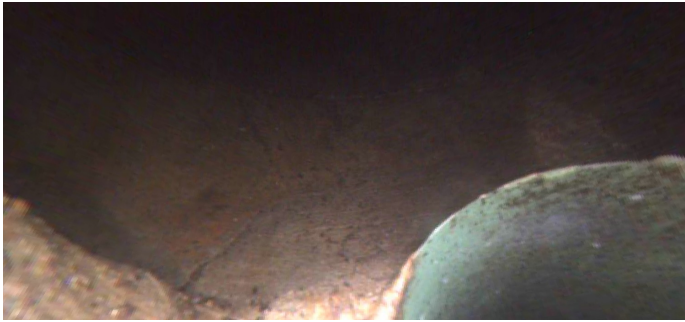
Code: **AMH**  
Description: **Manhole**

Distance (ft): **250.2**  
Structural Grade: **0**  
O&M Grade: **0**  
Clock Start/From:  
Clock To:  
1st Value:  
2nd Value:  
Value Percent:  
Continuous Index:  
Within 8" of Joint: **NO**  
Remarks: **M-507-066**

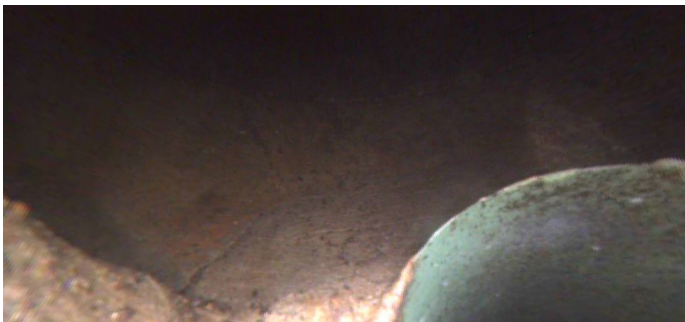
Code: **DAZ**  
Description: **Deposits Attached Other**

Distance (ft): **250.2**  
Structural Grade: **0**  
O&M Grade: **2**  
Clock Start/From: **7**  
Clock To: **5**  
1st Value:  
2nd Value:  
Value Percent: **5.000**  
Continuous Index: **F01**  
Within 8" of Joint:  
Remarks: **WANDER**

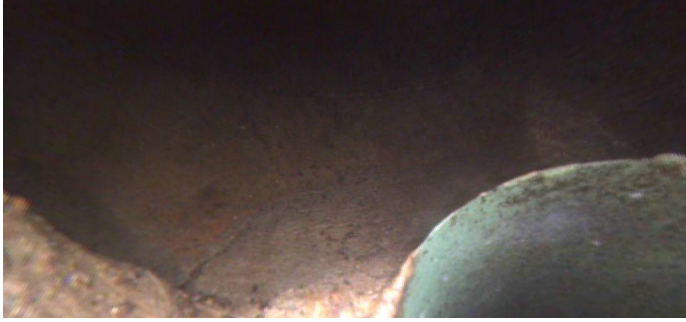
Code:	<b>DAGS</b>
Description:	<b>Deposits Attached Grease</b>
Distance (ft):	<b>250.2</b>
Structural Grade:	<b>0</b>
O&M Grade:	<b>2</b>
Clock Start/From:	<b>7</b>
Clock To:	<b>5</b>
1st Value:	
2nd Value:	
Value Percent:	<b>0.000</b>
Continuous Index:	<b>F02</b>
Within 8" of Joint:	<b>YES</b>
Remarks:	<b>LESS THAN 5%; WANDER</b>
