Profile/Photo Observation Report

Street:	CSOKASY LN	Flow Control:	Not Controlled
City:	Hobart, IN	Year Renewed:	
Location:	Light Highway	Tape/Media #:	
Purpose:	Routine Assessment	Dia/Height:	8"
Use:	Sanitary	Material:	PVC
Drain Area:	NA	Lining:	
Category:	NA		
Comment:	Flow direction wrong

Location Details:		Direction of Survey:	Downstream
US MH:	M-507-067	DS MH:	M-507-068
		Total Length Surveyed (ft):	314.9

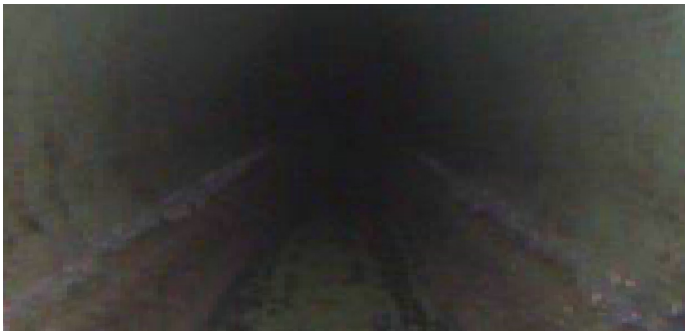
Code: **AMH**
Description: **Manhole**

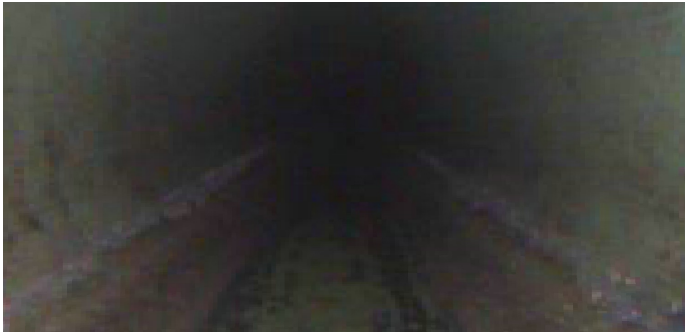
Code:	MWL
Description:	Water Level

Distance (ft):	.0
Structural Grade:	0
O&M Grade:	0
Clock Start/From:	
Clock To:	
1st Value:	
2nd Value:	
Value Percent:	5.000
Continuous Index:	
Within 8" of Joint:	NO
Remarks:

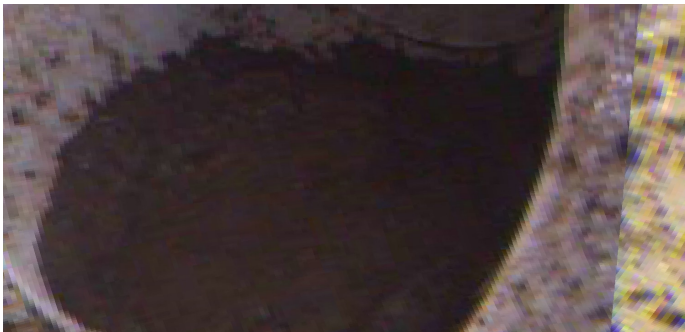
Code:	TFD
Description:	Tap Factory Defective

Distance (ft):	41.5
Structural Grade:	0
O&M Grade:	2
Clock Start/From:	3
Clock To:	
1st Value:	4.000
2nd Value:	
Value Percent:	
Continuous Index:	
Within 8" of Joint:	NO
Remarks:	DEPOSITS BLOCKING INSIDE TAP

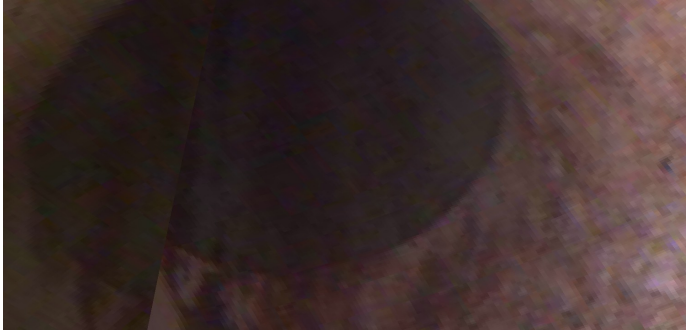
Code: **TF**
Description: **Tap Factory**

Distance (ft): **83.8**
Structural Grade: **0**
O&M Grade: **0**
Clock Start/From: **10**
Clock To:
1st Value: **4.000**
2nd Value:
Value Percent:
Continuous Index:
Within 8" of Joint:
Remarks:

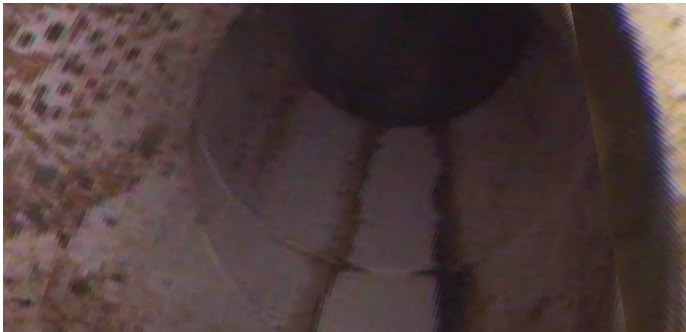
Code: **TF**
Description: **Tap Factory**

Distance (ft): **140.0**
Structural Grade: **0**
O&M Grade: **0**
Clock Start/From: **2**
Clock To:
1st Value: **4.000**
2nd Value:
Value Percent:
Continuous Index:
Within 8" of Joint:
Remarks:

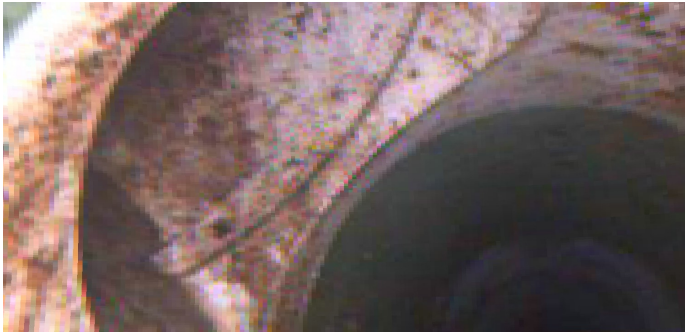
Code: **TF**
Description: **Tap Factory**

Distance (ft): **168.7**
Structural Grade: **0**
O&M Grade: **0**
Clock Start/From: **2**
Clock To:
1st Value: **4.000**
2nd Value:
Value Percent:
Continuous Index:
Within 8" of Joint:
Remarks:

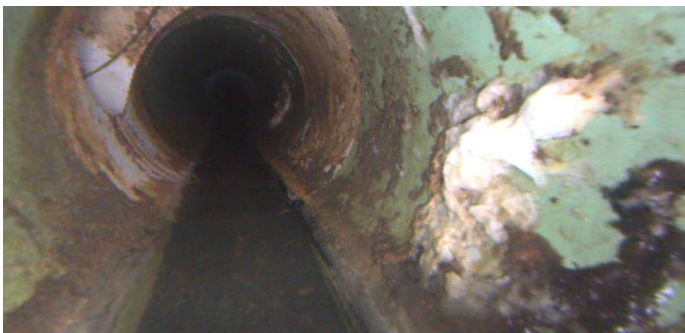
Code: **DAGS**
Description: **Deposits Attached Grease**

Distance (ft): **223.6**
Structural Grade: **0**
O&M Grade: **2**
Clock Start/From: **3**
Clock To: **4**
1st Value:
2nd Value:
Value Percent: **5.000**
Continuous Index:
Within 8" of Joint: **NO**
Remarks:

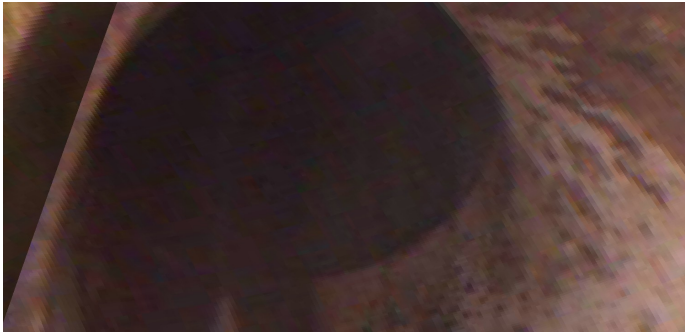
Code: **TF**
Description: **Tap Factory**

Distance (ft): **224.4**
Structural Grade: **0**
O&M Grade: **0**
Clock Start/From: **10**
Clock To:
1st Value: **4.000**
2nd Value:
Value Percent:
Continuous Index:
Within 8" of Joint:
Remarks:

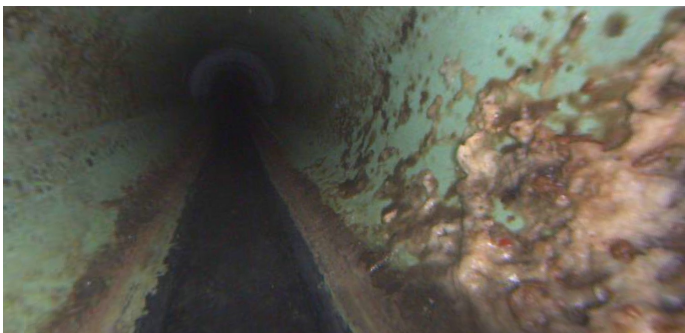
Code: **DAGS**
Description: **Deposits Attached Grease**

Distance (ft): **225.5**
Structural Grade: **0**
O&M Grade: **2**
Clock Start/From: **3**
Clock To: **4**
1st Value:
2nd Value:
Value Percent: **5.000**
Continuous Index:
Within 8" of Joint: **NO**
Remarks:

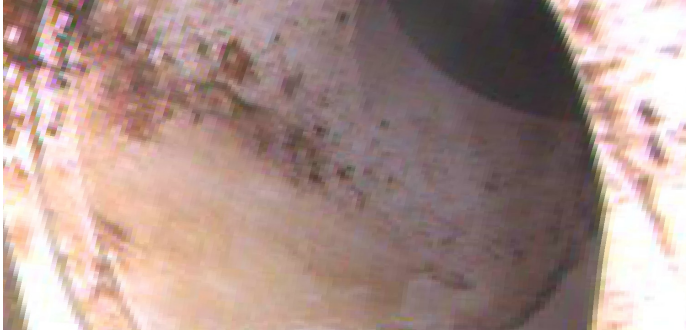
Code: **TF**
Description: **Tap Factory**

Distance (ft): **241.7**
Structural Grade: **0**
O&M Grade: **0**
Clock Start/From: **2**
Clock To:
1st Value: **4.000**
2nd Value:
Value Percent:
Continuous Index:
Within 8" of Joint:
Remarks:

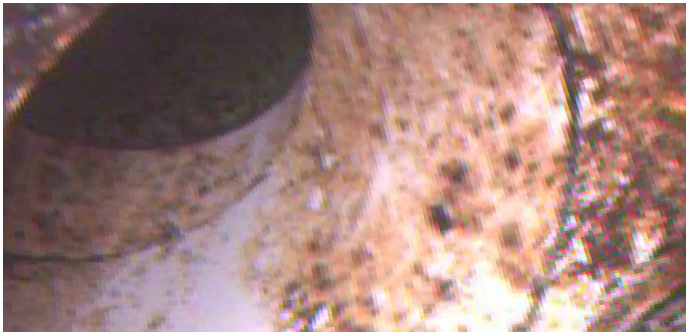
Code: **TF**
Description: **Tap Factory**

Distance (ft): **281.2**
Structural Grade: **0**
O&M Grade: **0**
Clock Start/From: **10**
Clock To:
1st Value: **4.000**
2nd Value:
Value Percent:
Continuous Index:
Within 8" of Joint:
Remarks:

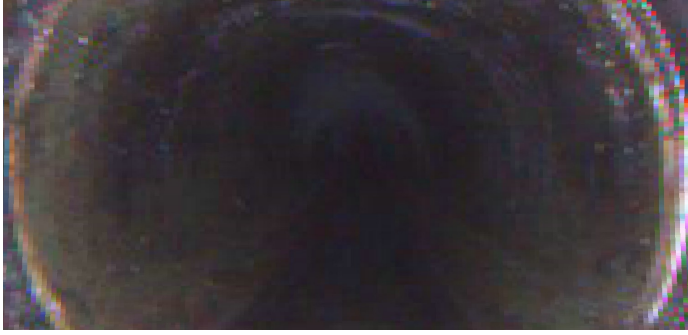
Code:	AMH
Description:	Manhole
Distance (ft):	314.9
Structural Grade:	0
O&M Grade:	0
Clock Start/From:	
Clock To:	
1st Value:	
2nd Value:	
Value Percent:	
Continuous Index:	
Within 8" of Joint:	NO
Remarks:	M-507-068
