Profile/Photo Observation Report

Date:	03/26/2018	Weather:		Coding:	PACP 6.0
Pipe Length (ft):	304.8	Owner:	NA	Pre Clean:	No Pre-Cleaning
P.O.#:		Surveyor:	Justin Gonzales	PSR:	P-507-067-068
Customer:		Clean Date:	01/01/1900	Shape:	C

Street:	FOXCROFT STREET	Flow Control:	Not Controlled
City:	Hobart, IN	Year Renewed:	
Location:	Light Highway	Tape/Media #:	
Purpose:	Routine Assessment	Dia/Height:	8"
Use:	Sanitary	Material:	PVC
Drain Area:	NA	Lining:	
Category:	NA		
Comment:	Flow direction wrong

Location Details:		Direction of Survey:	Downstream
US MH:	M-507-067	DS MH:	M-507-068
		Total Length Surveyed (ft):	314.9

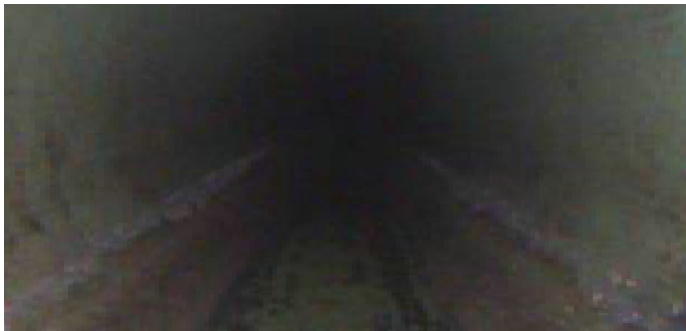
Code: **AMH**
Description: **Manhole**

Distance (ft): **.0**
Structural Grade: **0**
O&M Grade: **0**
Clock Start/From:
Clock To:
1st Value:
2nd Value:
Value Percent:
Continuous Index:
Within 8" of Joint: **NO**
Remarks: **M-507-067**

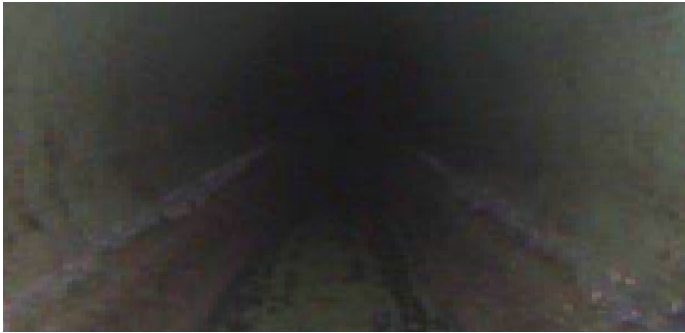
Code:	MWL
Description:	Water Level

Distance (ft):	.0
Structural Grade:	0
O&M Grade:	0
Clock Start/From:	
Clock To:	
1st Value:	
2nd Value:	
Value Percent:	5.000
Continuous Index:	
Within 8" of Joint:	NO
Remarks:

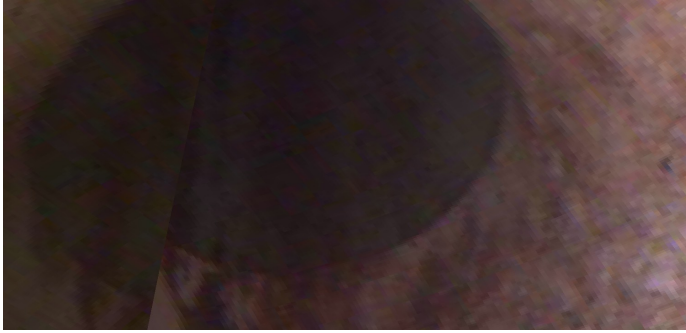
Code: **TF**
Description: **Tap Factory**

Distance (ft): **83.8**
Structural Grade: **0**
O&M Grade: **0**
Clock Start/From: **10**
Clock To:
1st Value: **4.000**
2nd Value:
Value Percent:
Continuous Index:
Within 8" of Joint:
Remarks:

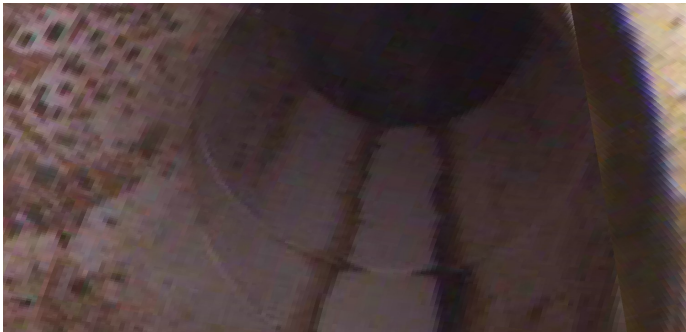
Code: **TF**
Description: **Tap Factory**

Distance (ft): **140.0**
Structural Grade: **0**
O&M Grade: **0**
Clock Start/From: **2**
Clock To:
1st Value: **4.000**
2nd Value:
Value Percent:
Continuous Index:
Within 8" of Joint:
Remarks:

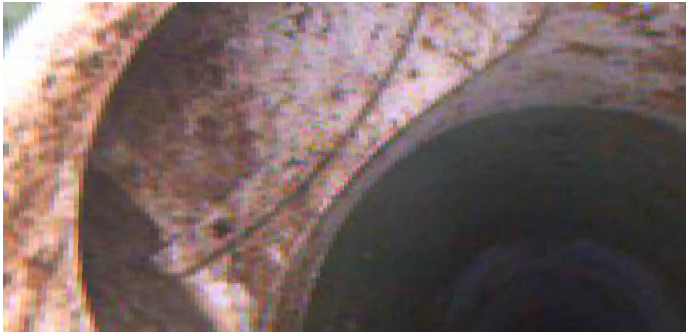
Code: **TF**
Description: **Tap Factory**

Distance (ft): **168.7**
Structural Grade: **0**
O&M Grade: **0**
Clock Start/From: **2**
Clock To:
1st Value: **4.000**
2nd Value:
Value Percent:
Continuous Index:
Within 8" of Joint:
Remarks:

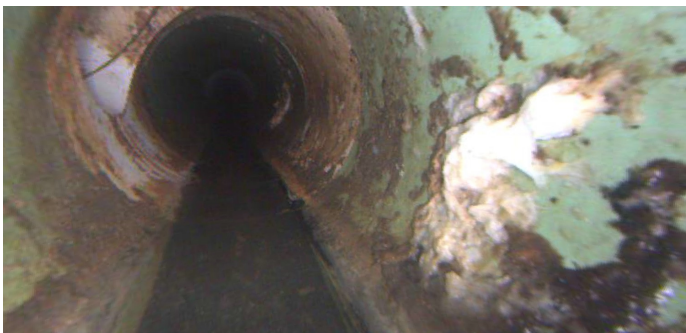
Code: **DAGS**
Description: **Deposits Attached Grease**

Distance (ft): **223.6**
Structural Grade: **0**
O&M Grade: **2**
Clock Start/From: **3**
Clock To: **4**
1st Value:
2nd Value:
Value Percent: **5.000**
Continuous Index:
Within 8" of Joint: **NO**
Remarks:

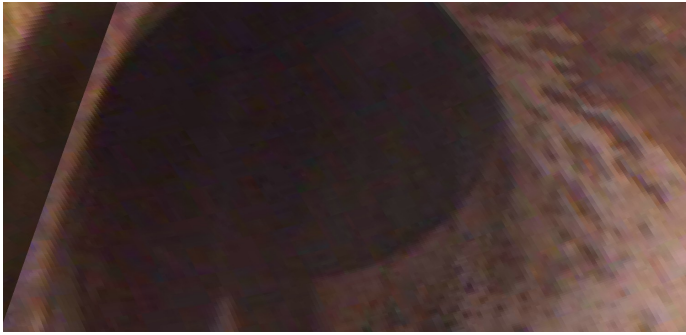
Code: **TF**
Description: **Tap Factory**

Distance (ft): **224.4**
Structural Grade: **0**
O&M Grade: **0**
Clock Start/From: **10**
Clock To:
1st Value: **4.000**
2nd Value:
Value Percent:
Continuous Index:
Within 8" of Joint:
Remarks:

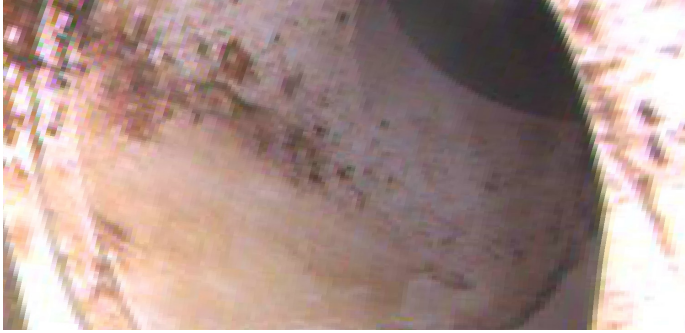
Code: **TF**
Description: **Tap Factory**

Distance (ft): **241.7**
Structural Grade: **0**
O&M Grade: **0**
Clock Start/From: **2**
Clock To:
1st Value: **4.000**
2nd Value:
Value Percent:
Continuous Index:
Within 8" of Joint:
Remarks:

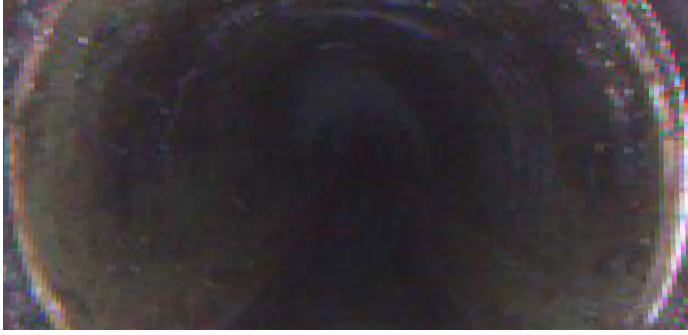
Code:	AMH
Description:	Manhole
Distance (ft):	314.9
Structural Grade:	0
O&M Grade:	0
Clock Start/From:	
Clock To:	
1st Value:	
2nd Value:	
Value Percent:	
Continuous Index:	
Within 8" of Joint:	NO
Remarks:	M-507-068
